Description of document: General Services Administration (GSA) Architectural Assessment Report on the Old Post Office Building, 2012

OLD POST OFFICE
HSR

EXISTING EXTERIOR CONDITIONS SURVEY

EXISTING INTERIOR CONDITIONS SURVEY

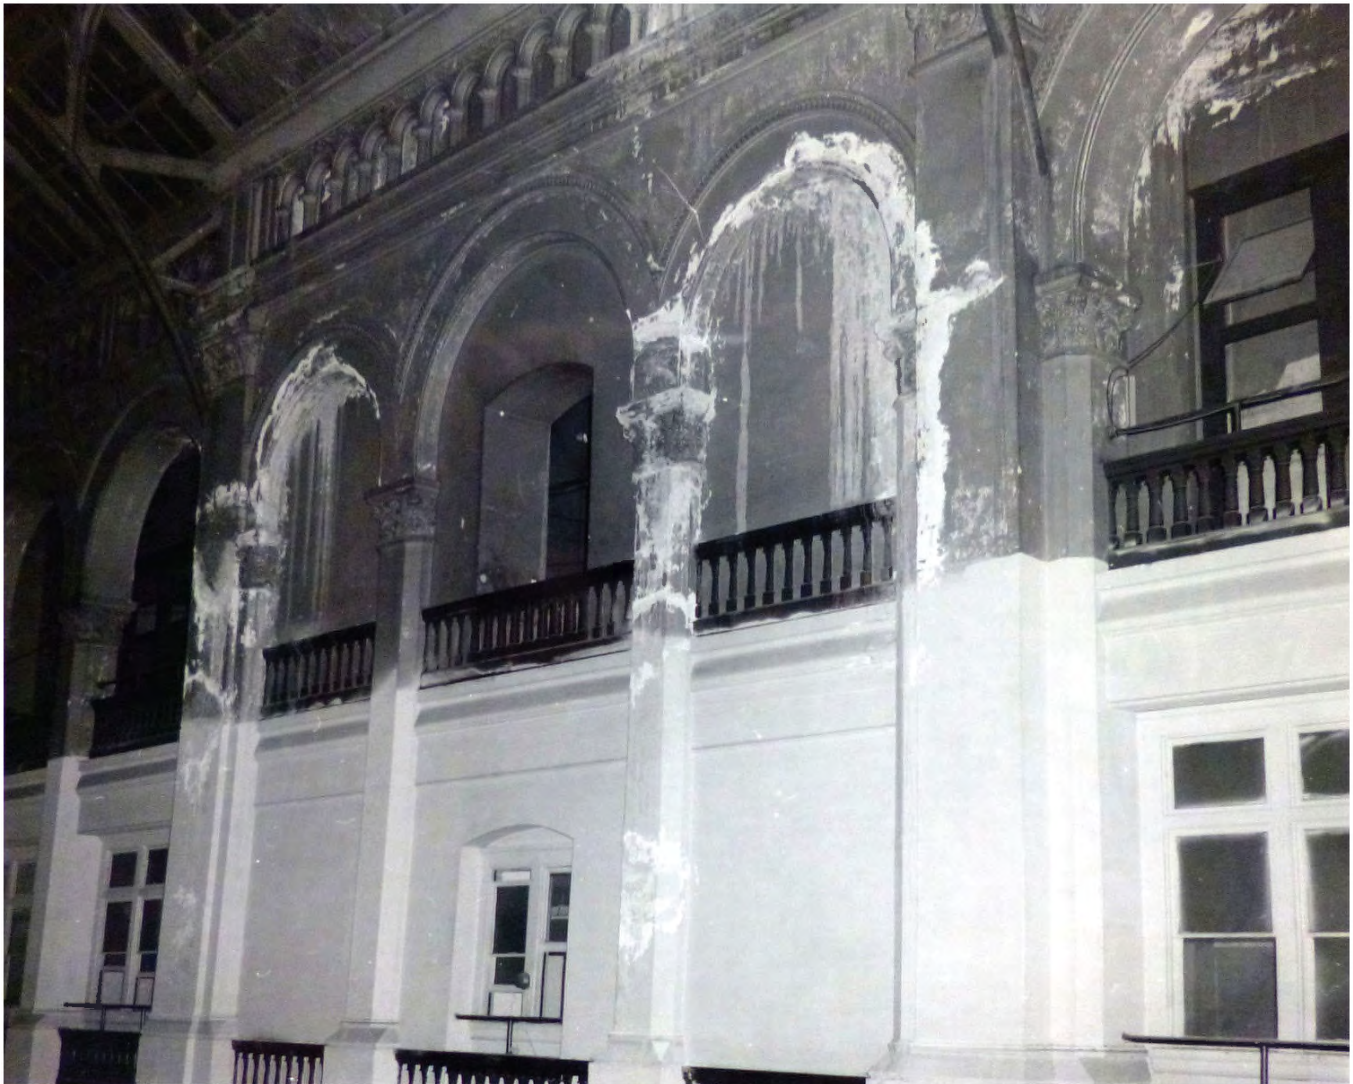
FIGURE 30: Undated photograph of cortile arcade, showing water damage. Image Courtesy of GSA-NCR Technical Resource Center, Reports and Photographs

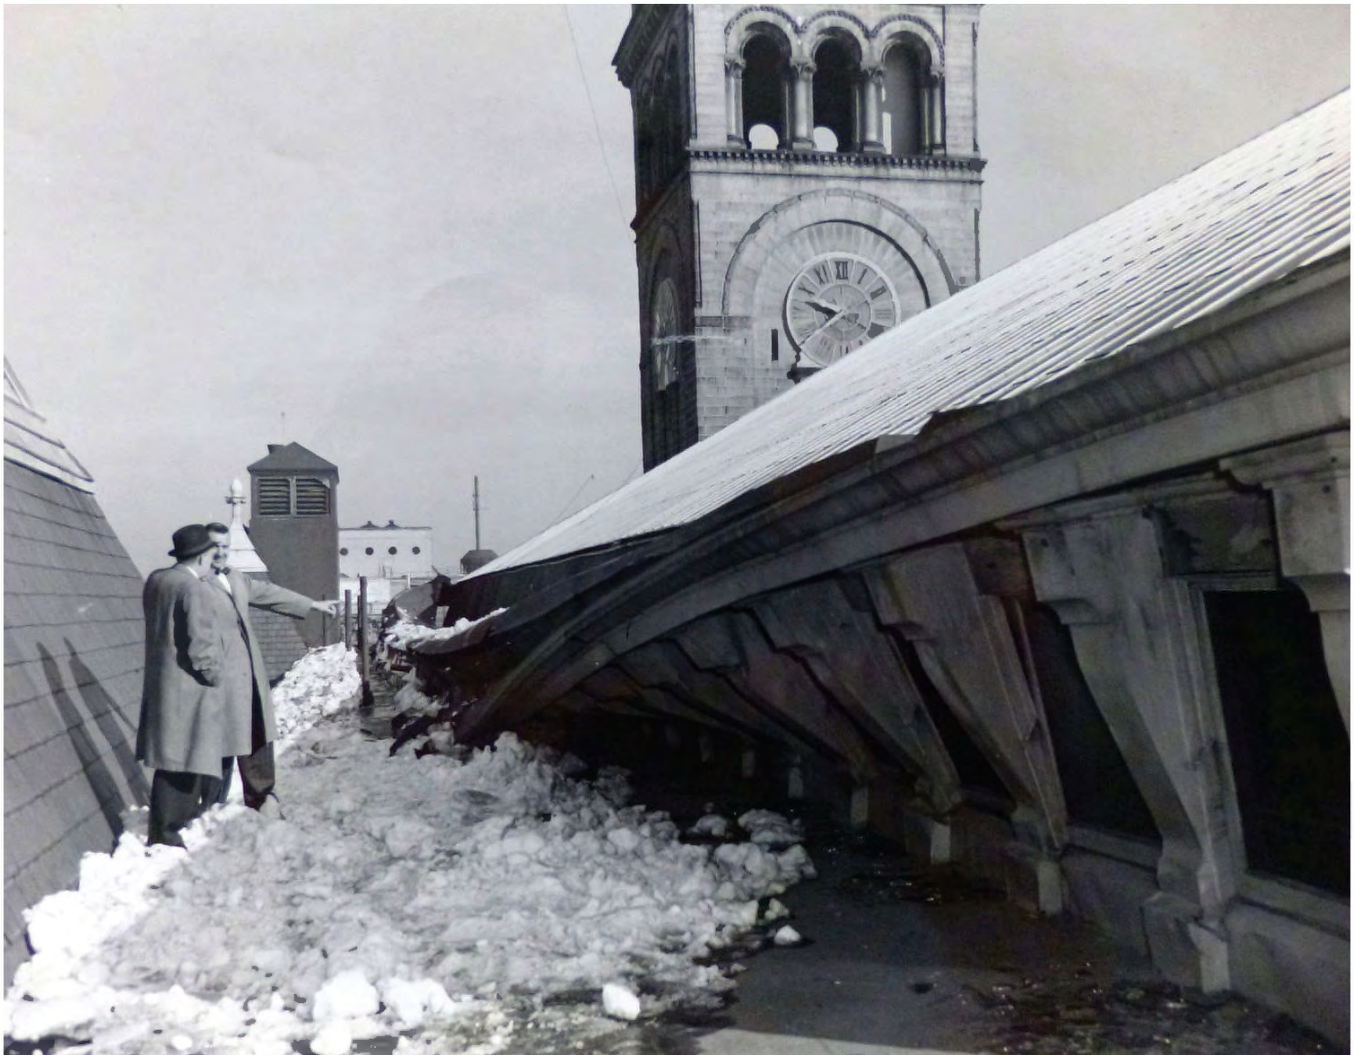
FIGURE 32: Undated photograph of men inspecting roof, showing deteriorated condition of skylight roof clerestory. Image Courtesy of GSA-NCR Technical Resource Center, Reports and Photographs

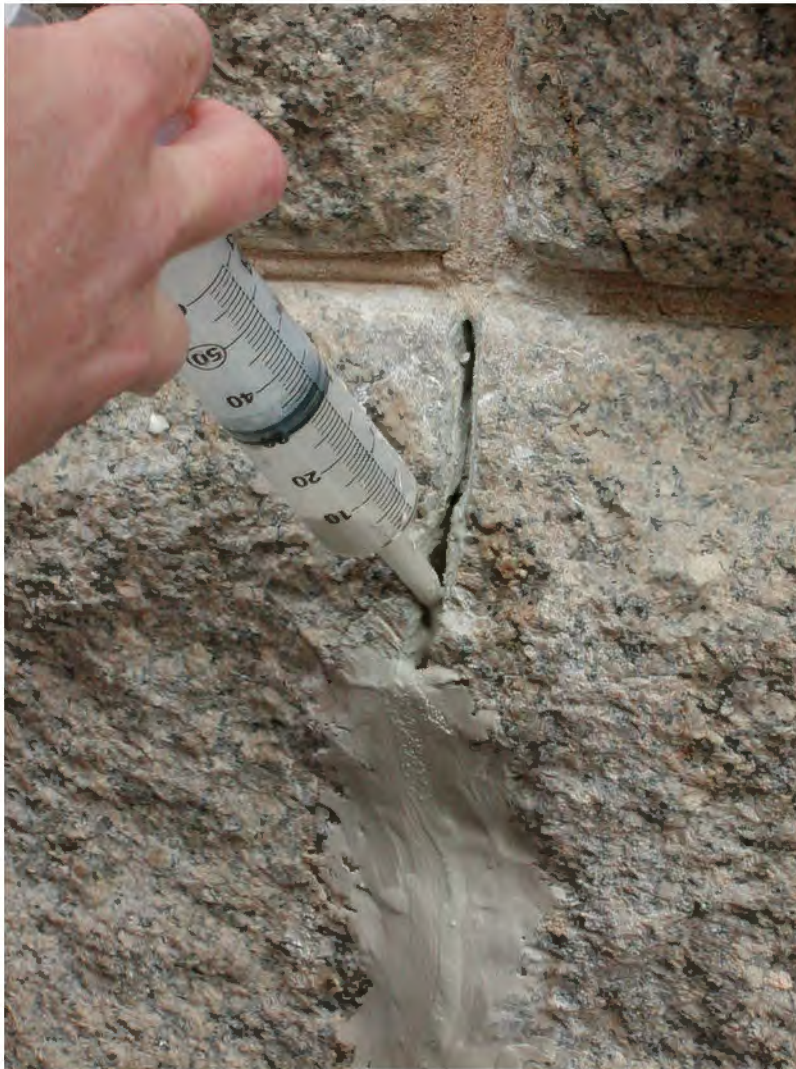
FIGURE 14: Successful Repair Campaigns, September 2006. Photo Courtesy T. McDowell

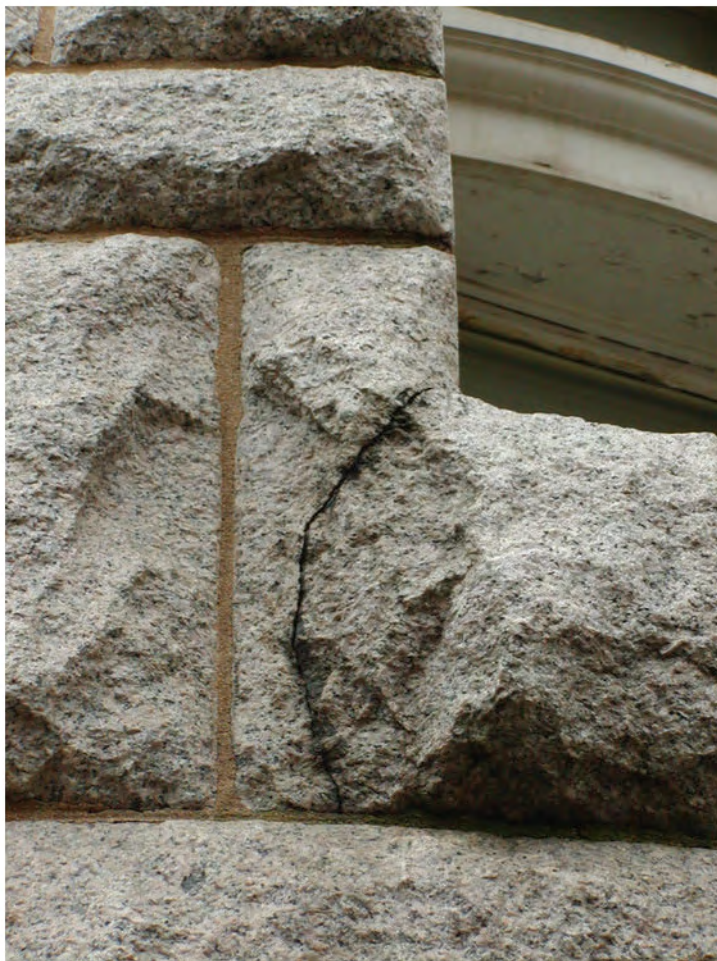
FIGURE 20: Re-pointed Joint at SW Corner Turret, 2006.
Photo Courtesy T. McDowell

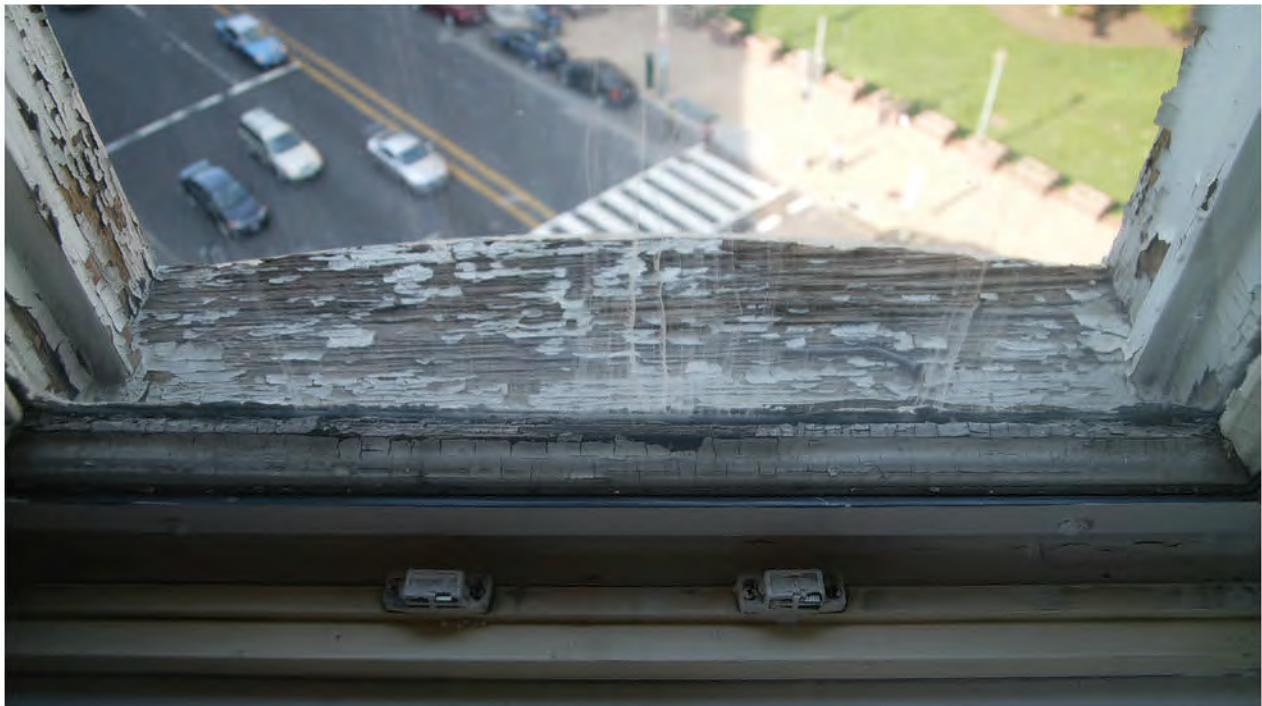
FIGURE 56: Paint Is Almost Gone at the Sill and Lower Section of the Jamb, 2012. Photo Courtesy OLBN Inc..

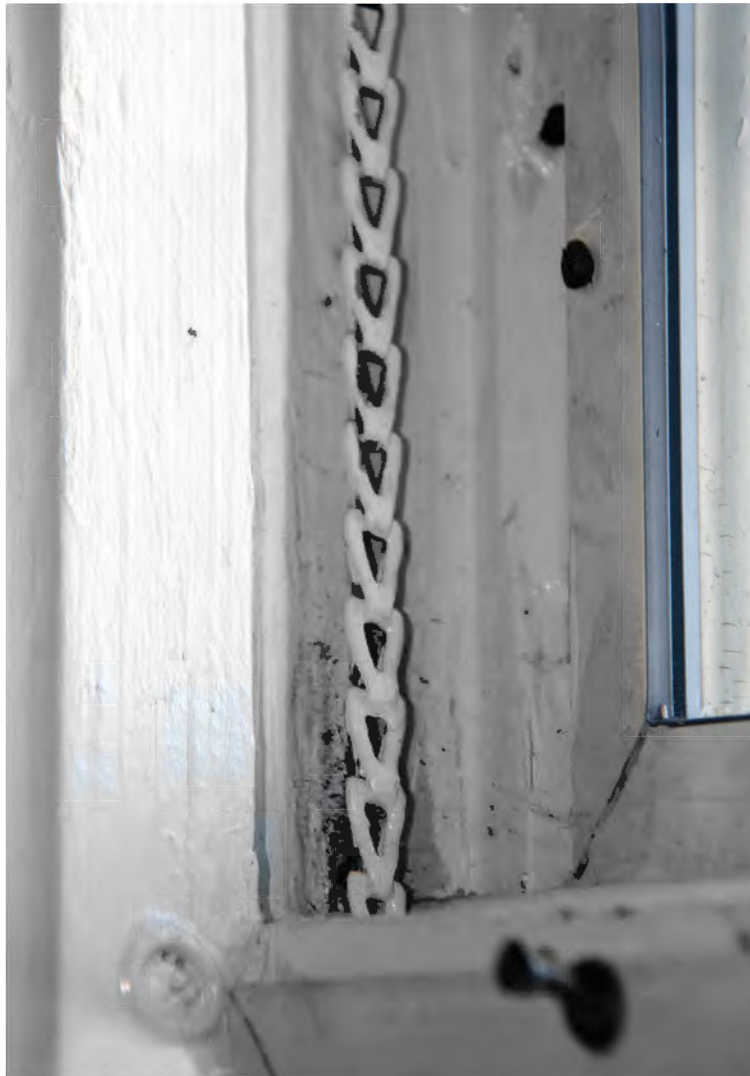
FIGURE 59: Painted Sash Chains, 2012. Photo Courtesy OLBN Inc..

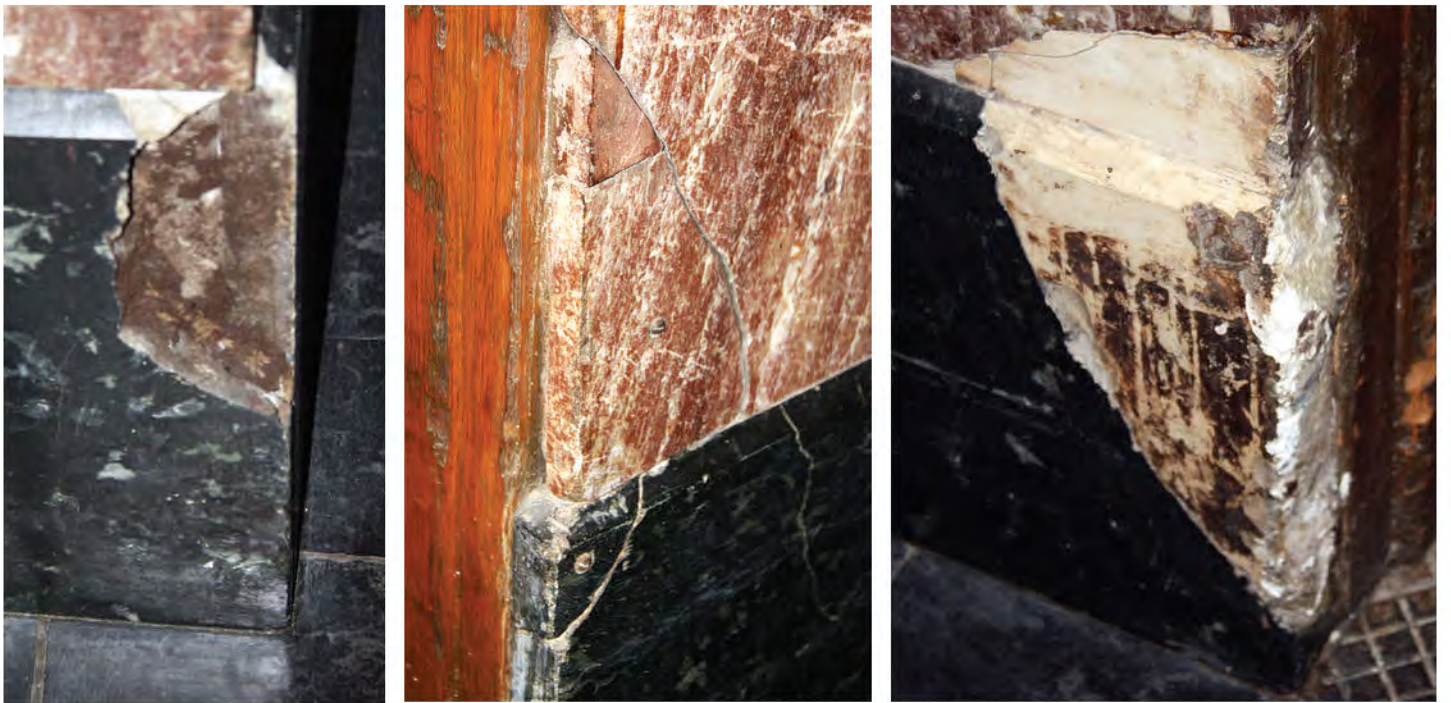
FIGURES 80, 81 & 82: Different types of Mechanical Damage Inflicted on the Marble Wainscot, Resulting in Broken and Missing Pieces, 2012. Photos Courtesy OLBN Inc..
