Description of document: General Services Administration (GSA) Architectural Assessment Report on the Old Post Office Building, 2012

OLD POST OFFICE
HSR

EXISTING EXTERIOR CONDITIONS SURVEY

EXISTING INTERIOR CONDITIONS SURVEY

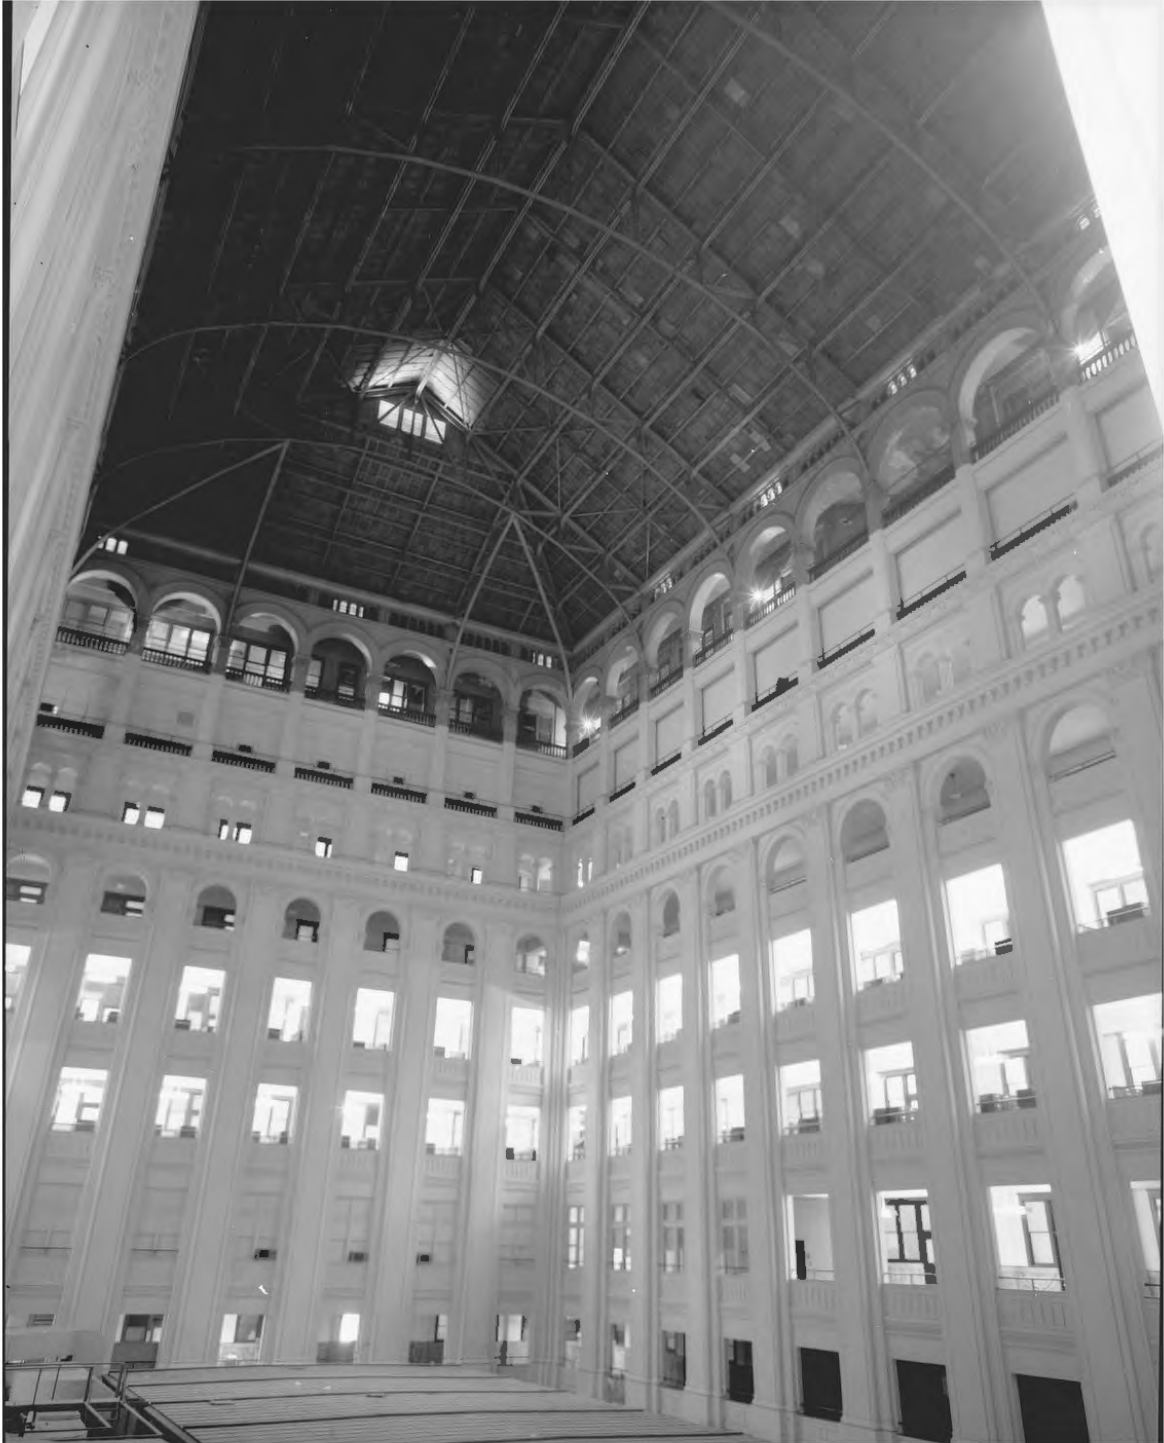
FIGURE 31: 1967 Building Interior. Image Courtesy of the Library of Congress, Prints and Photographs Division, HABS Collection

On the exterior, the quarry-faced stone of the first and mezzanine stories had gathered soot more rapidly than the honed finish of the upper floors, giving the building's street-level exterior a dark, grimy film. Further, the windows' exterior awnings had been removed, and many featured mounted air conditioning units. On the roof, the cast-iron clerestory windows wrapping the skylight roof were slowly collapsing, perhaps under the weight of its new metal-and-asbestos shell. Without direct intervention, the continued deterioration of the roofing structure would have made inhabitation of the building unwise.

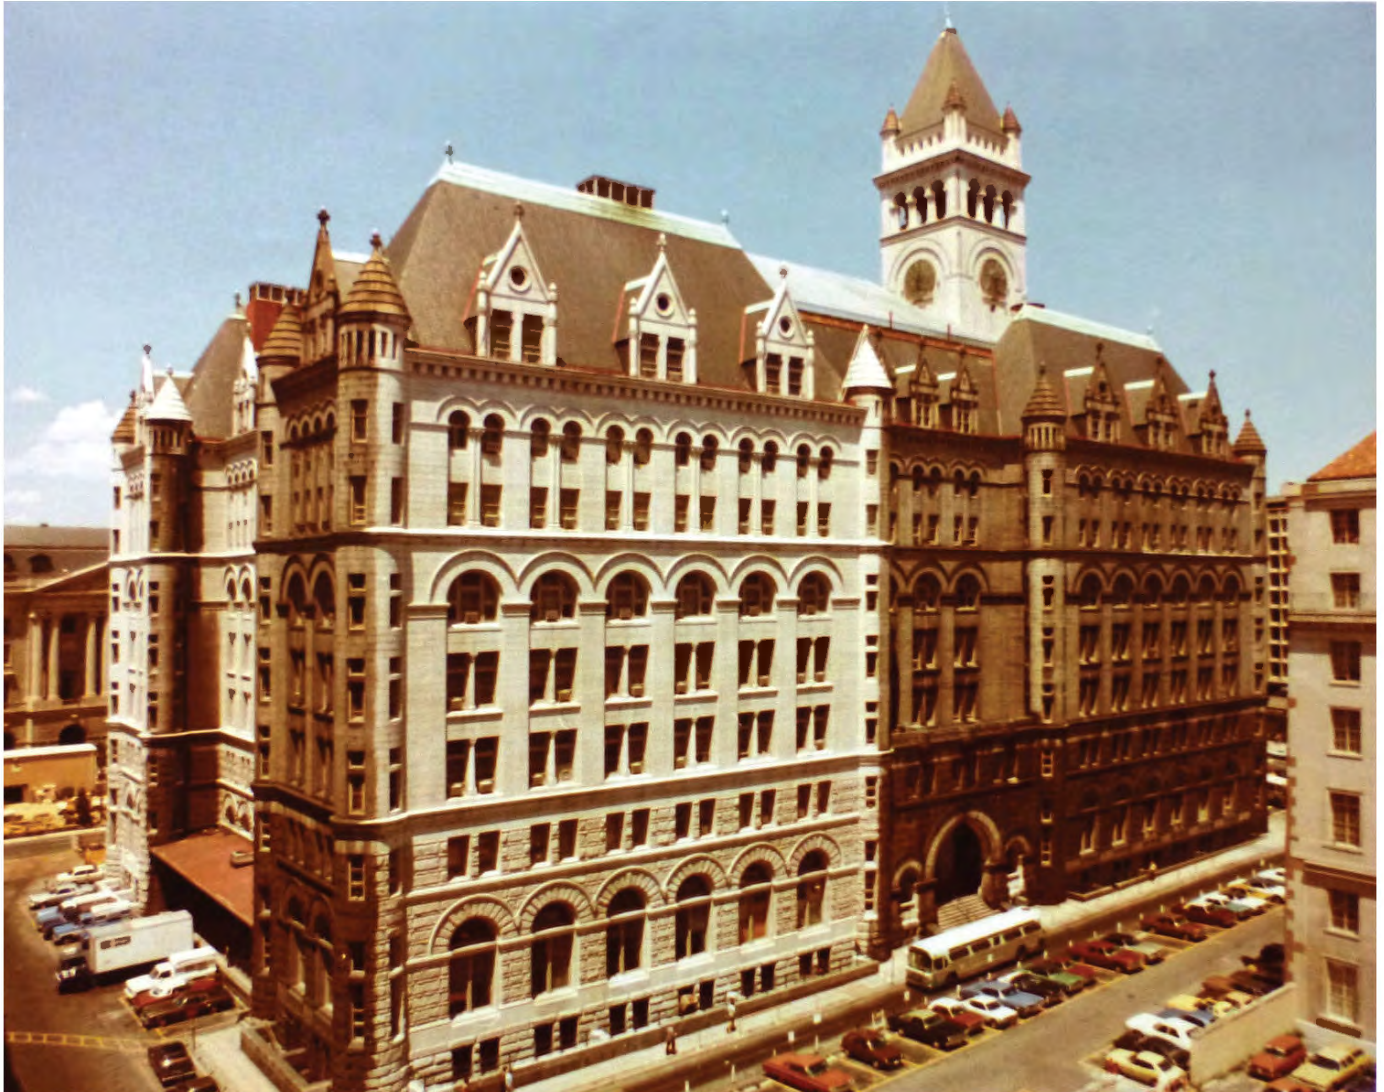
FIGURE 36: Photograph of the Old Post Office with cleaning underway, from southeast. Image Courtesy of GSA-NCR Technical Resource Center, Reports and Photographs

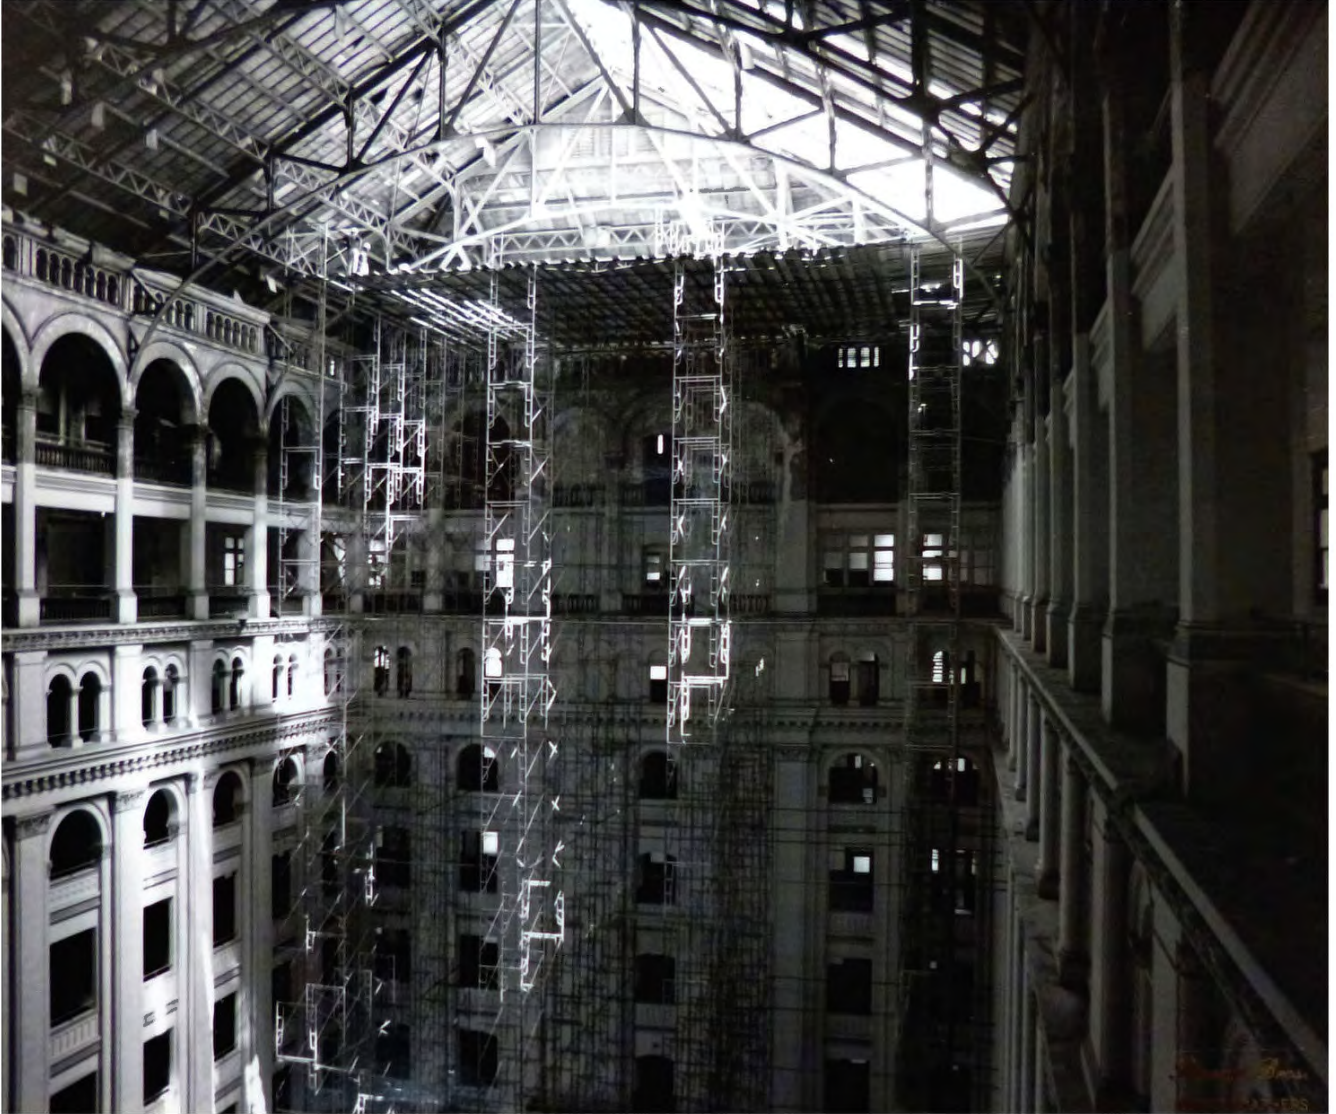
FIGURE 37: Construction progress photograph showing removal of roofing panels, 1979. Image Courtesy of GSA-NCR Technical Resource Center, Reports and Photographs

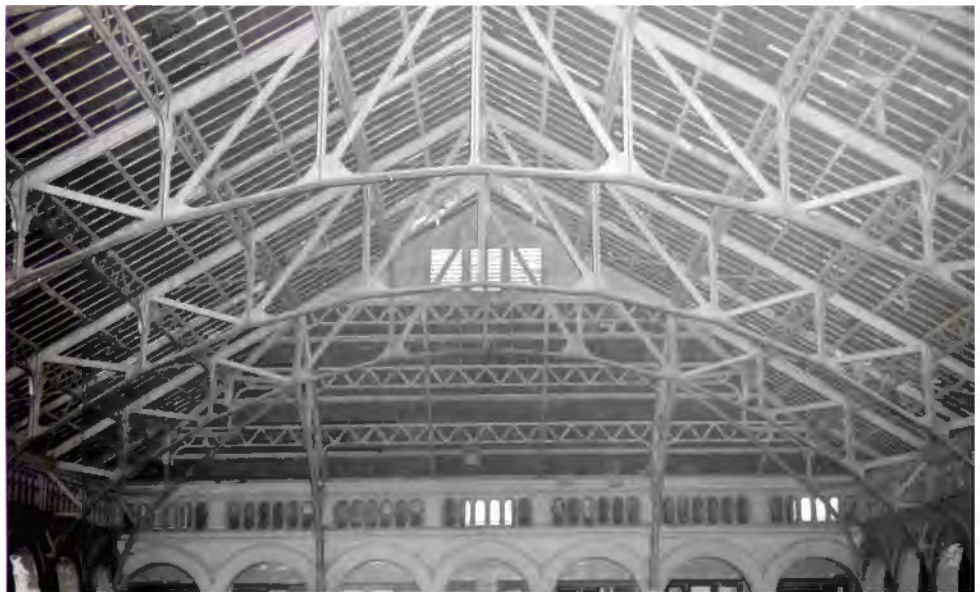
- Metal roofing panels and rigid insulation on skylight roof removed.
- Skylight's structural bracing retained, supported by new steel substructure.
- New tinted glass inserted.
- Flat roof membrane surrounding skylight replaced.
- Sagging clerestory stabilized and repaired.
- Slate hipped roofs repaired.
- Replacement of damaged shingles and copper flashing.
- Flat roofs above the three arcade porches repaired.
- Existing cladding replaced with built-up membranes.
- Roof drainage, gutters, and downspouts replaced or repaired.
- Metal vent shaft enclosures replaced or repaired.
- New Steel supports constructed along flat roof areas.

FIGURE 96: Photograph of the Skylight Over the Cortile of the Washington D.C. Post Office. Image Courtesy of GSA-NCR Technical Resource Center.

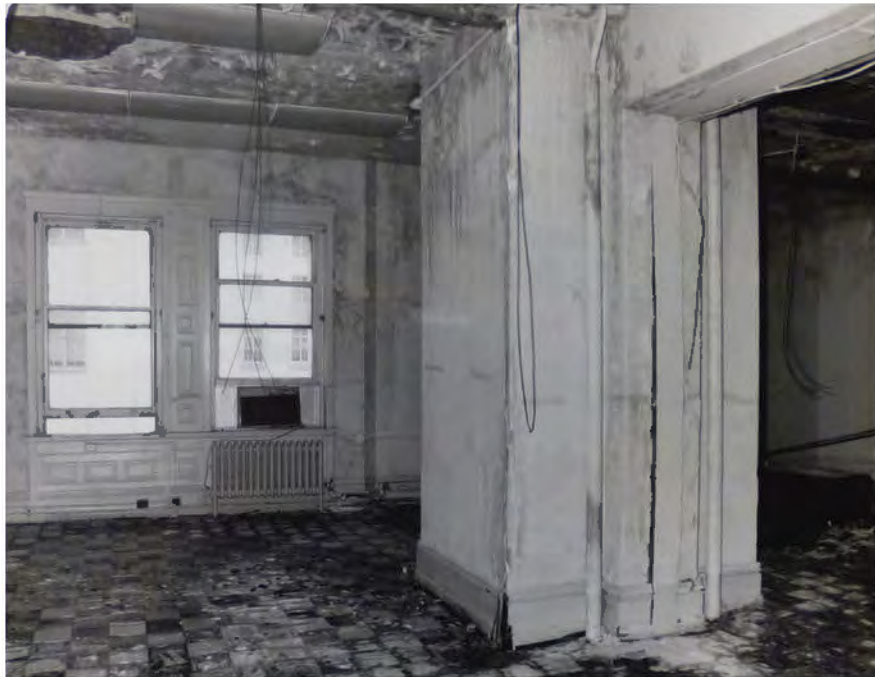
FIGURE 97: Washington D.C. Post Office, Condition of Office Space Prior to 1979 Renovation. Image Courtesy of GSA-NCR Technical Resource Center.

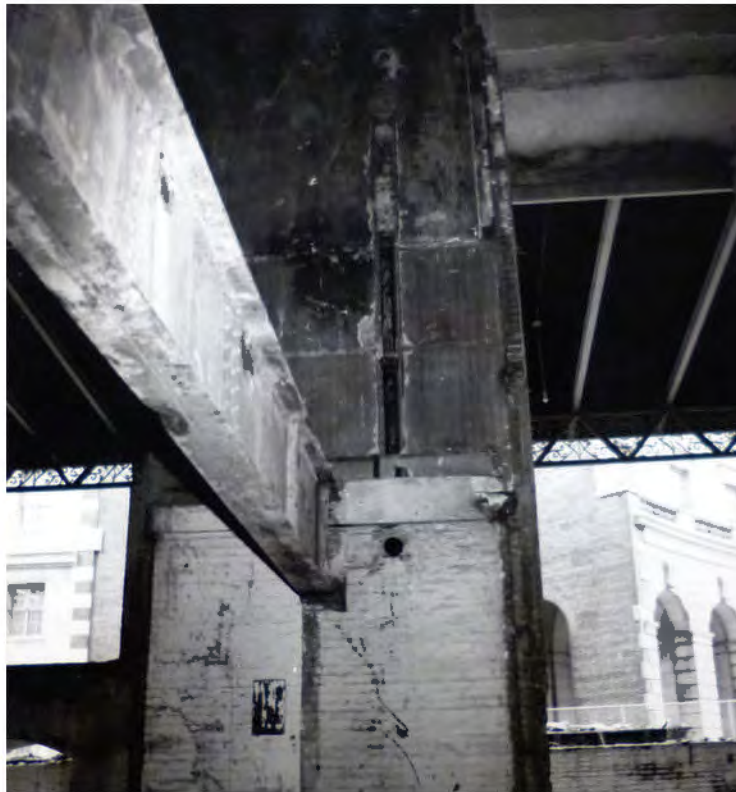
FIGURE 98: Washington D.C. Post Office, Condition of Basement Prior to 1979 Renovation. Image Courtesy of GSA-NCR Technical Resource Center.

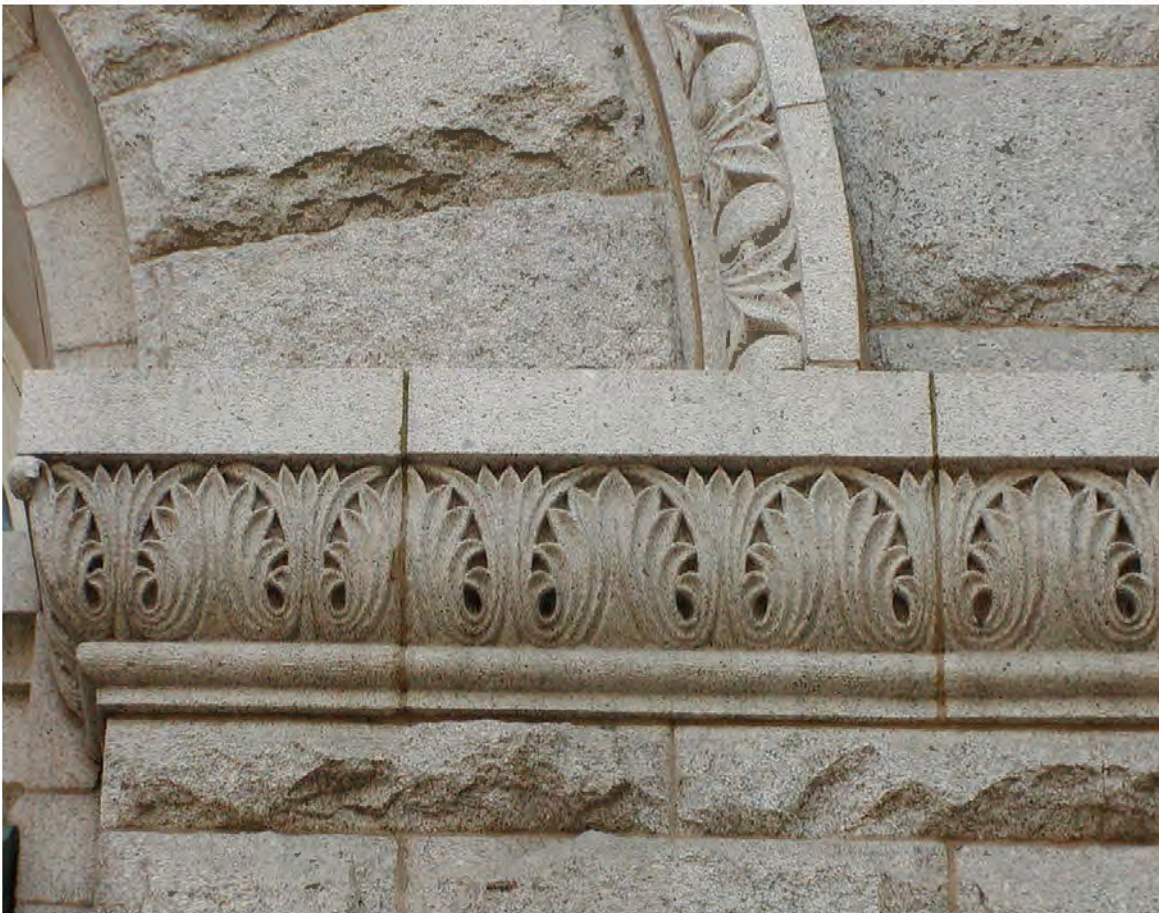
FIGURE 13: Detail of Vinalhaven Granite From the NE Turret Base, 2006. Photo Courtesy of T. McDowell.

- CONDITION:
- Some cases of wear and impact damage.
 - Some cracks & fissures
 - Some mortar is deteriorated and some is missing
 - General soiling and rust stains

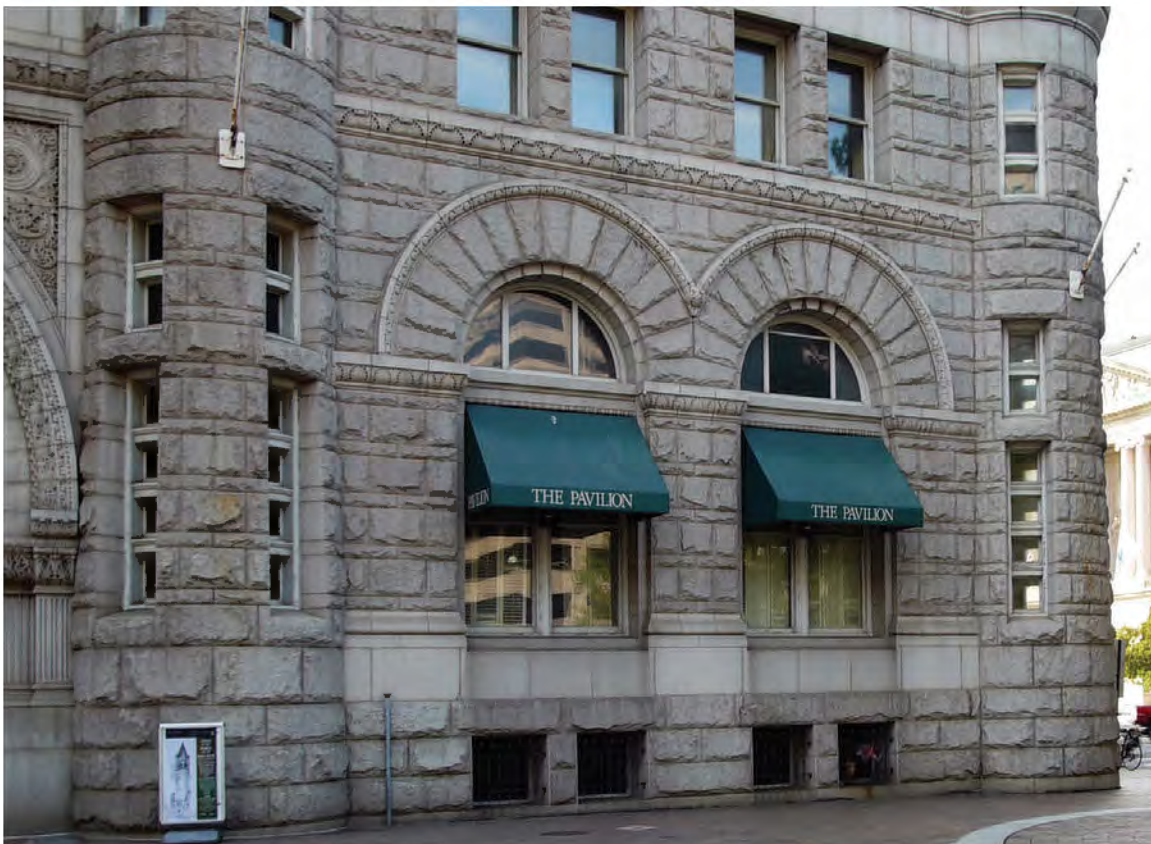
FIGURE 14: Detail of NW Building Base, 2012. Photo Courtesy OLBN Inc.

- MATERIALS:**
- Vinalhaven, Maine granite
 - Puzzolan cement mortar joints
- FINISHES:**
- Quarry faced: *Cladding slabs*
 - Dressed/ Honed: *Window opening sills, jambs and lintels*
1st floor sill / belt course
Mezzanine openings label moulding and soffits
All other carved pieces
- SIGNIFICANCE:**
- Granite: Original
 - Mortar: Original with some re pointing
- ALTERATIONS:**
- 8 of the basement level openings were altered to accommodate doors
 - Various spot repairs
 - Cleaning
- CONDITION:**
- Some cracks & fissures.
 - Limited spalling.
 - General soiling from environmental pollutants and rust stains

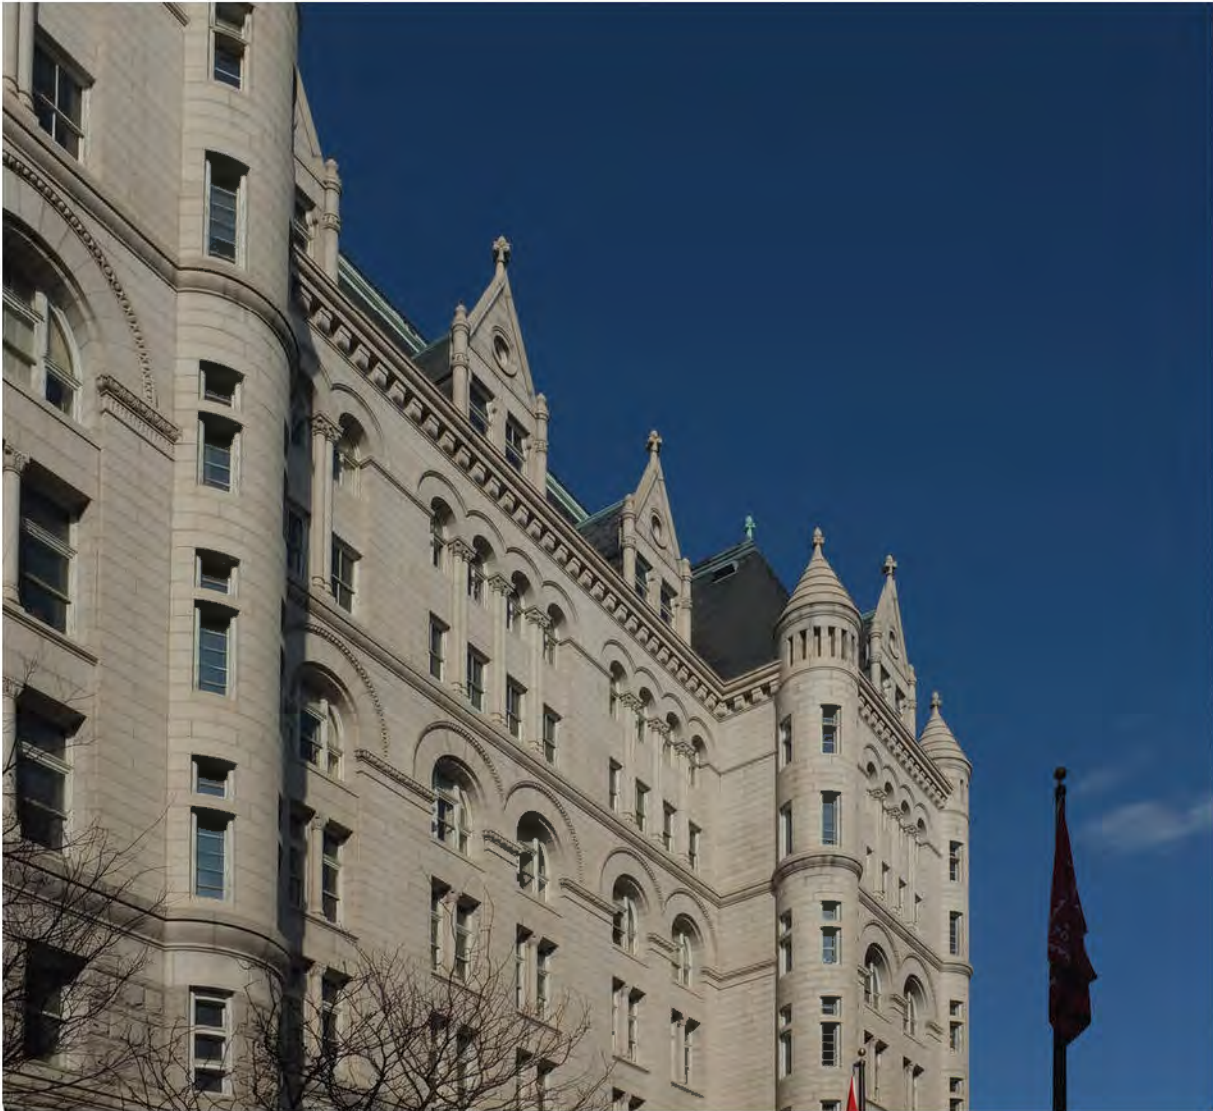
- General good condition with some cracks & fissures
- Some mortar is deteriorated and some is missing
- General soiling from environmental pollutants

FIGURE 21: Detail of Central Section of the South Elevation, 2012. Photo Courtesy OLBN Inc.

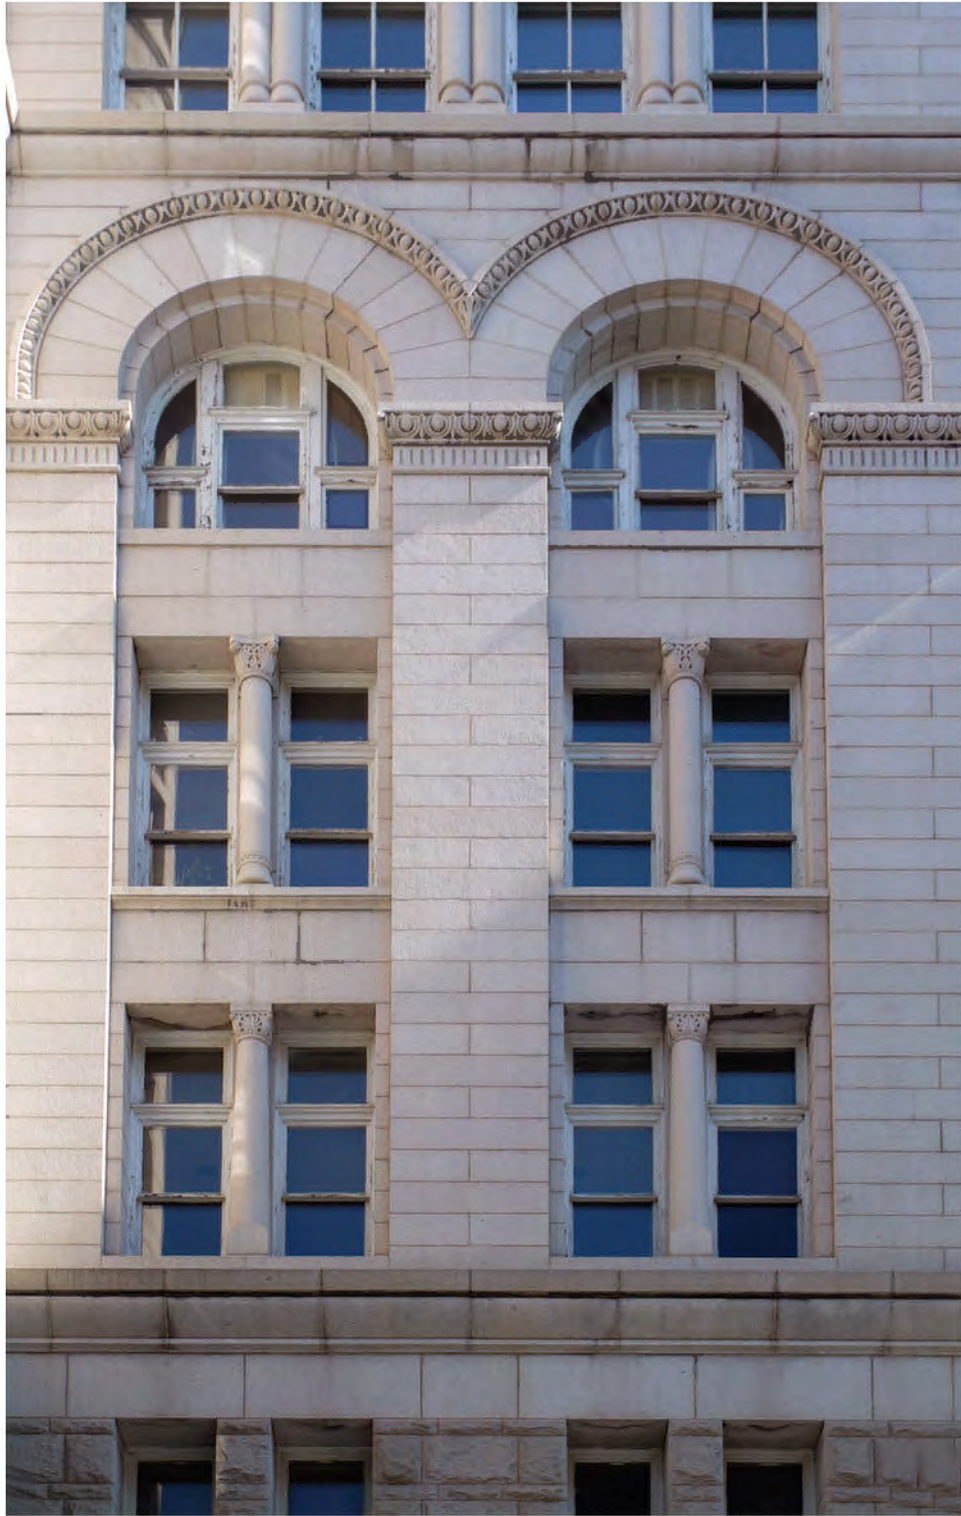
FIGURE 22: Detail of the NE Pavilion 3rd, 4th and 5th Floor Fenestration Openings, 2012.
Photo Courtesy OLBN Inc.

CONDITION: • General good condition
• Some mortar is deteriorated and some is missing
• General soiling from environmental pollutants

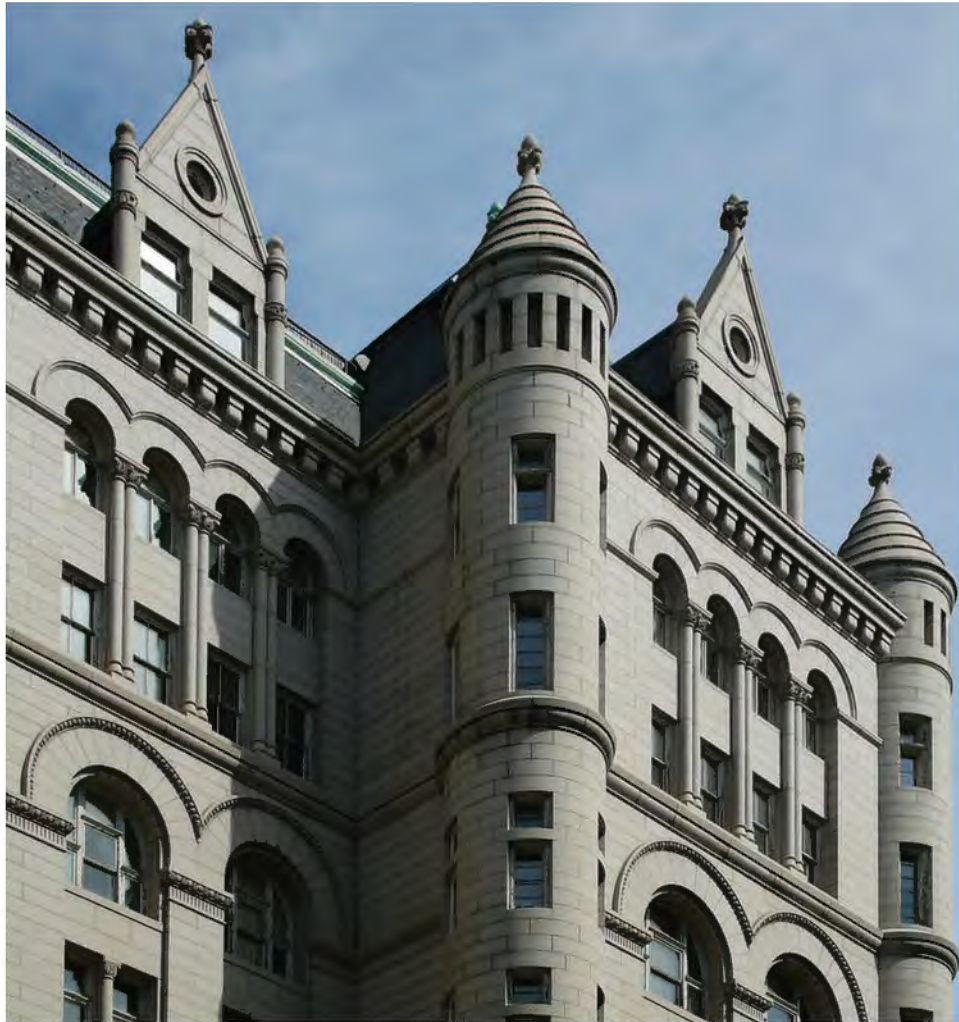
- Various spot repairs
- Cleaning
- Some mortar is deteriorated and some is missing
- General soiling from environmental pollutants

FIGURE 25: Detail of the South Elevation 6th& 7th Floor Openings, 2012. Photo Courtesy OLBN Inc.

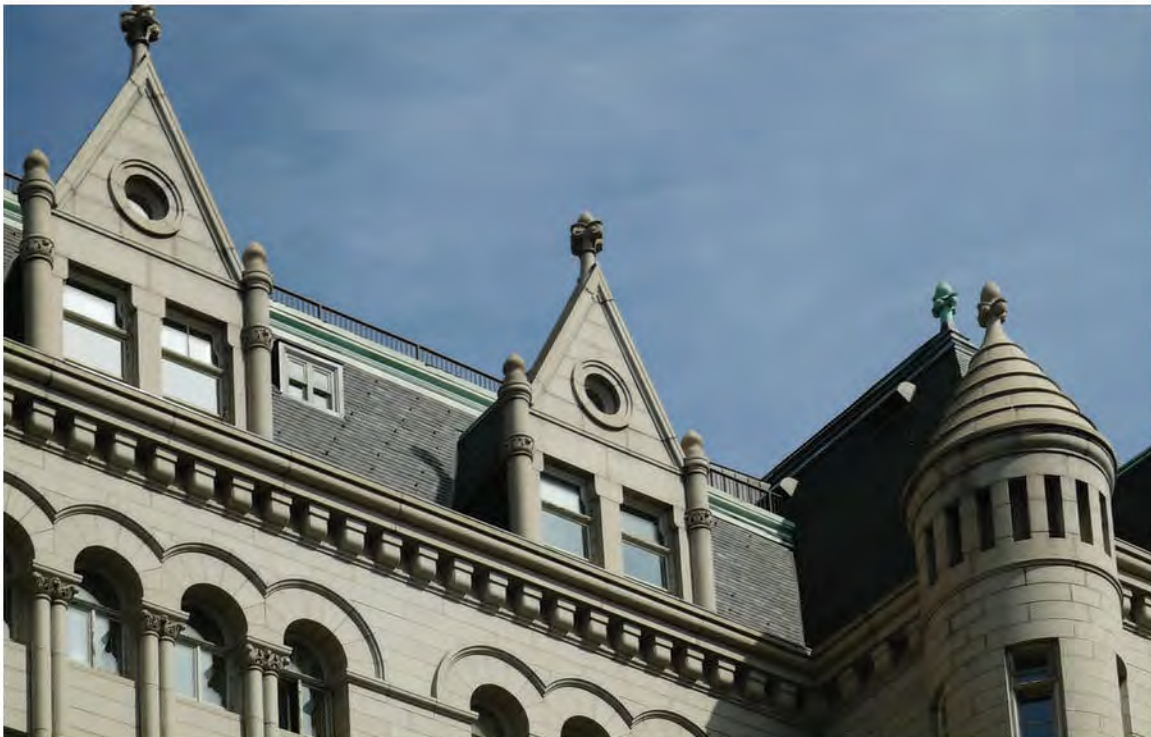
- General good condition
- Some mortar is deteriorated and some is missing
- General soiling from environmental pollutants

FIGURE 26: Detail of the South Elevation Cornice, 2012. Photo Courtesy OLBN Inc.

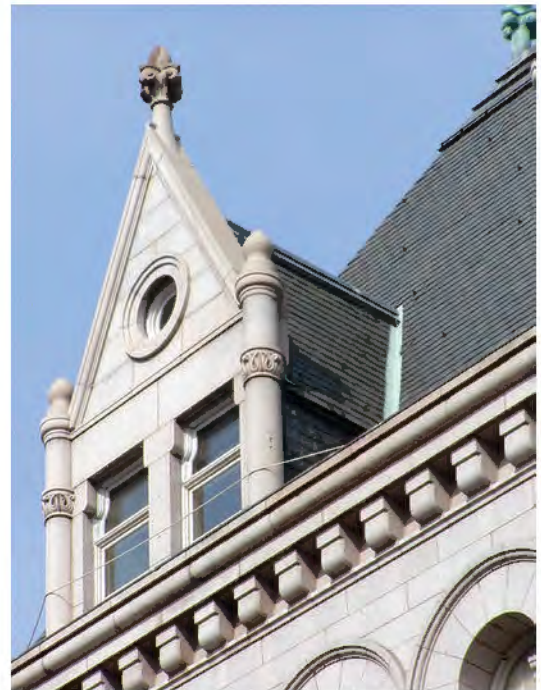
- General good condition
- Some mortar is deteriorated and some is missing
- General soiling from environmental pollutants

FIGURE 27: Large Dormer, 2012.
Photo Courtesy OLBN Inc.

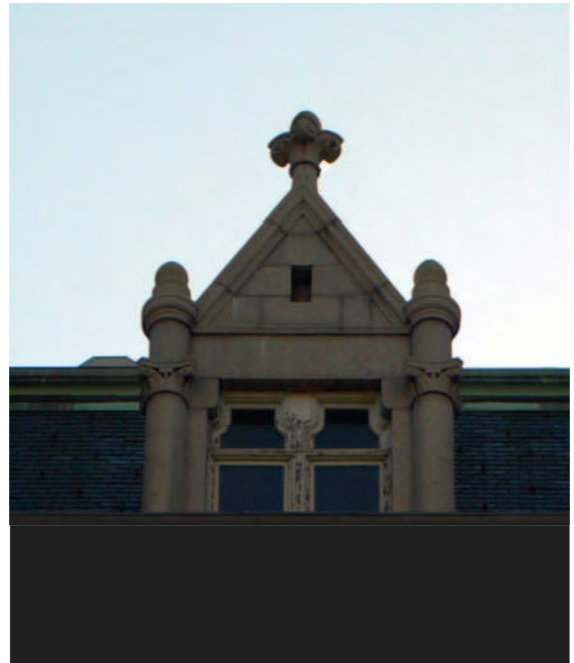
- General good condition
- Some mortar is deteriorated and some is missing
- General soiling from environmental pollutants

FIGURE 28: Small Dormer, 2012.
Photo Courtesy OLBN Inc.

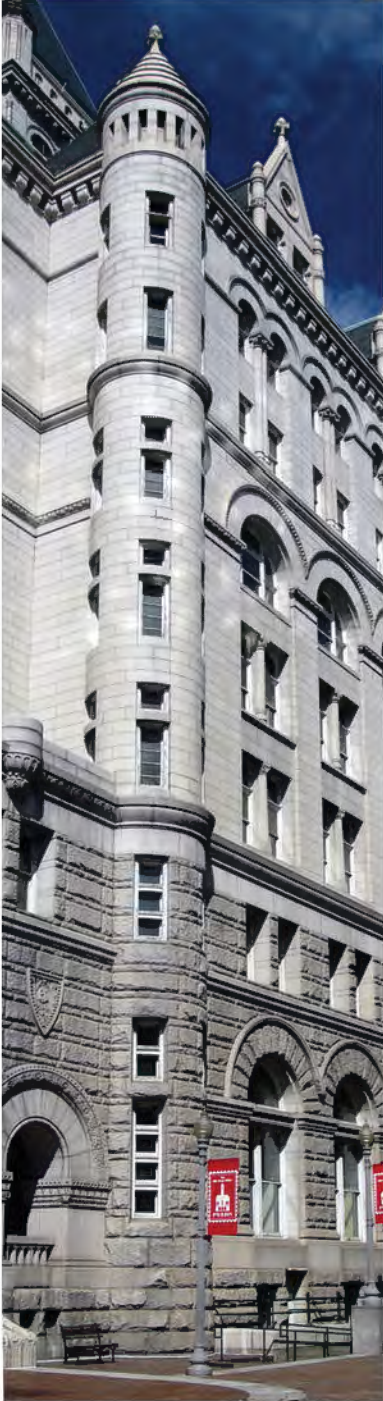
- Some cases of wear and impact damage.
- Some cracks & fissures
- Some mortar is deteriorated and some is missing
- General soiling and rust stains

FIGURE 29: East Elevation Corner Turret, 2012. Photo Courtesy OLBN Inc.

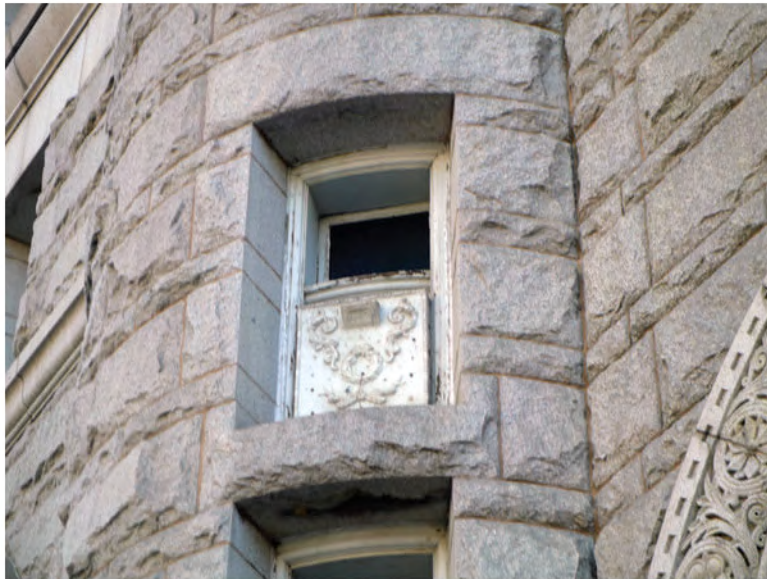
- MATERIALS:**
- Vinalhaven, Maine granite cladding
 - Puzzolan cement mortar joints
- FINISHES:**
- Quarry faced: *Cladding slabs*
 - Dressed/ Honed: *Window opening sills, jambs and lintels*
Sill course above first floor line
- SIGNIFICANCE:**
- Granite: Original
 - Mortar: Original with some re pointing
- ALTERATIONS:**
- Various spot repairs
 - Cleaning
- CONDITION:**
- Some cracks & fissures.
 - Limited spalling.
 - General soiling from environmental pollutants and rust stains

FIGURE 31: Base Detail NW Corner Turret Opening, 2012. Photo Courtesy OLBN Inc.

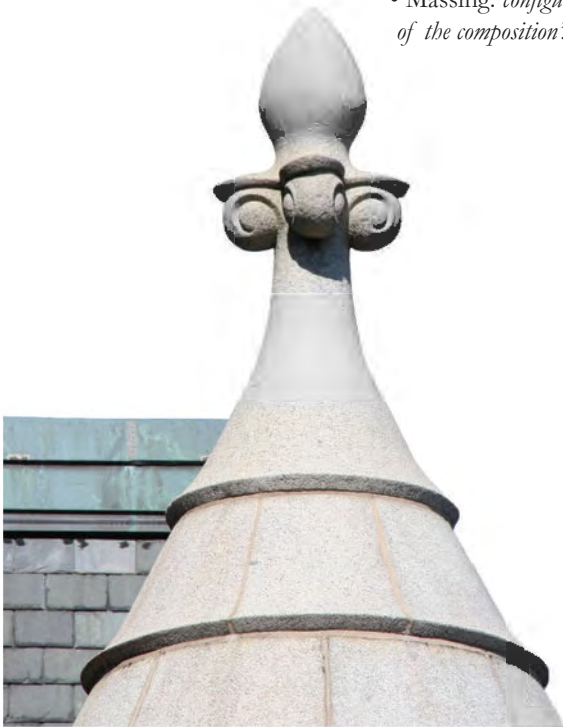
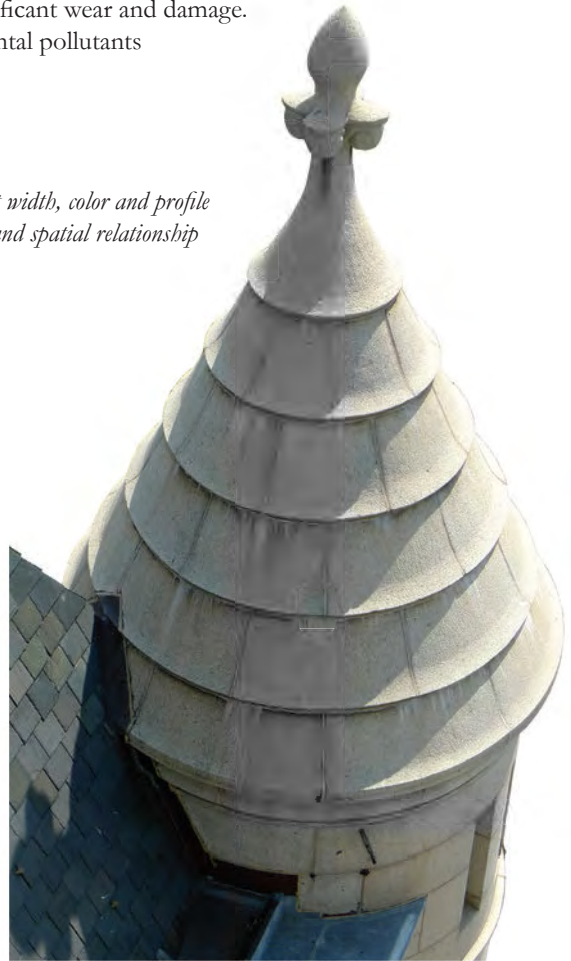
- Moderate to severe wear and impact damage to granite surfaces at the base, upper portions have insignificant wear and damage.
- General soiling from environmental pollutants

FIGURE 33: Detail Finial Corner Turret, 2012. Photo Courtesy OLBN Inc.

FIGURE 34: Detail Roof Corner Turret, 2012. Photo Courtesy GSA.

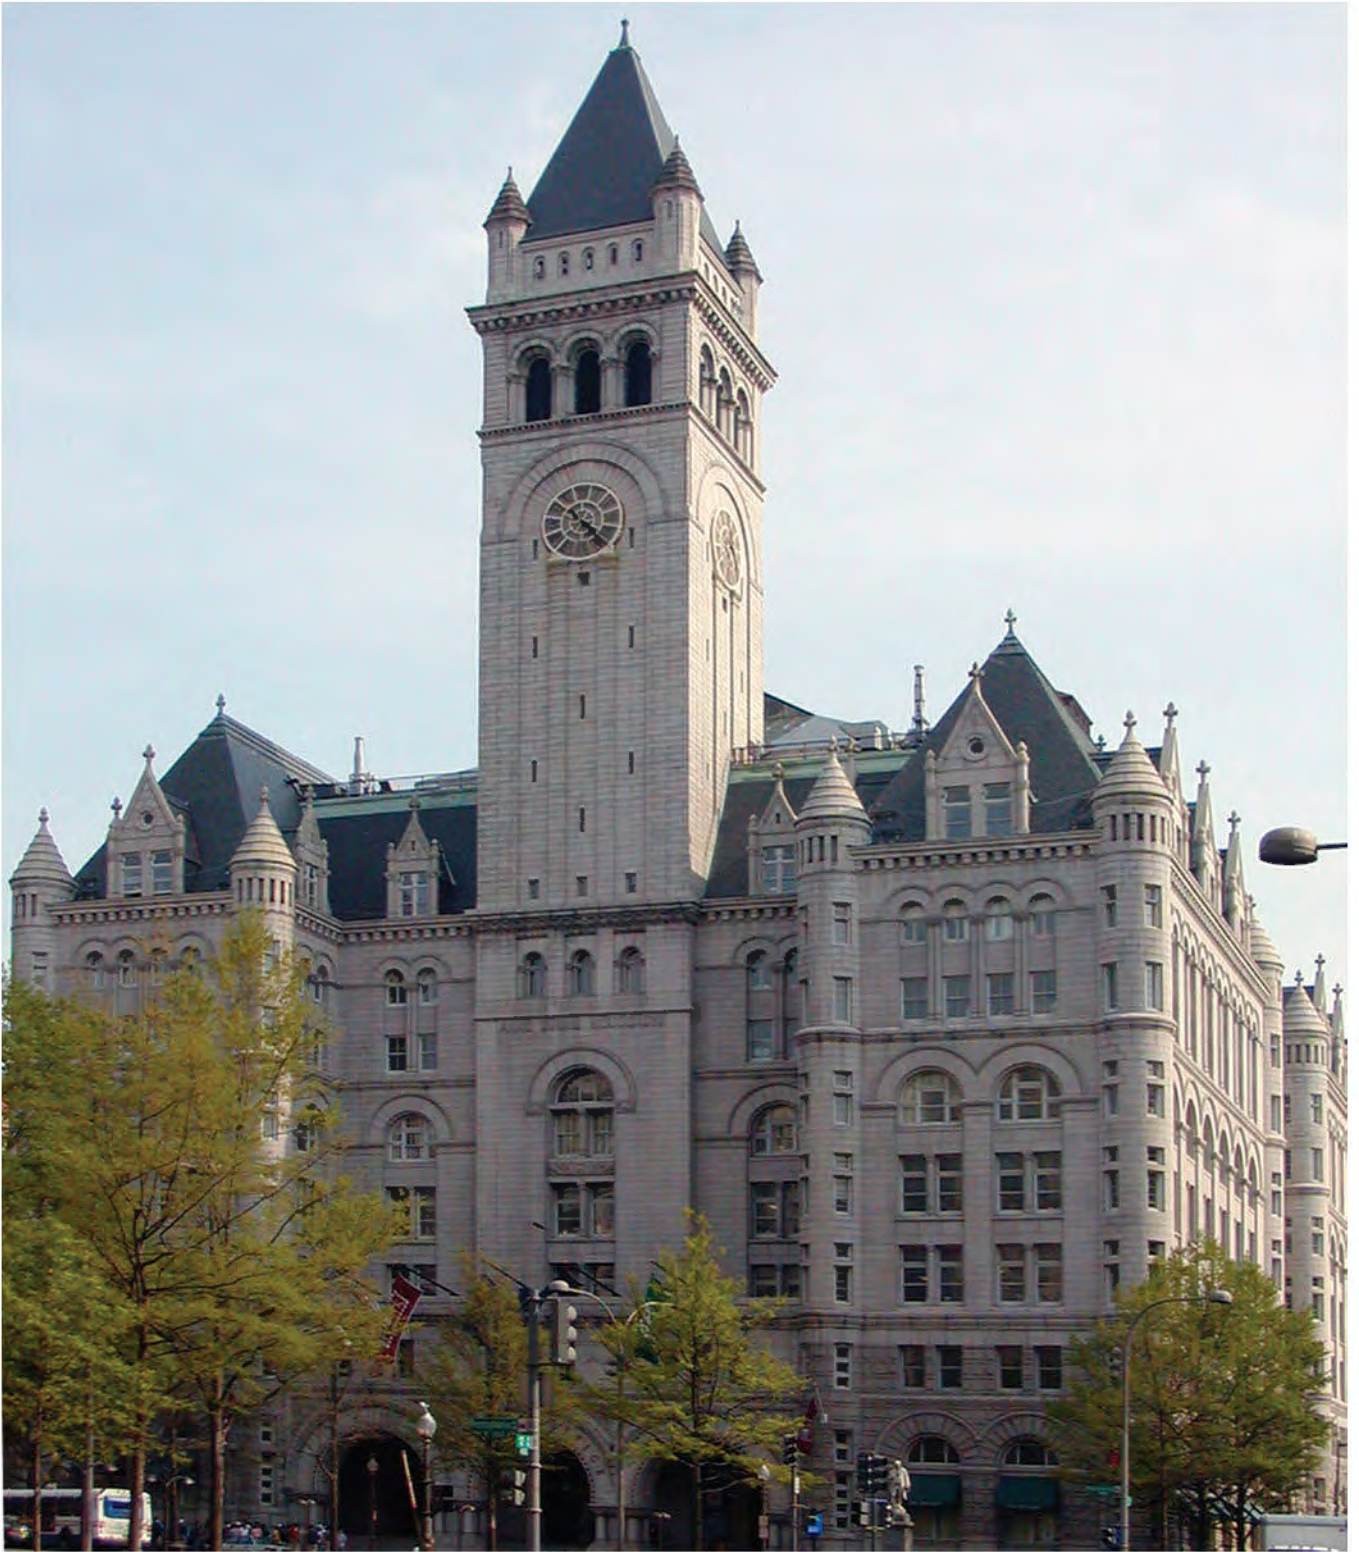
FIGURE 36: Detail of Clock Tower, 2006. Photo Courtesy T. McDowell.

- General good condition
- Some cracks & fissures
- Some mortar is deteriorated and some is missing
- General soiling from environmental pollutants

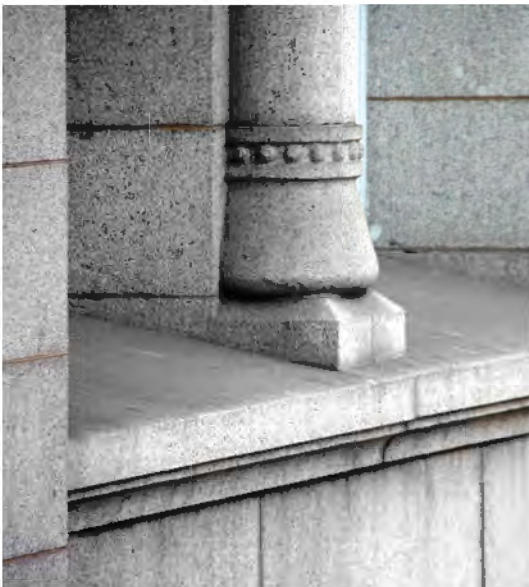
FIGURE 39: Detail of the Clock Tower 4th Floor Colonette Base, 2012. Photo Courtesy OLBN Inc.

- ALTERATIONS:
- Various spot repairs
 - Several mortar re-pointing campaigns
 - Cleaning

- CONDITION:
- General good condition
 - Some mortar is deteriorated and some is missing
 - General soiling from environmental pollutants

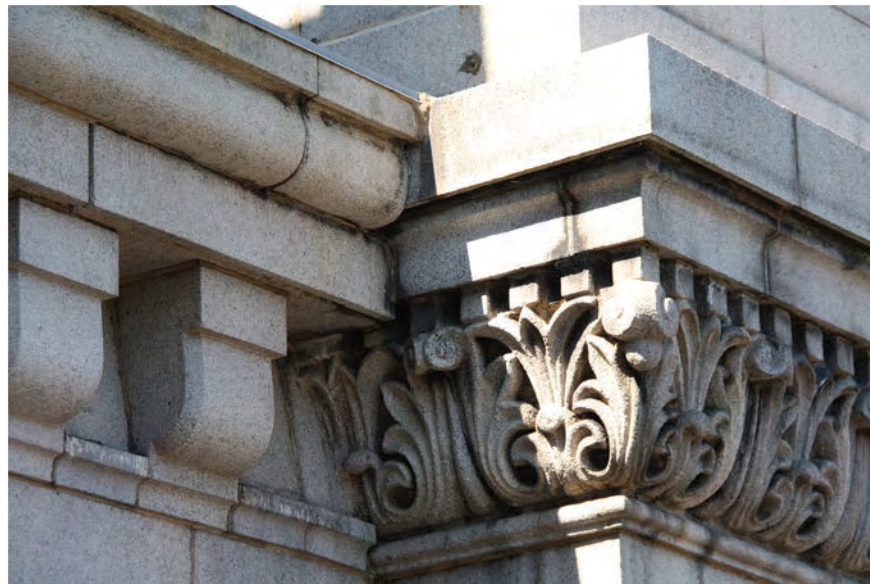
FIGURE 43: Detail of the Clock Tower Cornice /Belt Course, 2012. Photo Courtesy OLBN Inc.

- Various spot repairs
- Several mortar re-pointing campaigns
- Cleaning

- General good condition
- General soiling from environmental pollutants

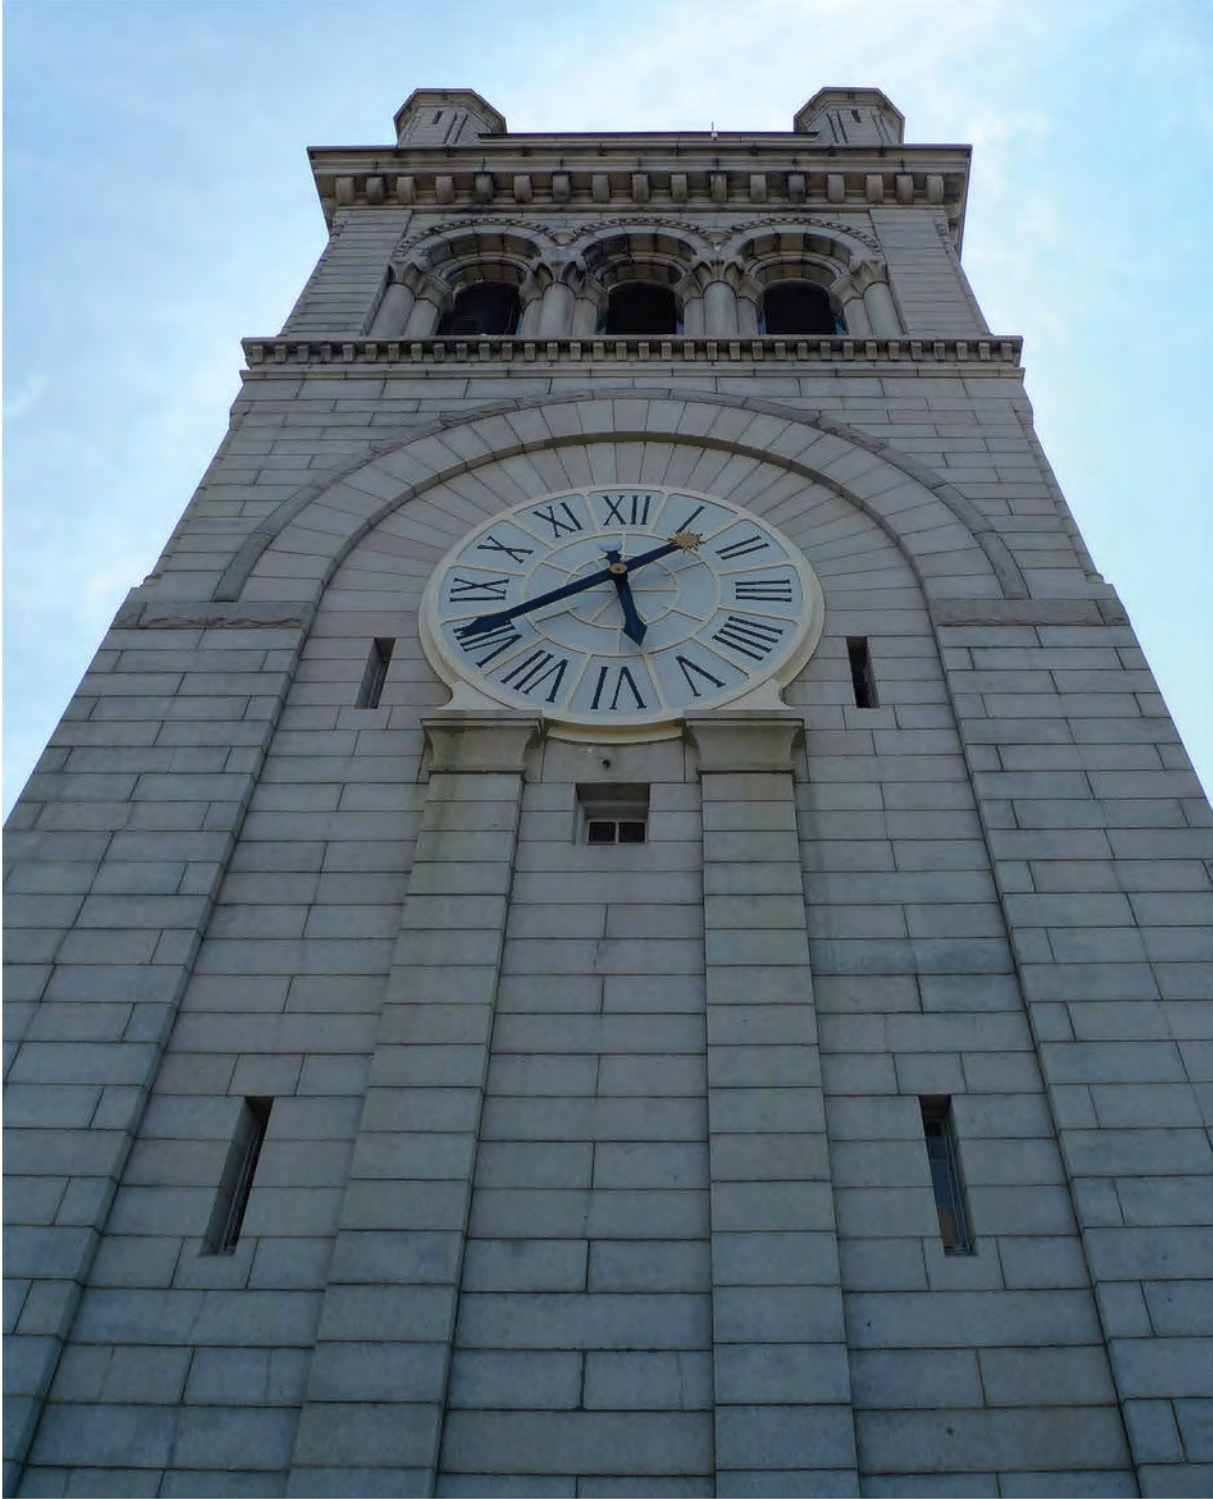
FIGURE 44: Detail of the Clock Tower North face, 2012. Photo Courtesy OLBN Inc.

- Various spot repairs
- Several mortar re-pointing campaigns
- Cleaning

- General good condition
- General soiling from environmental pollutants
