Description of document: General Services Administration (GSA) Architectural Assessment Report on the Old Post Office Building, 2012

OLD POST OFFICE
HSR

EXISTING EXTERIOR CONDITIONS SURVEY

EXISTING INTERIOR CONDITIONS SURVEY

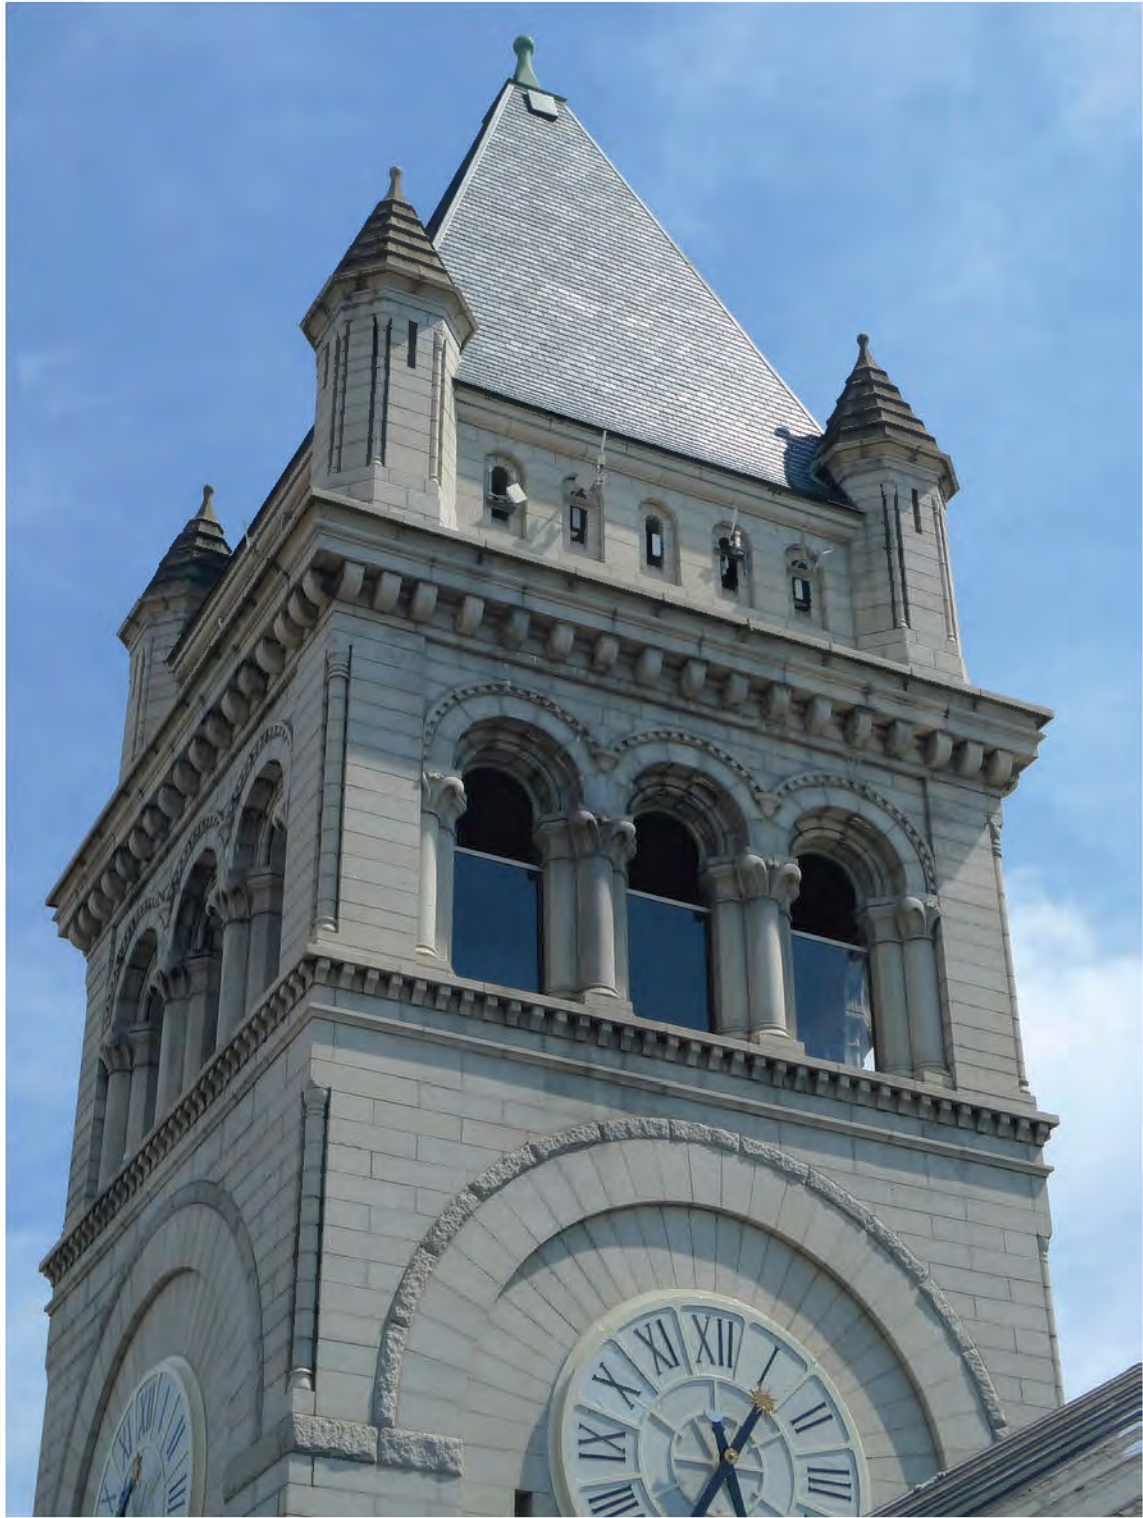
FIGURE 47: Detail of the Clock Tower NW View, 2012. Photo Courtesy OLBN Inc.

- Various spot repairs
- Several mortar re-pointing campaigns
- Cleaning
- Plexiglas screens and steel cabling installed

- General good condition
- General soiling from environmental pollutants
- Safety features installed invasively into the granite.

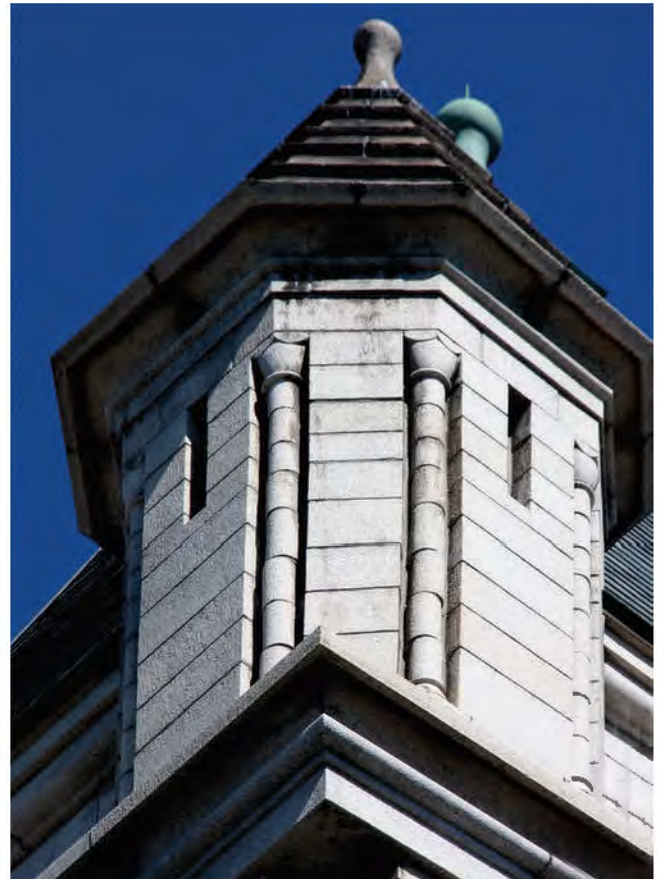
FIGURE 48: Detail of the Clock Tower Pinnacle, 2012.
Photo Courtesy OLBN Inc.

- General good condition, though the granite colonette segments show displacement.
- General soiling from environmental pollutants

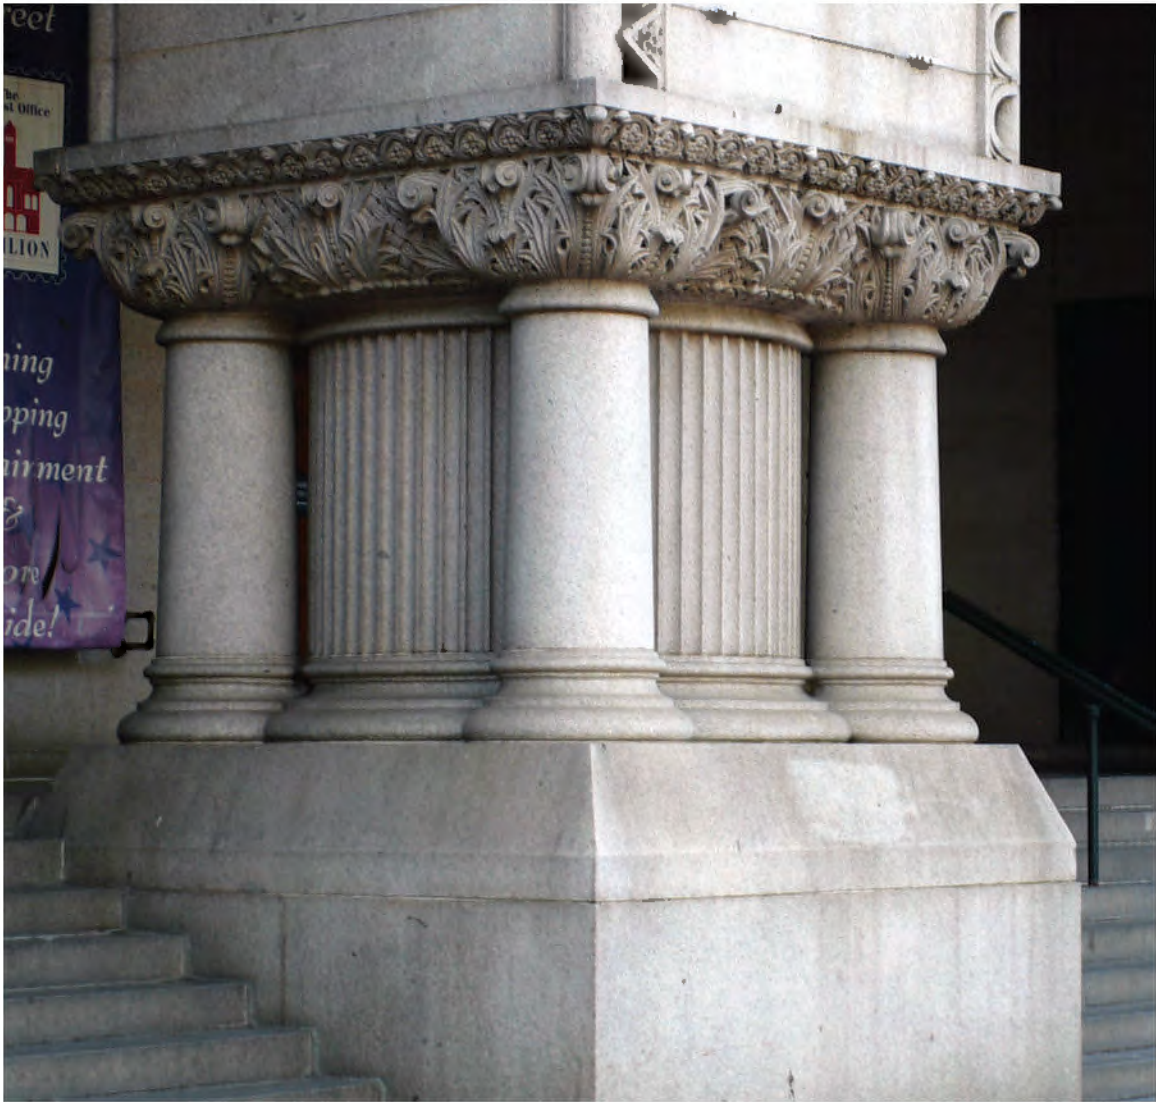
FIGURE 52: Pennsylvania Avenue Portico Pier, 2012. Photo Courtesy OLBN Inc.

- Various spot repairs
- Several mortar re-pointing campaigns
- Cleaning

- General good condition
- General soiling from environmental pollutants

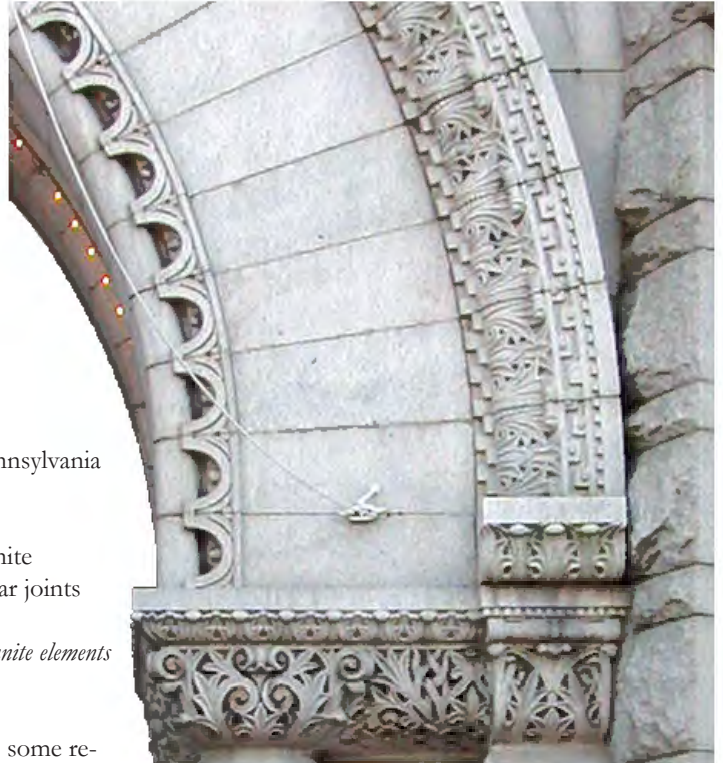
FIGURE 53: Pennsylvania Avenue Arch Label Moulding, 2012.
Photo Courtesy OLBN Inc.

- Various spot repairs
- Cleaning
- Several mortar re-pointing campaigns

- General good condition
- General soiling from environmental pollutants

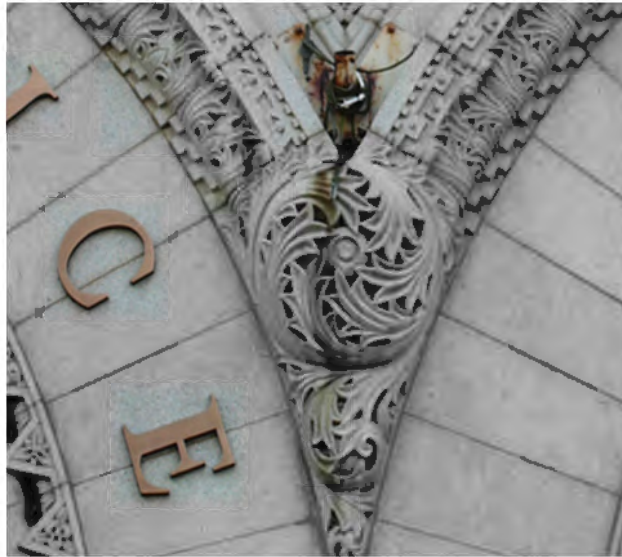
FIGURE 54: Pennsylvania Avenue Arch Label Moulding Intersection, 2012. Photo Courtesy OLBN Inc.

- Various spot repairs
- Several mortar re-pointing campaigns
- Cleaning

- General good condition
- General soiling from environmental pollutants

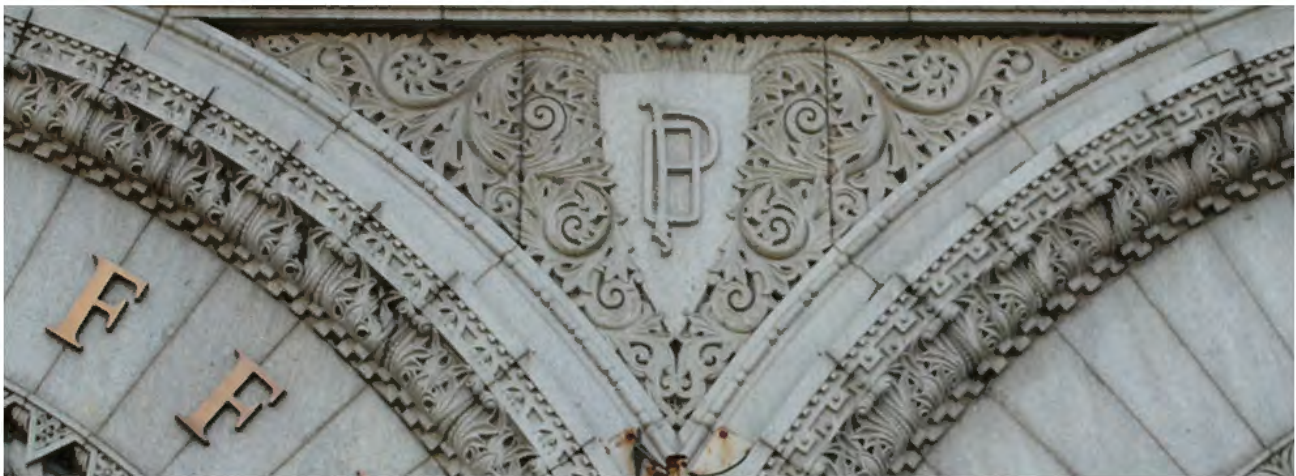
FIGURE 55: Pennsylvania Avenue Portico Spandrel, 2012. Photo Courtesy OLBN Inc.

- Various spot repairs
- Cleaning
- Several mortar re-pointing campaigns

- General good condition
- General soiling from environmental pollutants

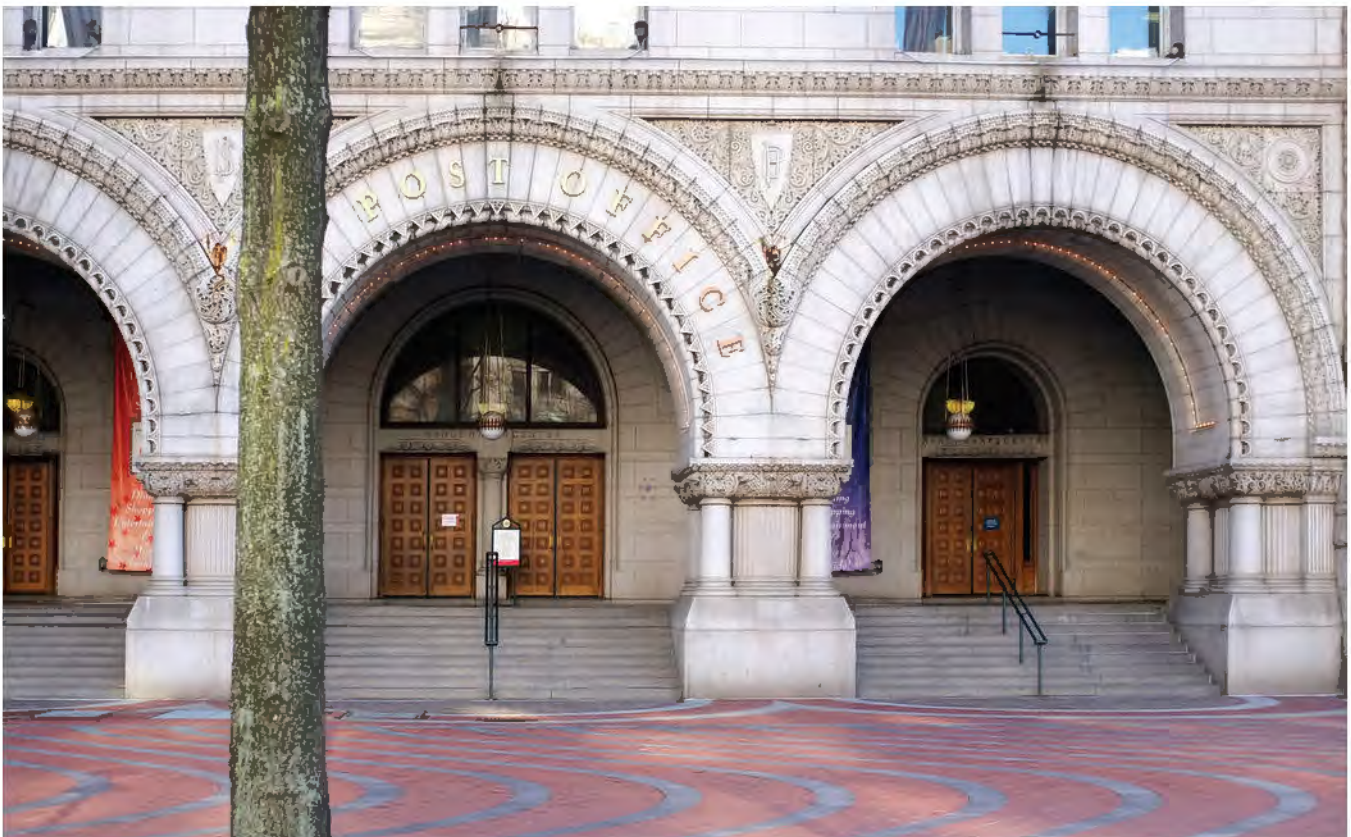
FIGURE 57: Pennsylvania Avenue Portico, 2012. Photo Courtesy OLBN Inc.

- Various spot repairs
- Several mortar re-pointing campaigns
- Cleaning

- CONDITION:
- General good condition
 - General soiling from environmental pollutants

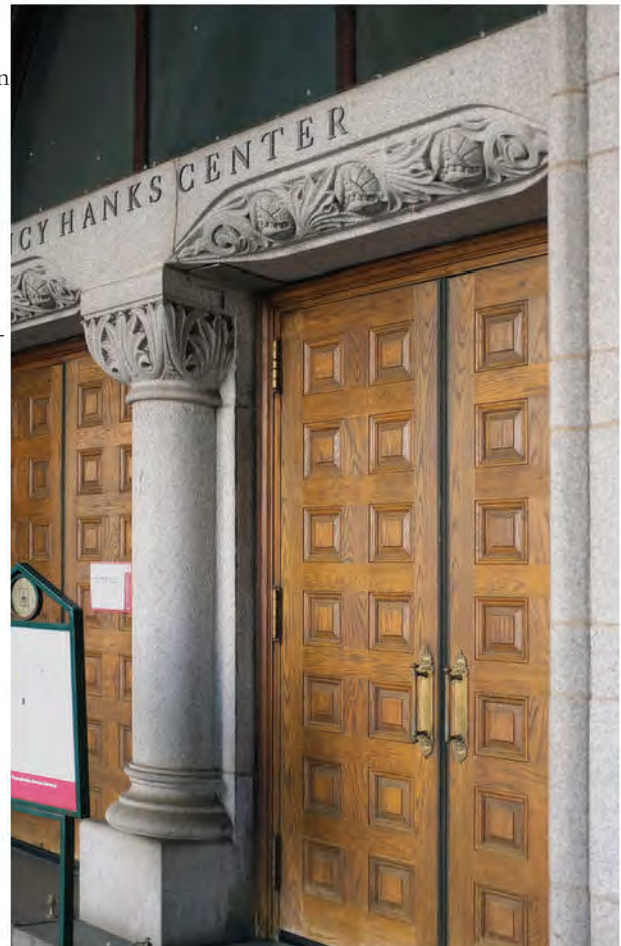
FIGURE 61: Pennsylvania Avenue Central Entrance Doorway Engaged Column, 2012. Photo Courtesy OLBN Inc.

- Various spot repairs
- Several mortar re-pointing campaigns
- Cleaning

- General good condition
- General soiling from environment

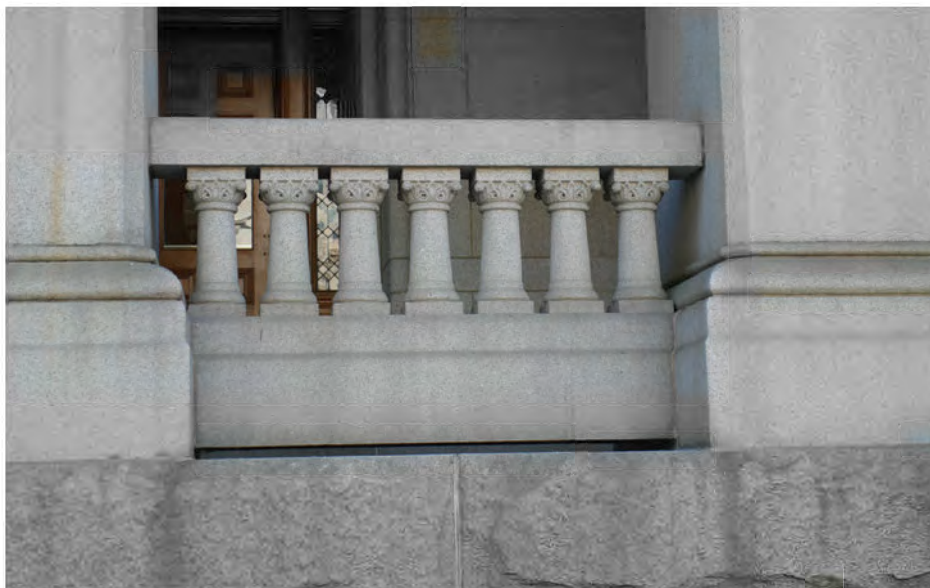
- General good condition
- General soiling from environmental pollutants
- Rust stains at connections with piers

FIGURE 68: 11th Street Portico Balustrade, 2012. Photo Courtesy OLBN Inc.

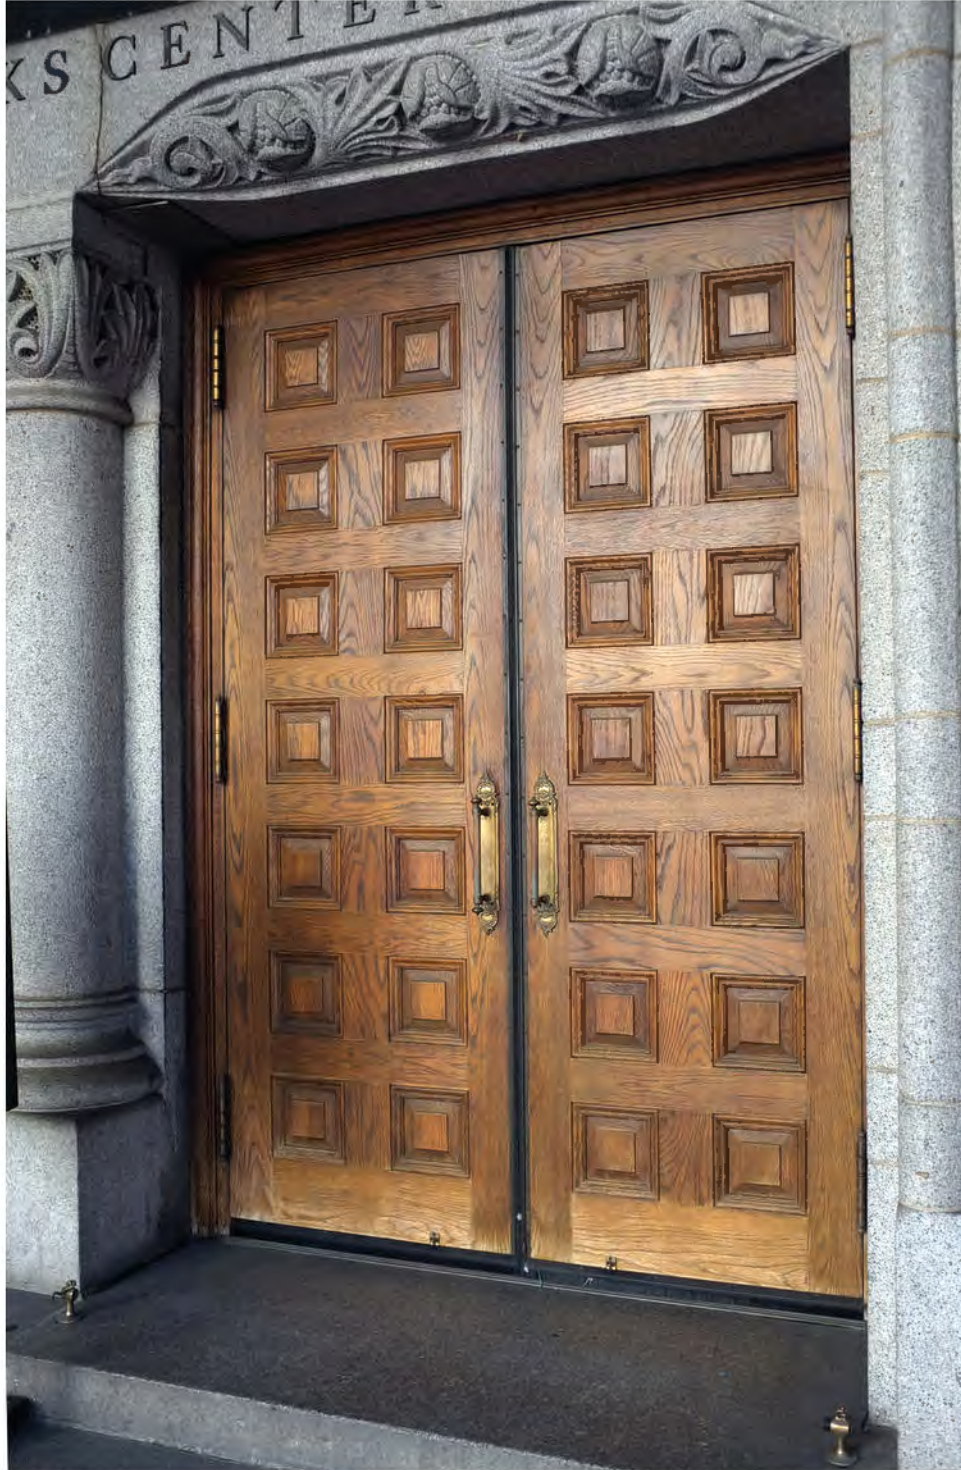
FIGURE 76: Pennsylvania Avenue Central Door Assemblies, 2012. Photo Courtesy OLBN Inc.

- Moderate to severe wear and impact damage to wood surfaces, particularly at the base.
- Some staining from environmental pollutants.

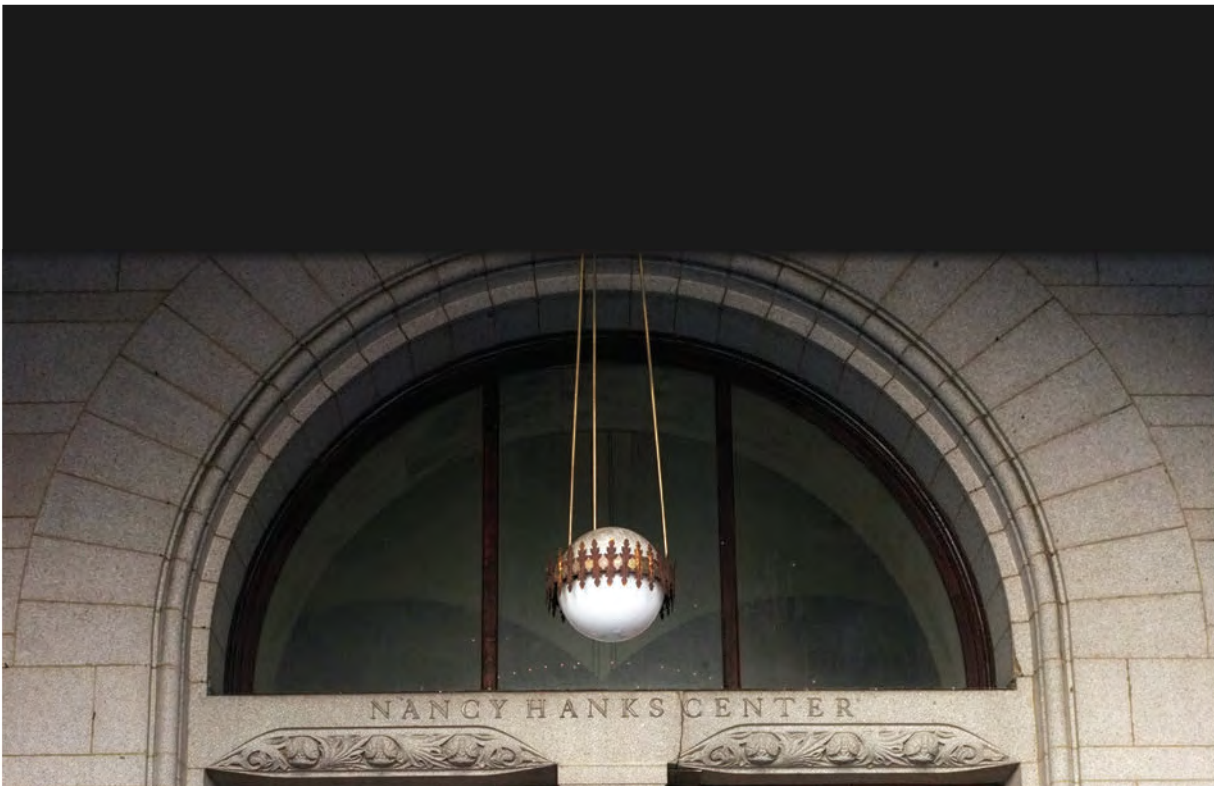
- Minor severe wear and impact damage.
- Some staining from environmental pollutants.

FIGURE 77: Pennsylvania Avenue Central Transom, 2012. Photo : Courtesy OLBN Inc.

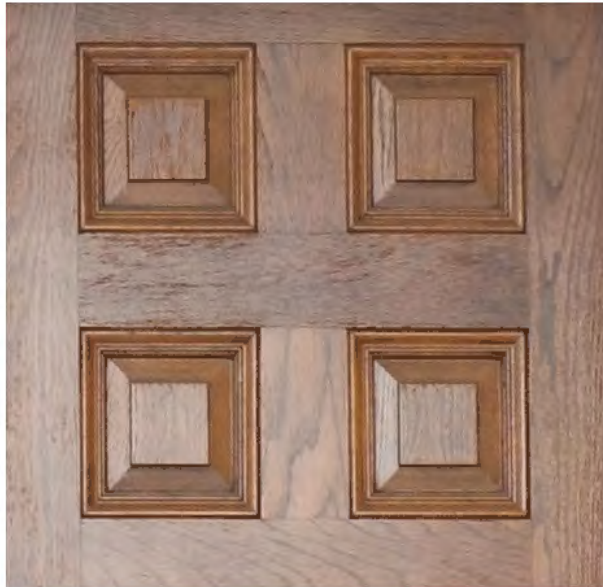
- Moderate to severe wear and impact damage to wood surfaces, particularly at the base.
- Some staining from environmental pollutants.

FIGURE 78: Detail of Pennsylvania Avenue NW Door, 2012. Photo Courtesy OLBN Inc.

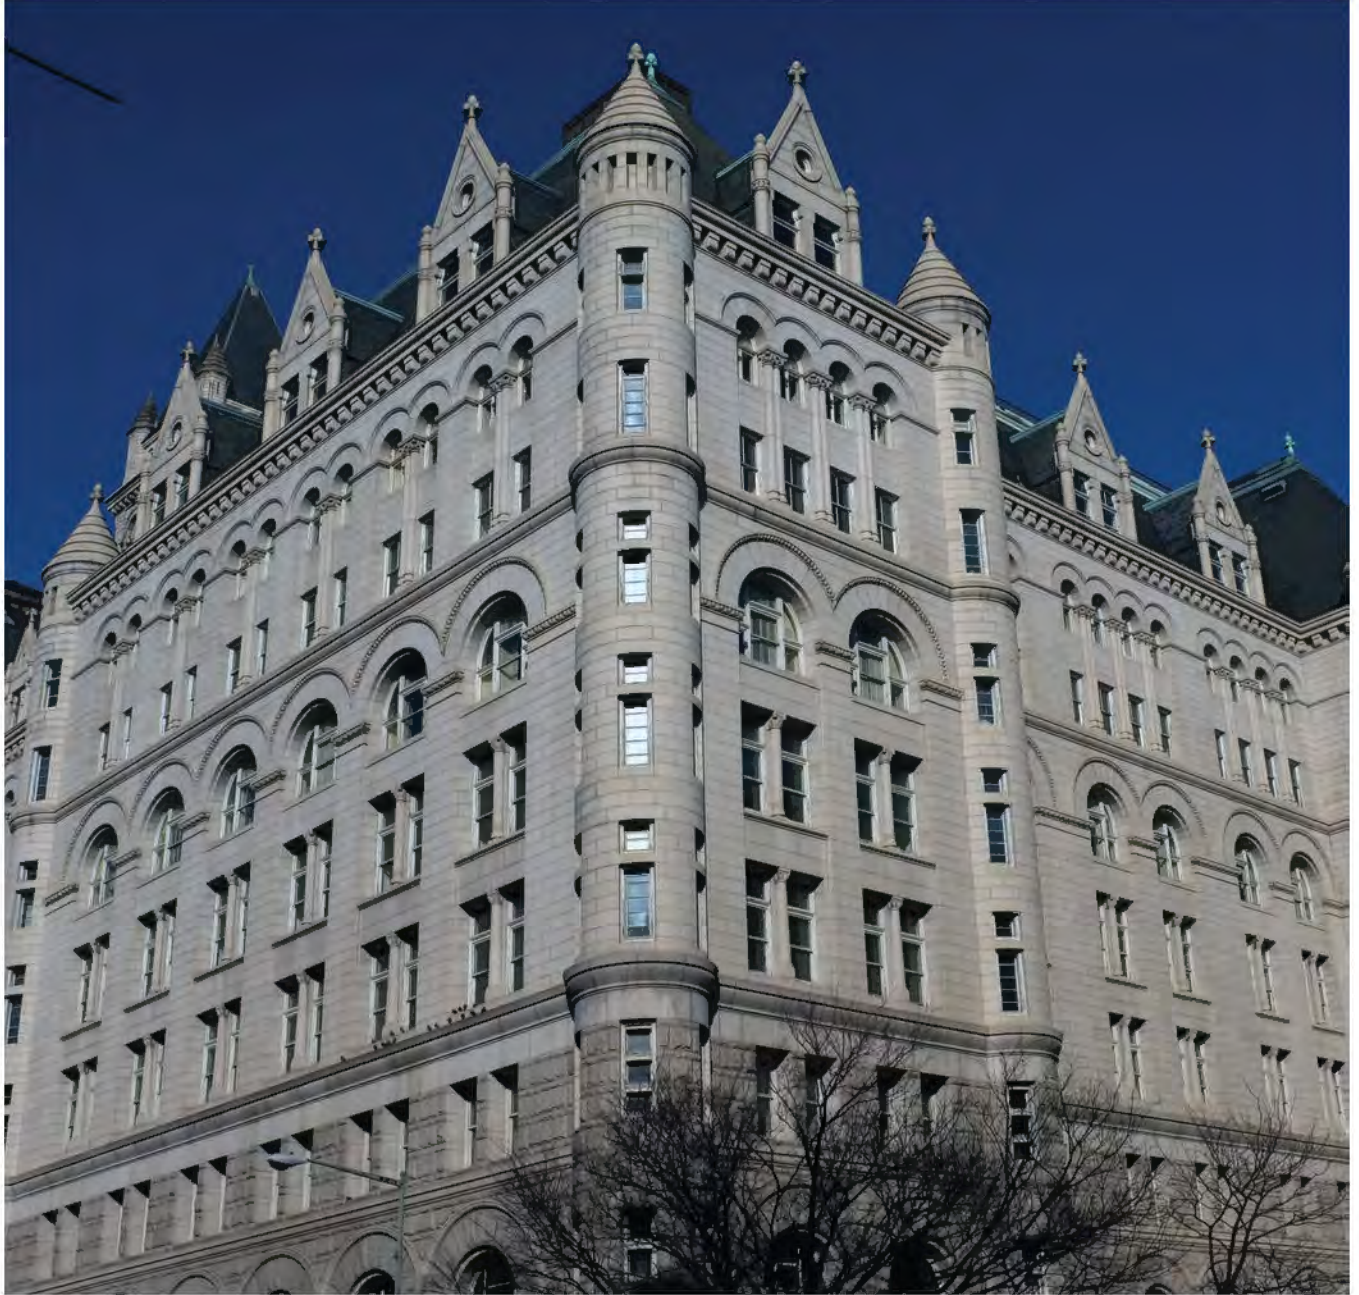
FIGURE 89: 12th and C Streets, 2012. Photo Courtesy OLBN Inc.

- CONDITION:
- Typical cases of exterior wear and impact damage.
 - Some staining from environmental pollutants.
 - Moderate to severe degradation of painted surfaces on sashes and sills.

- A case by case evaluation is needed to accurately assess the condition.

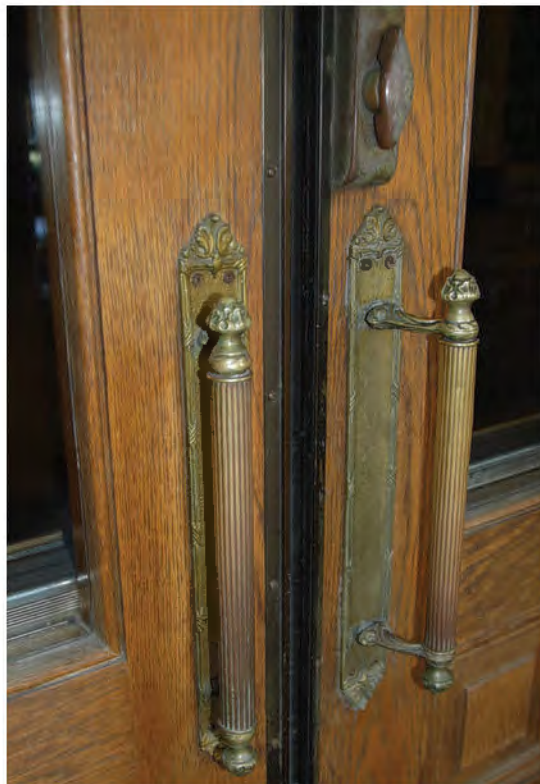
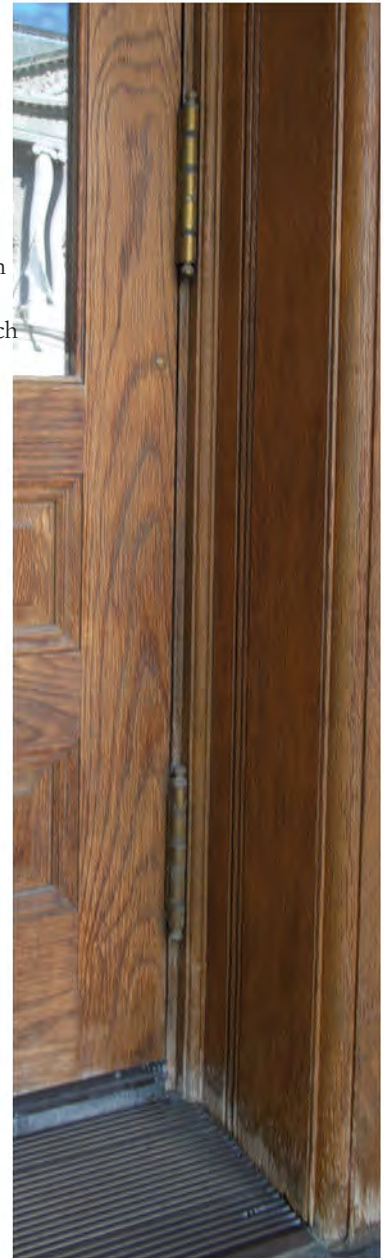
CONDITION: • Mechanical impact resulting in dents, pits and scratches
• Some staining from environmental pollutants.
• Tarnish

FIGURE 91: Building Hardwares, 2012. Photo Courtesy OLBN Inc.

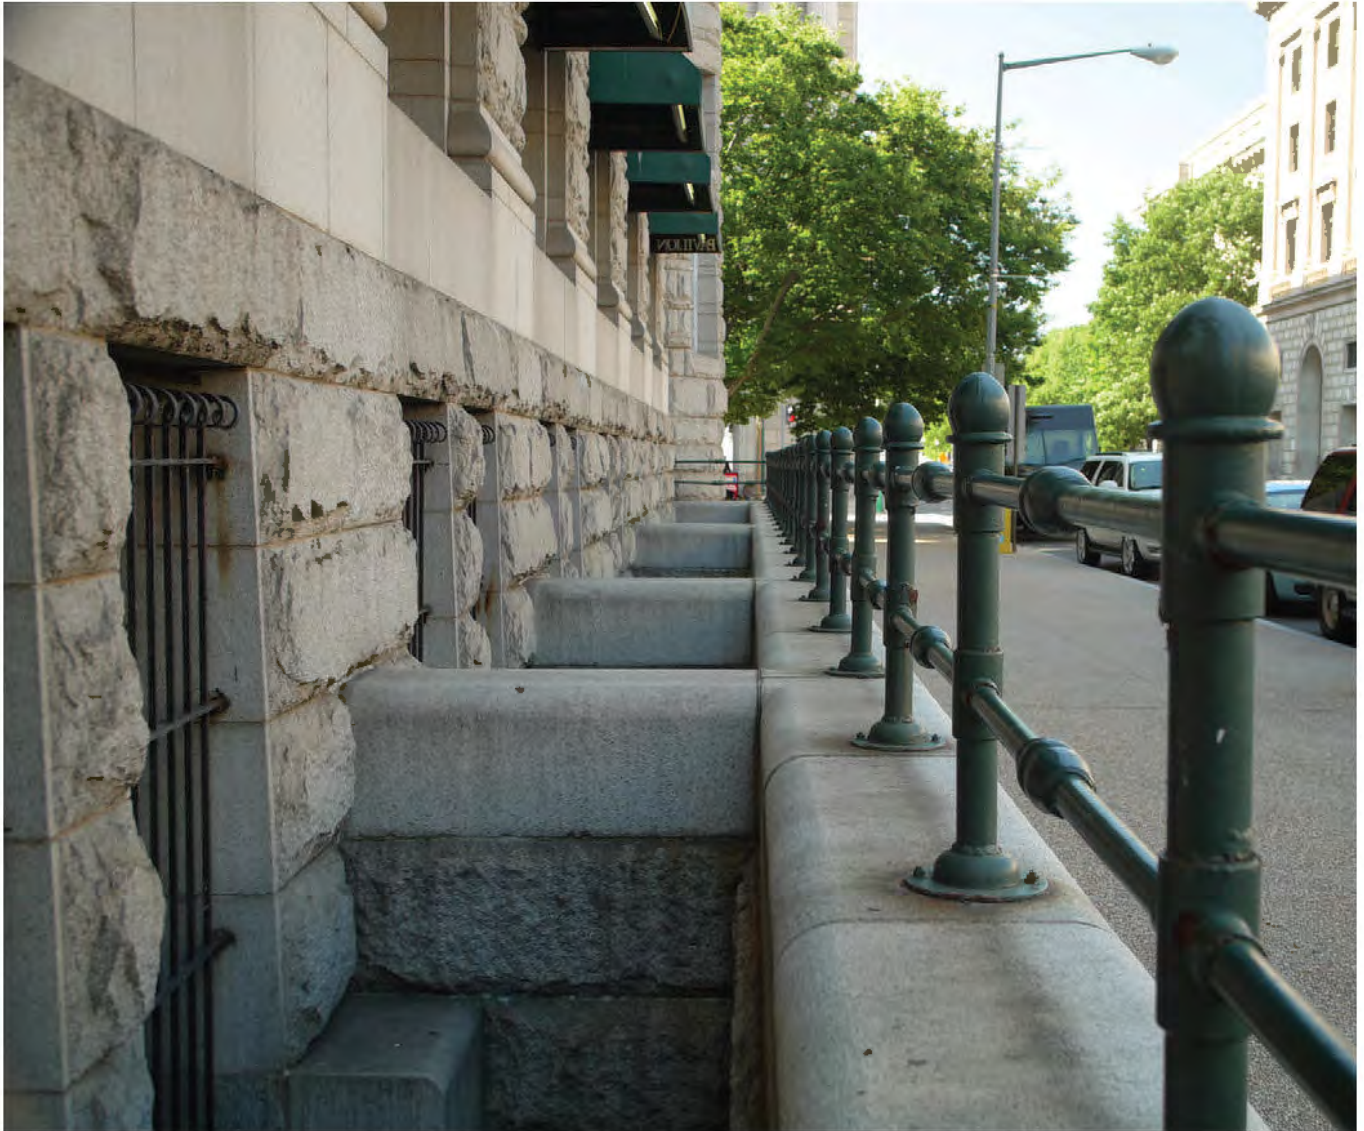
- Visible deterioration of paint.
- Cases of rust.
- Some staining from environmental pollutants.
- Parts of granite base cracked and missing.

FIGURE 93: Moats and Railings 12th Street, 2012. Photo Courtesy OLBN Inc.

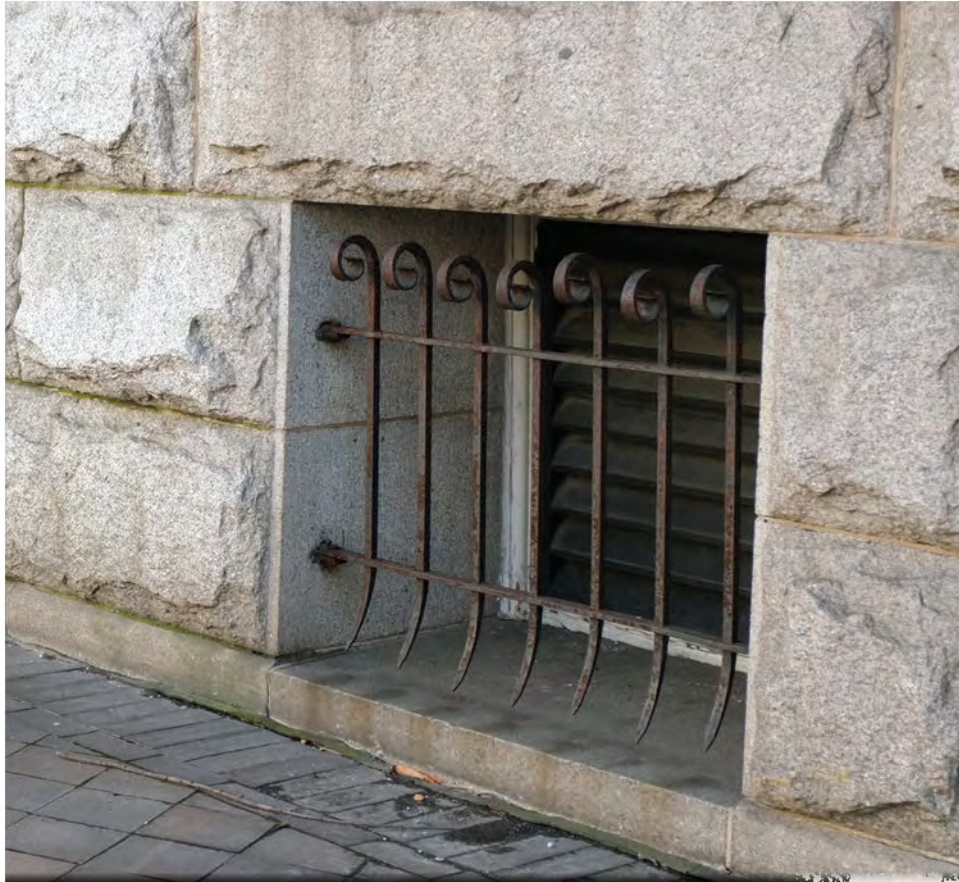
CONDITION: • Visible deterioration of paint.
• Cases of rust.

FIGURE 94: North Elevation Basement Window Guard, 2012. Photo Courtesy OLBN Inc.

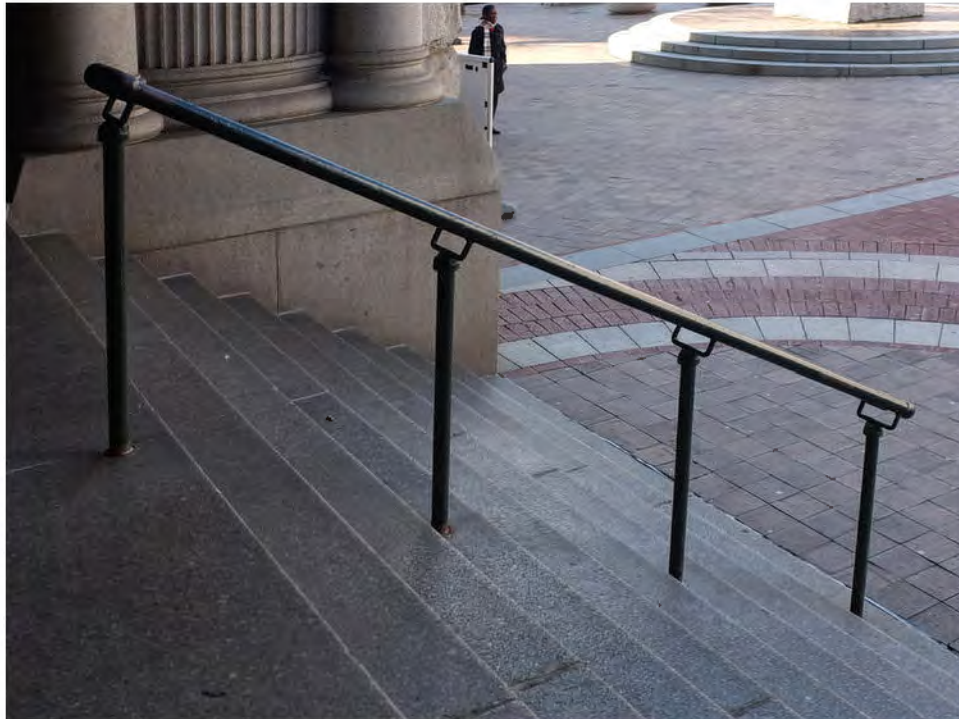
CONDITION: • Visible deterioration of paint.
• Cases of rust.

FIGURE 95: North Portico Staircase Railing, 2012. Photo Courtesy OLBN Inc.

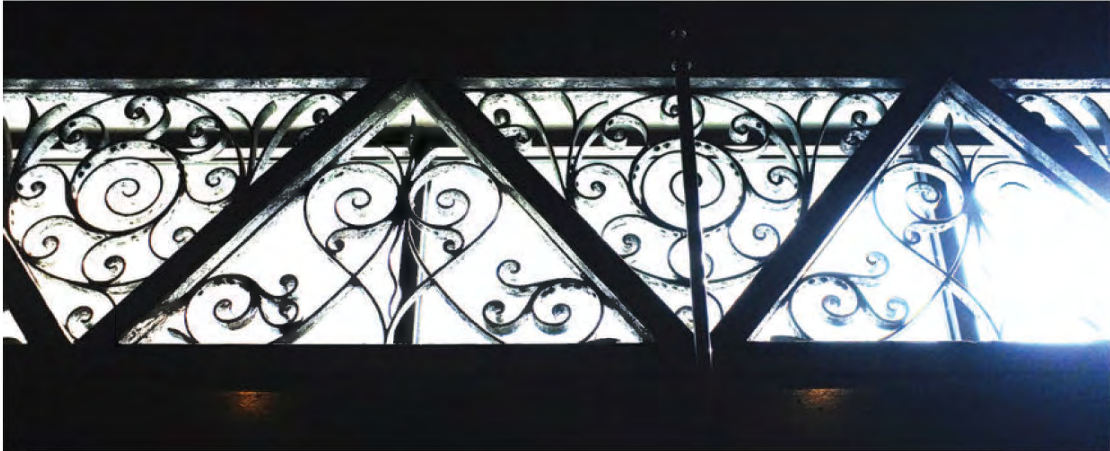
- Visible deterioration of paint.
- Cases of rust.

FIGURE 96: South Elevation Truss, 2012. Photo Courtesy OLBN Inc.

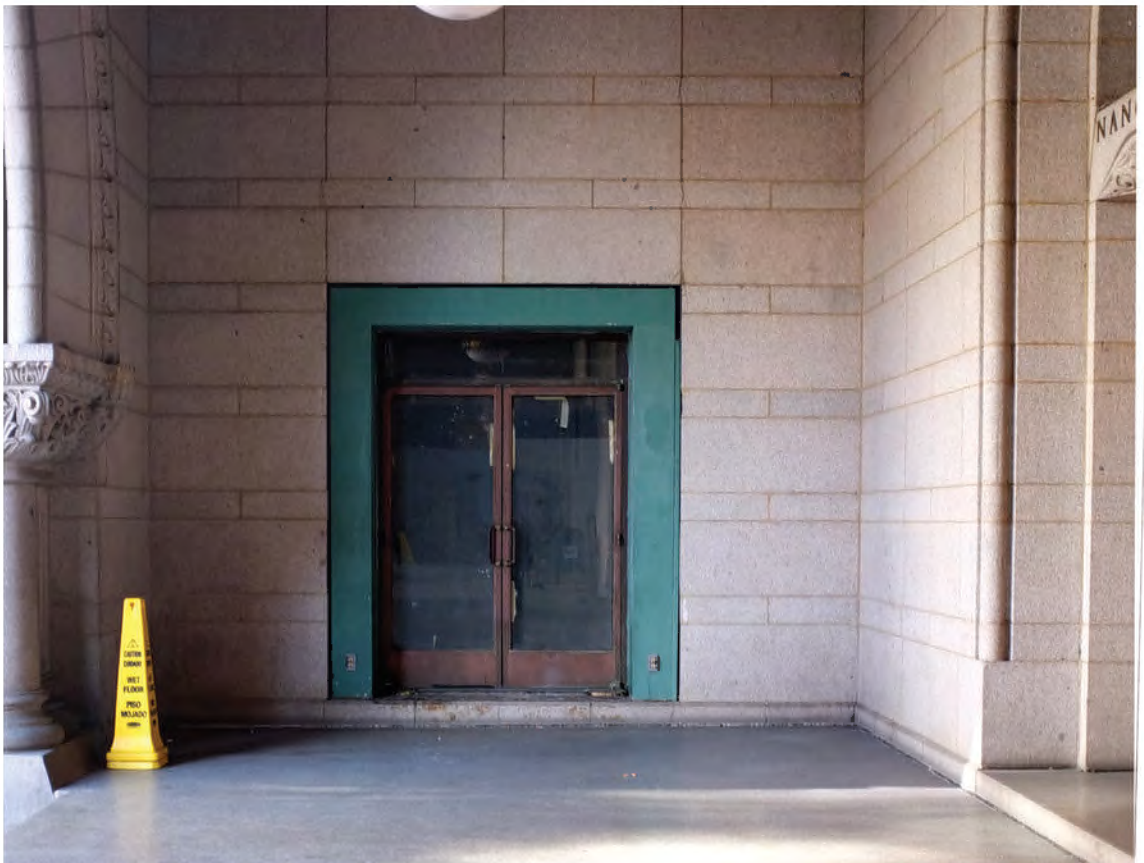
- Dirt
- Moderate wear and impact damage.

FIGURE 98: Pennsylvania Avenue Portico Restaurant Entrance, 2012. Photo Courtesy OLBN Inc.

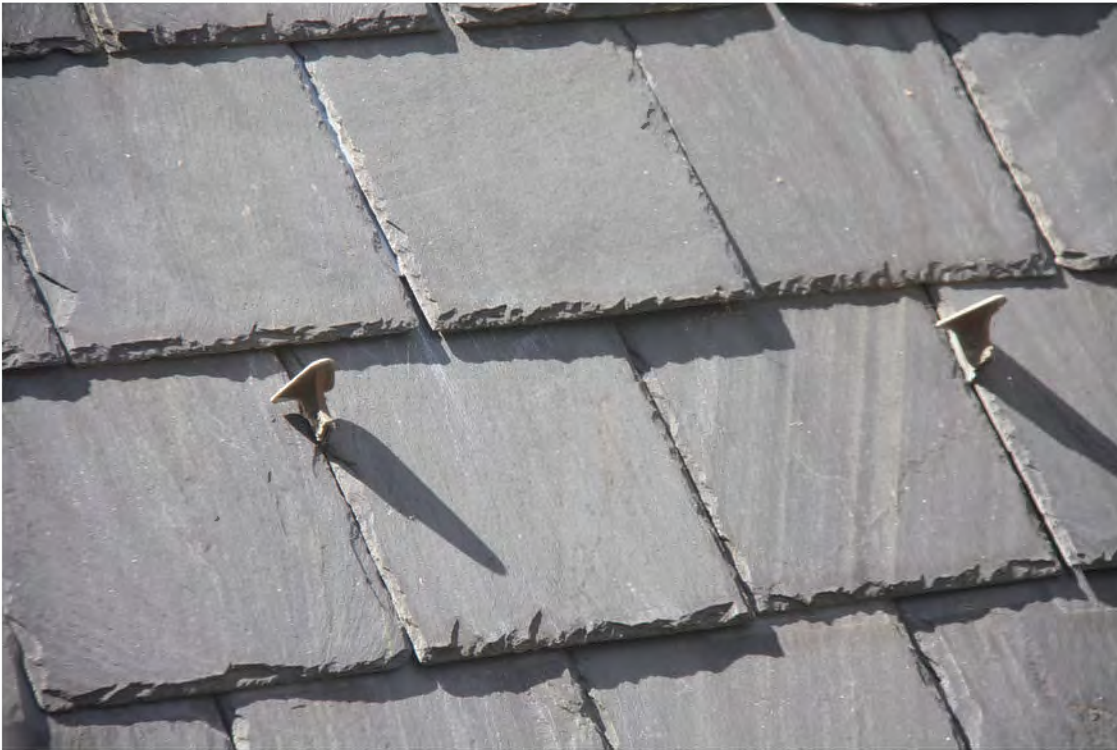
CONDITION: • Expected wear and impact damage.

FIGURE 99: Snow Guards, 2012. Photo Courtesy OLBN Inc.

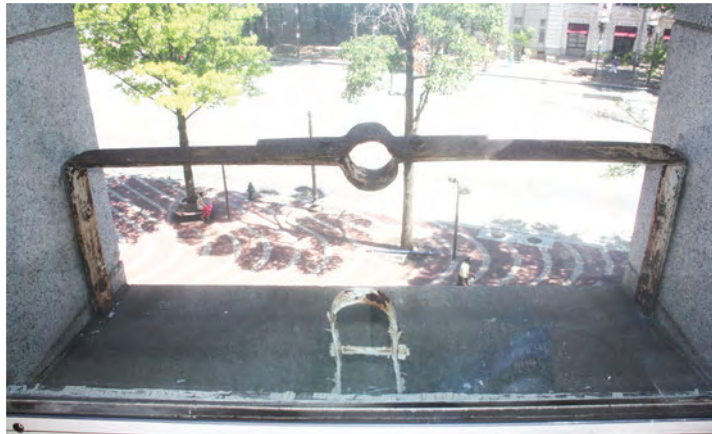
CONDITION: • Heavy deterioration of paint.
• Significant rust.

FIGURE 100: Pennsylvania Avenue Abandoned Flag Holder 2nd Floor, 2012. Photo Courtesy OLBN Inc.

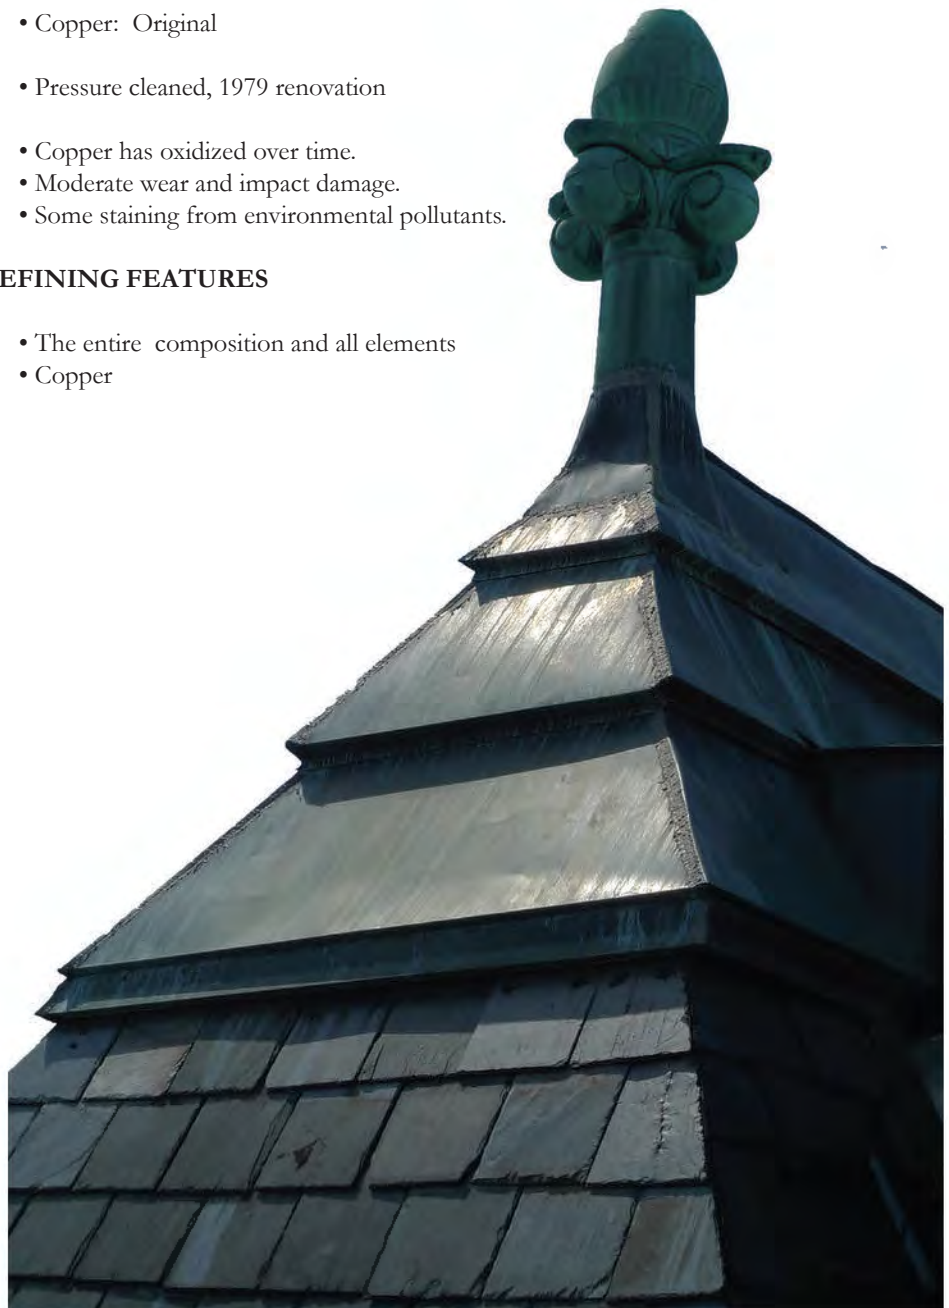
CONDITION:

- Copper has oxidized over time.
- Moderate wear and impact damage.
- Some staining from environmental pollutants.

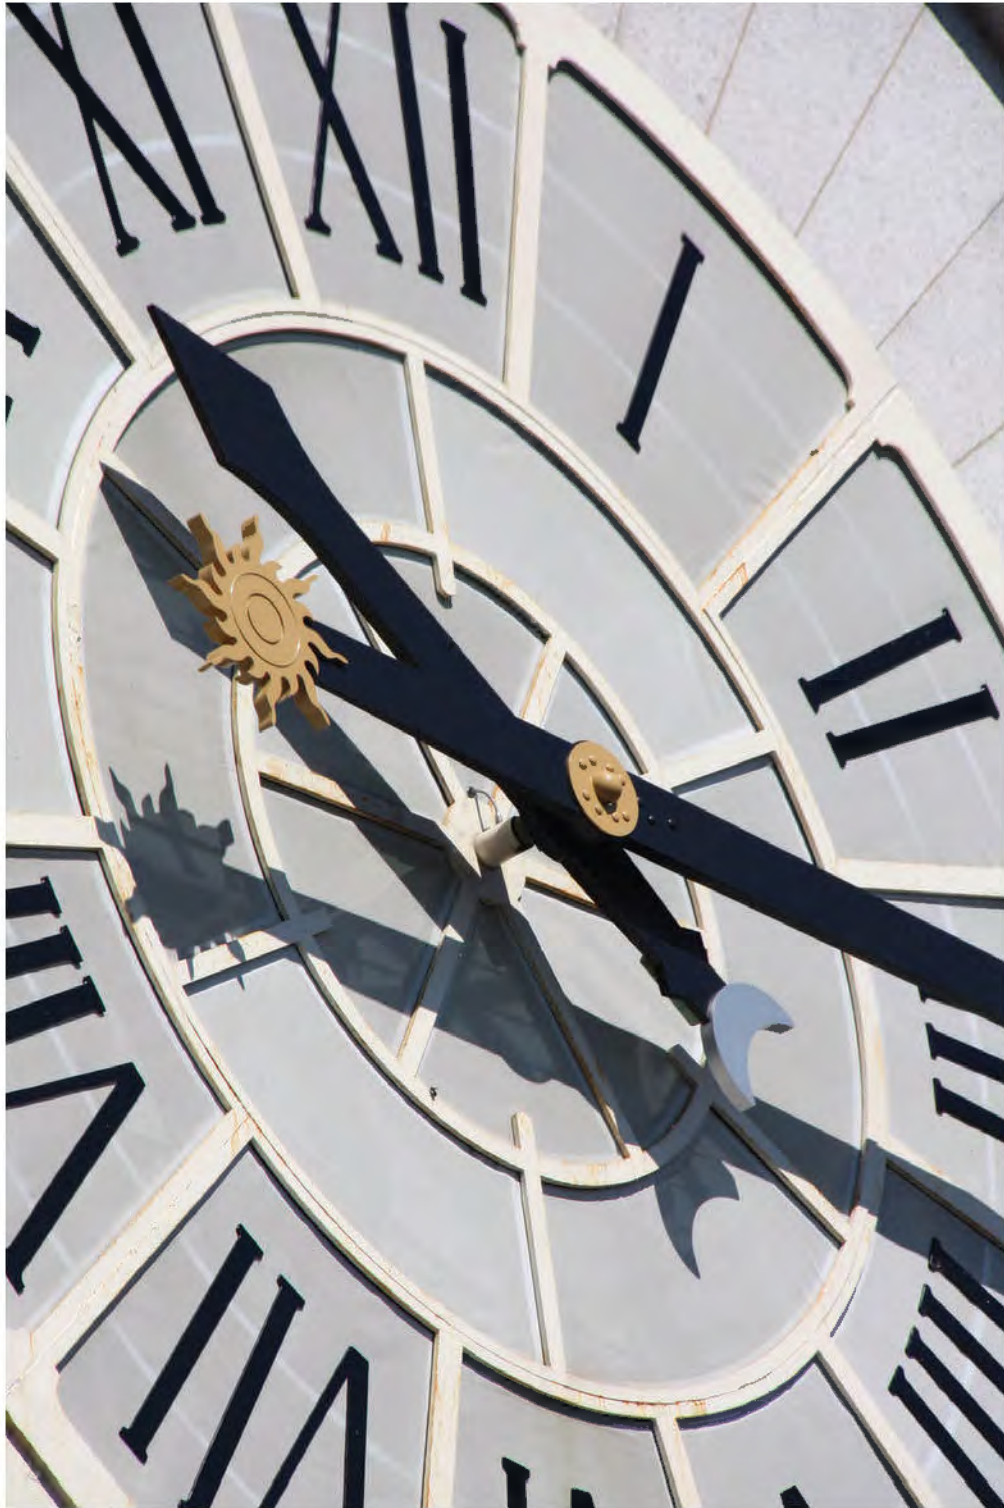
CONDITION:

- The clock has been recently restored, thus it does not present any deficiencies.

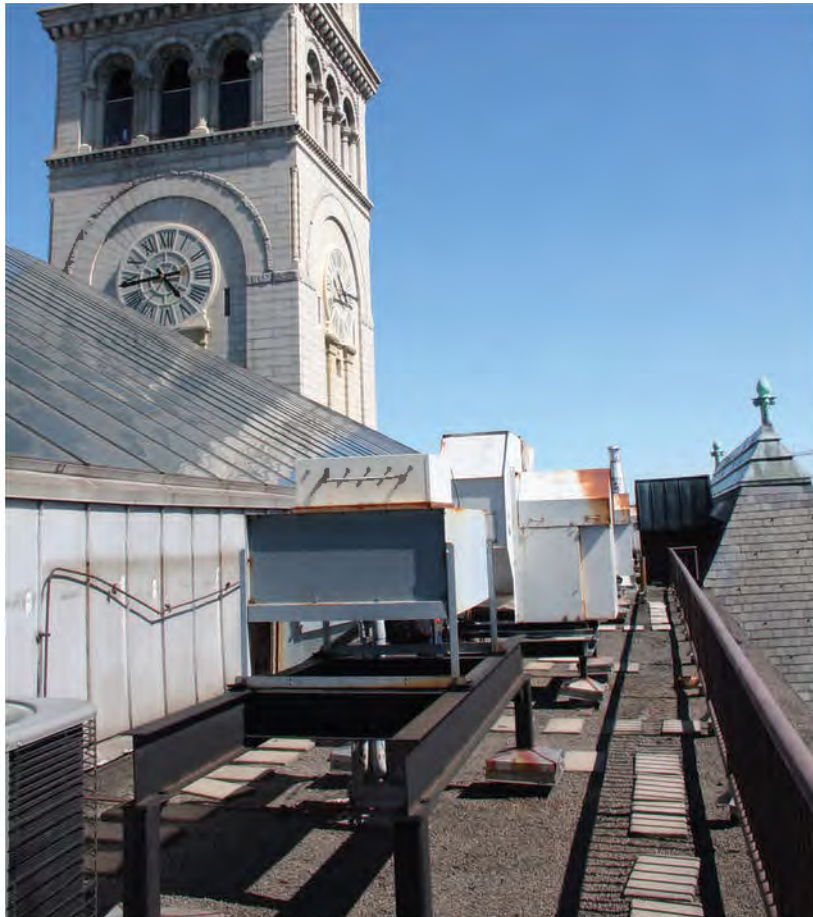
CONDITION: • Normal wear and impact damage.
• Some staining and rusting from environmental pollutants and water.
