Description of document: General Services Administration (GSA) Architectural Assessment Report on the Old Post Office Building, 2012

OLD POST OFFICE
HSR

EXISTING EXTERIOR CONDITIONS SURVEY

EXISTING INTERIOR CONDITIONS SURVEY

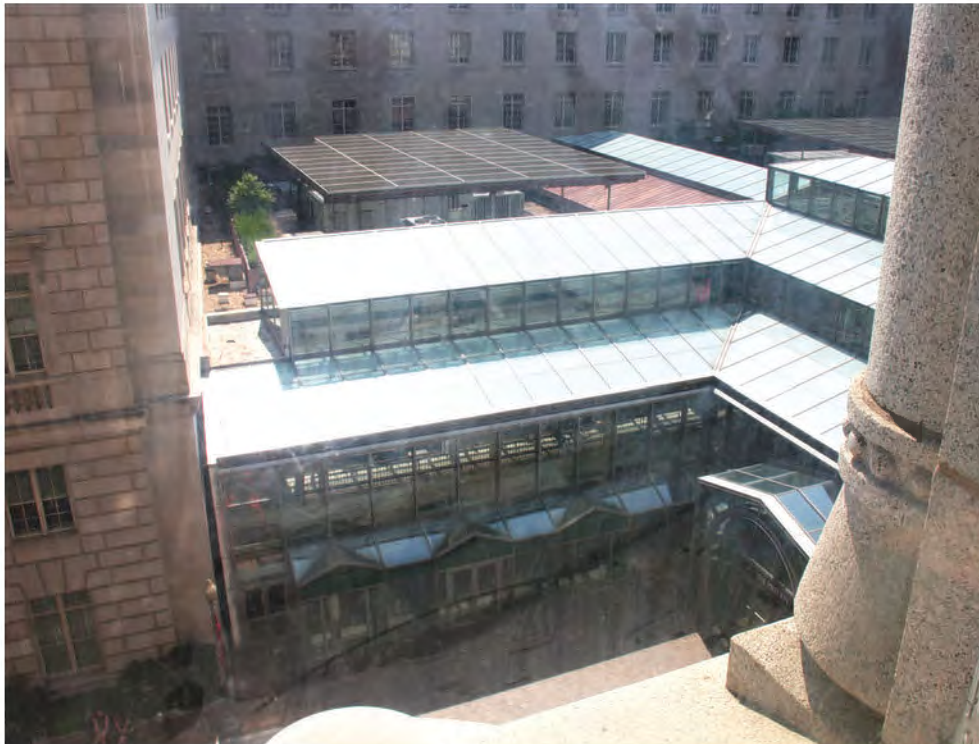
CONDITION:

- Normal wear and impact damage on exterior.
- Some staining and rusting from environmental pollutants and water.
- Interior surfaces and materials have moderate to heavy wear and damage from lack of maintenance.

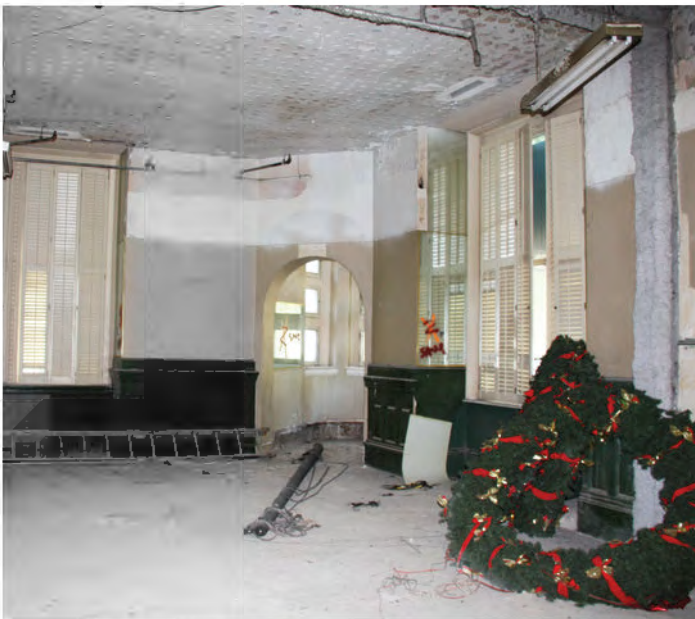
Currently, the northwest corner pavilion is unoccupied and in a severe state of disrepair. As described previously, this corner pavilion was outfitted in the 1970's to be a restaurant. The restaurant having closed after a short period of time in operation, the space was left vacant, unattended and unmaintained. A good portion of original wood wainscoting is extant, along with window surrounds, plaster work walls and crown mouldings. However, these elements, especially the plaster work on the walls and crown mouldings are severely damaged.

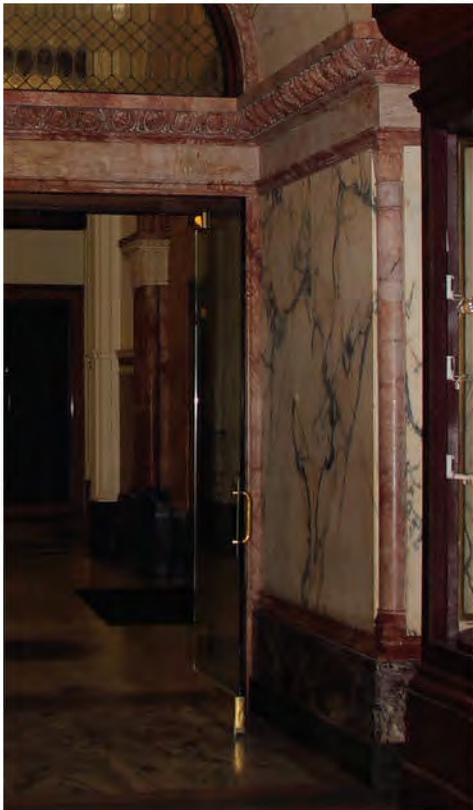
- Marble wainscot has hairline cracks

FIGURE 19: Detail of Tower Lobby Wainscot, 2012. Image Courtesy of OLBN Inc.

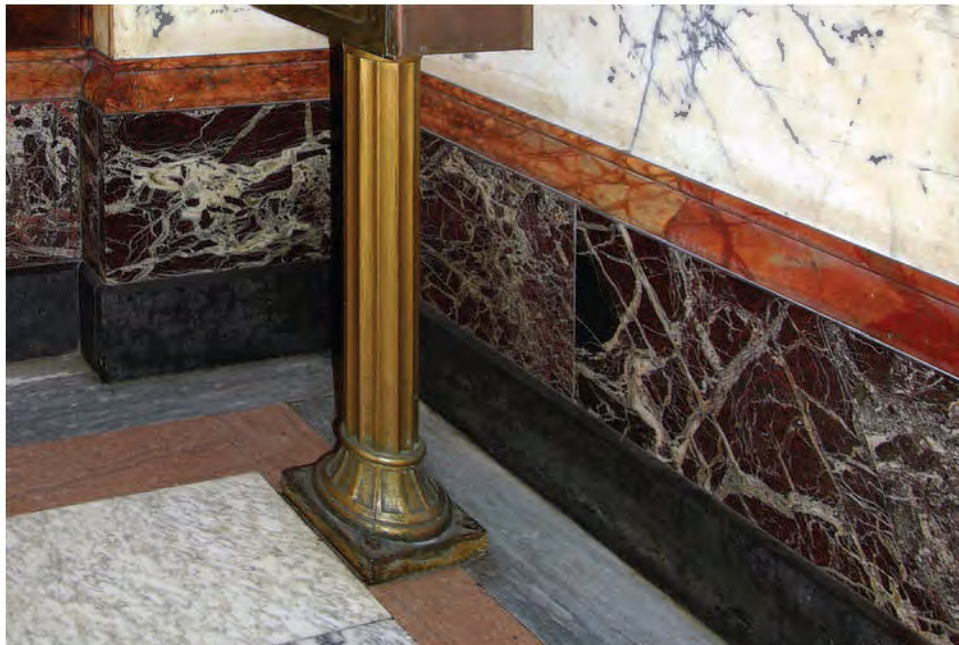
- Some evidence of wear and impact damage, particularly to baseboard.
- On the south wall, a small section of the dado marble cap, missing most likely, was substituted with wood and faux painted to match.

FIGURE 22: Detail of Tower Lobby Base, 2012. Image Courtesy of OLBN Inc.

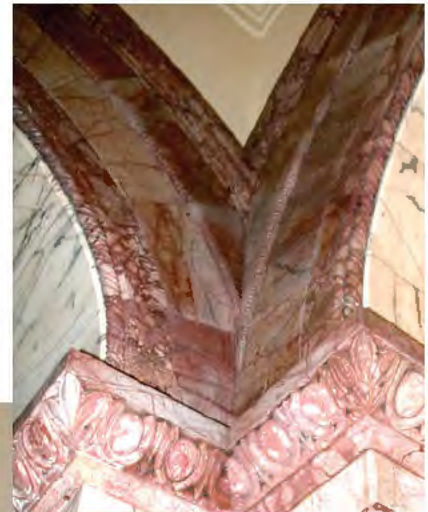
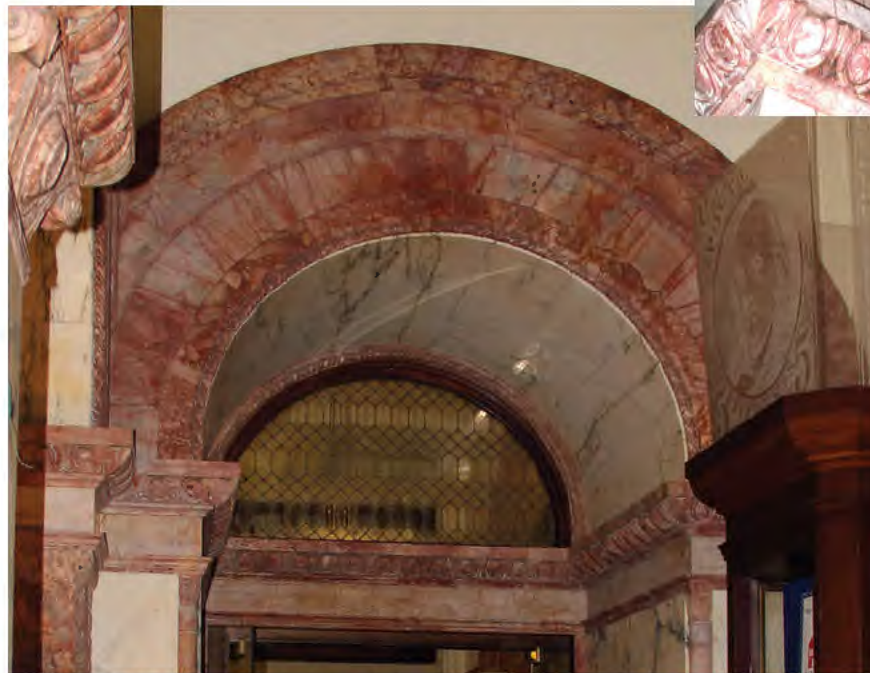
- *Marble has hairline cracks*

FIGURES 26 & 27: Detail of West Tower Archway, 2012. Image Courtesy of OLBN Inc.

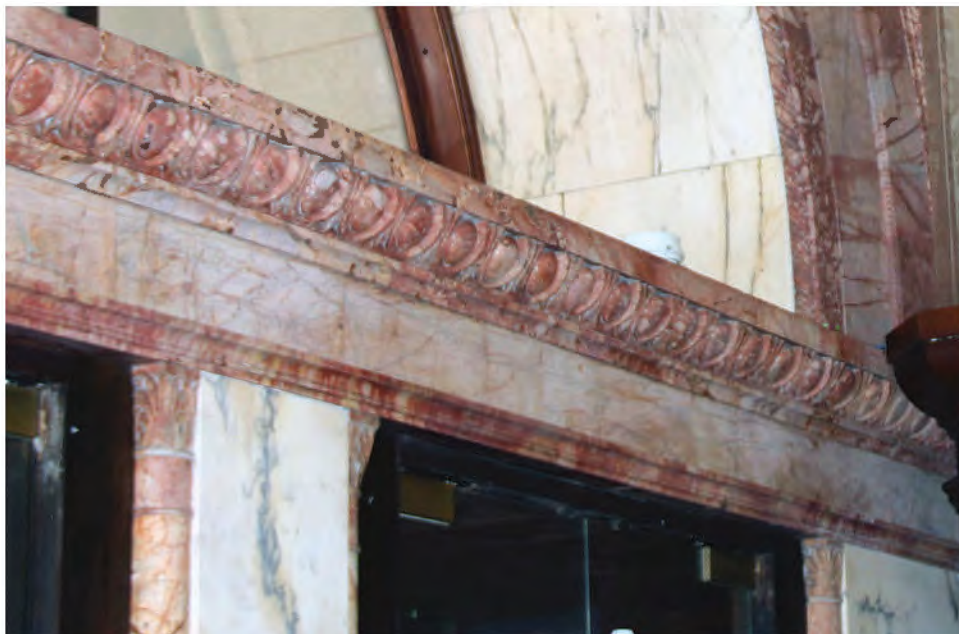
- CONDITION:
- Mild to moderate wear on doors

FIGURE 32: Detail Tower Lobby Vestibule, 2012. Image Courtesy of OLBN Inc.

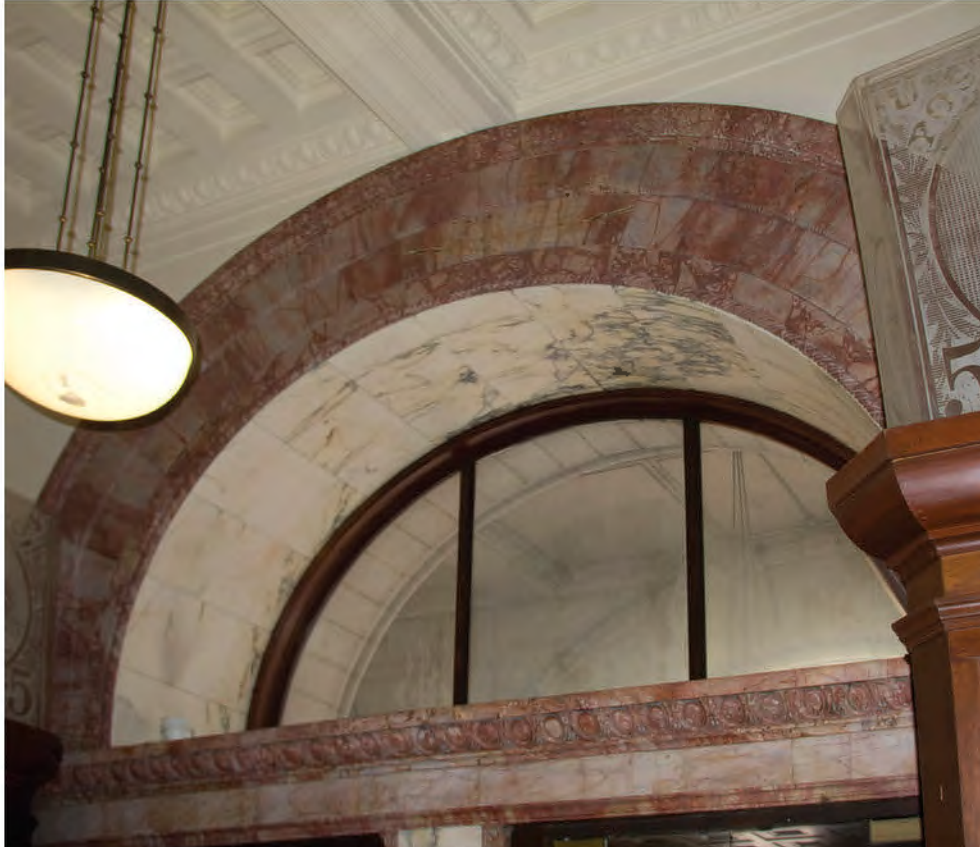
- Marble has hairline cracks

FIGURE 33: Tower Lobby North Wall Archway, 2012. Image Courtesy of OLBN Inc.

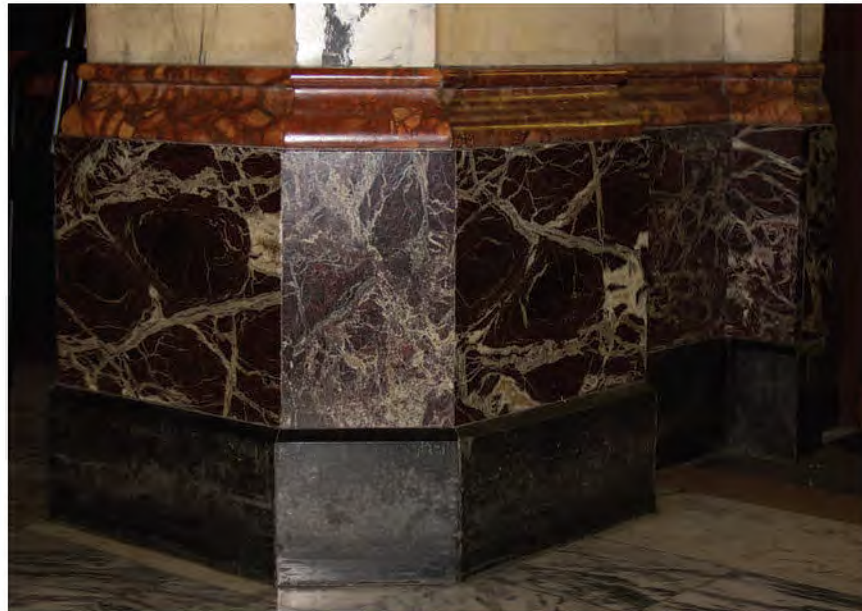
- Some evidence of wear and impact damage, particularly to baseboard.
- On the east section of the wall, a small section of the dado marble cap was substituted with wood and faux painted to match.

FIGURE 44: Detail of Tower Lobby South Wall Pilaster Base, 2012. Image Courtesy of OLBN Inc.

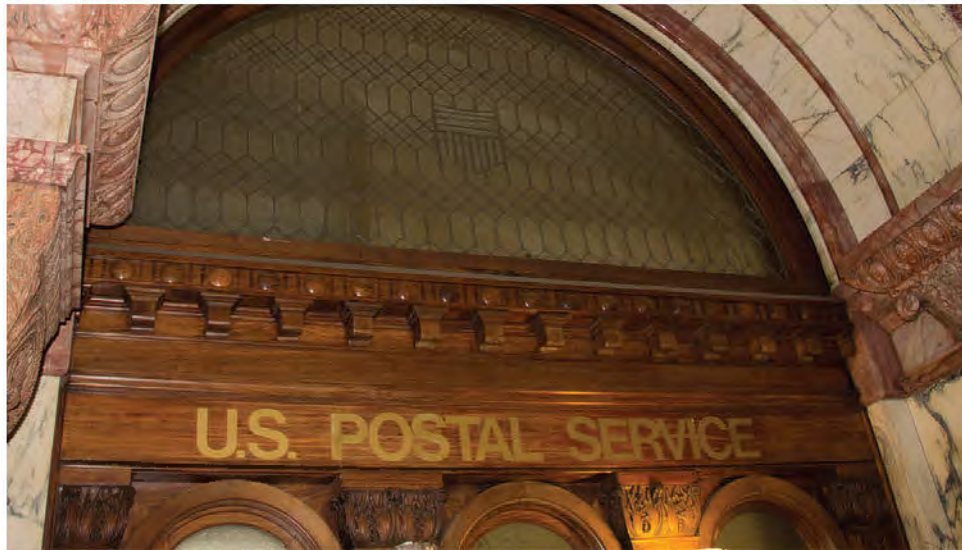
- No issues observed

FIGURE 46: Detail of Tower Lobby Feature Wall Entablature, 2012. Image Courtesy of OLBN Inc.

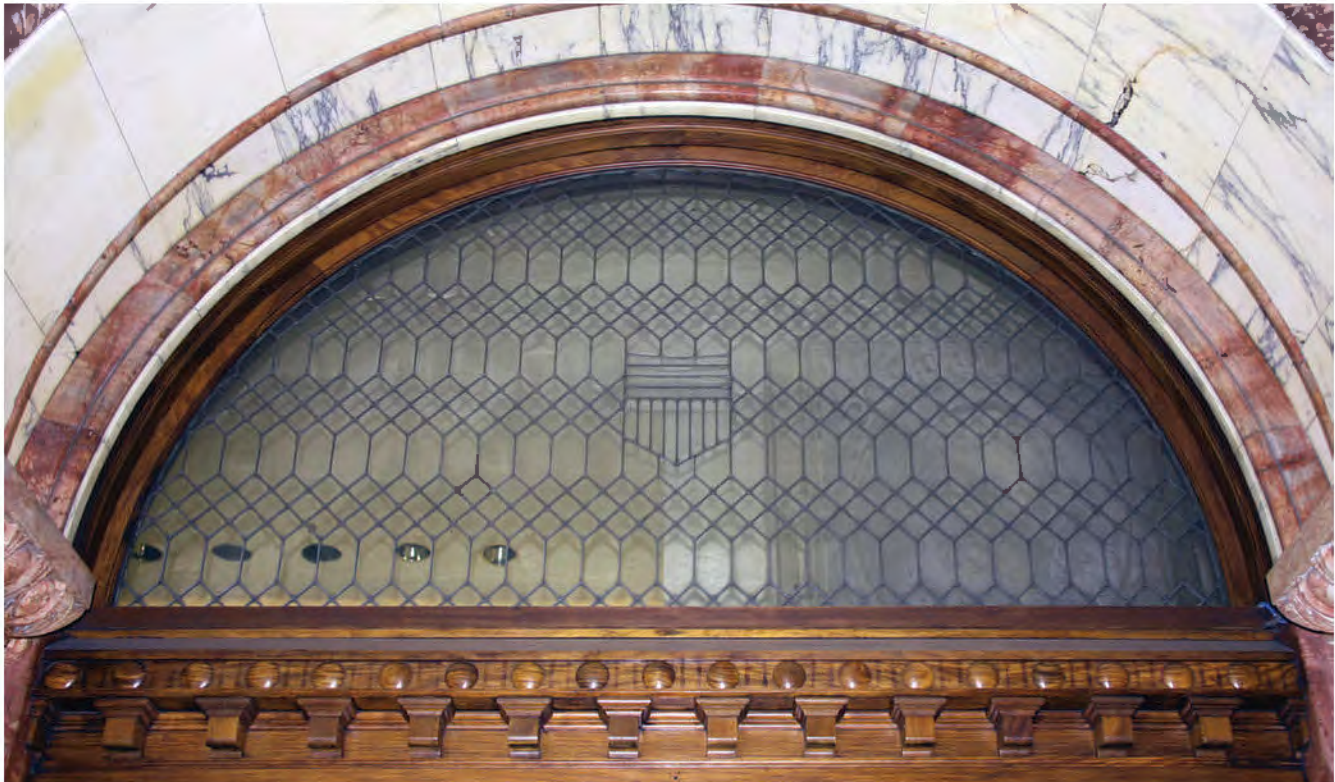
- LOCATION: South wall of tower lobby
- MATERIALS:
 - Mahogany: *Frame*
 - Leaded glass
- FINISHES:
 - Mahogany: *Varnished*
- SIGNIFICANCE:
 - Mahogany elements: *Original*
 - Leaded glass: *Original*
- ALTERATIONS:
 - Mahogany: *Cleaned and possibly refinished during the 1979 renovation.*
 - Leaded glass: *Cleaned during the 1979 renovation.*
- CONDITION:
 - No issues observed

FIGURE 47: Detail of Tower Lobby Feature Wall Transom, 2012. Image Courtesy of OLBN Inc.

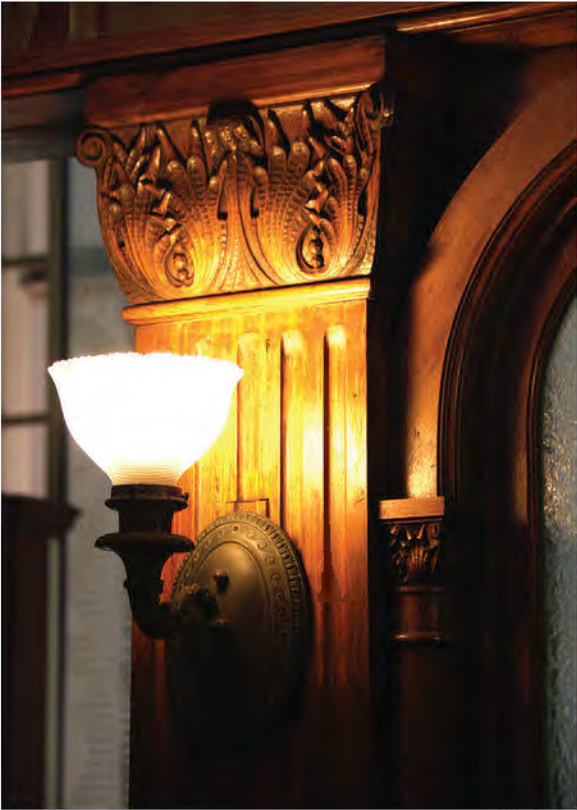
- CONDITION:
- Evidence of wear

FIGURE 49: Detail of Tower Lobby Feature Wall Pilaster, 2012. Image Courtesy of OLBN Inc.

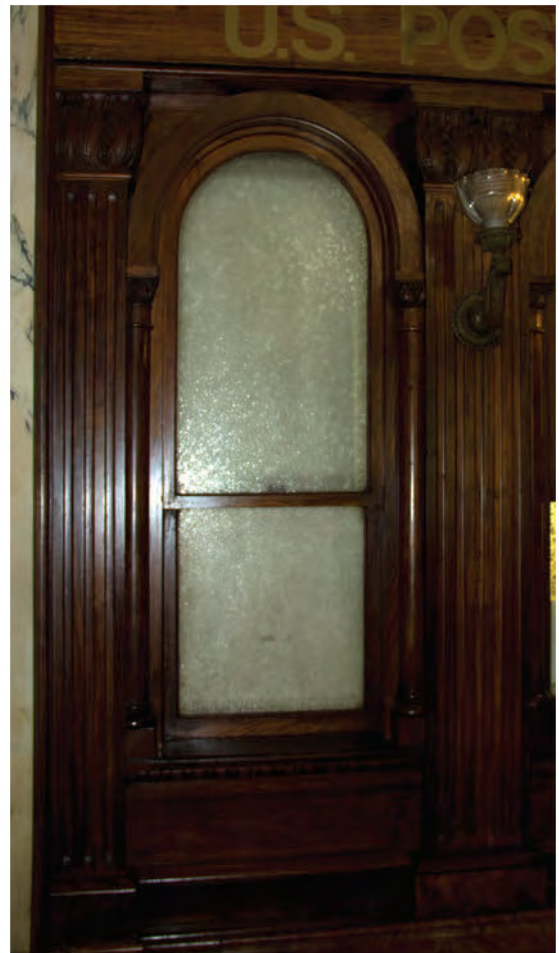
- Evidence of wear

FIGURE 50: Detail of Tower Lobby Feature Wall Windows, 2012. Image Courtesy of OLBN Inc.

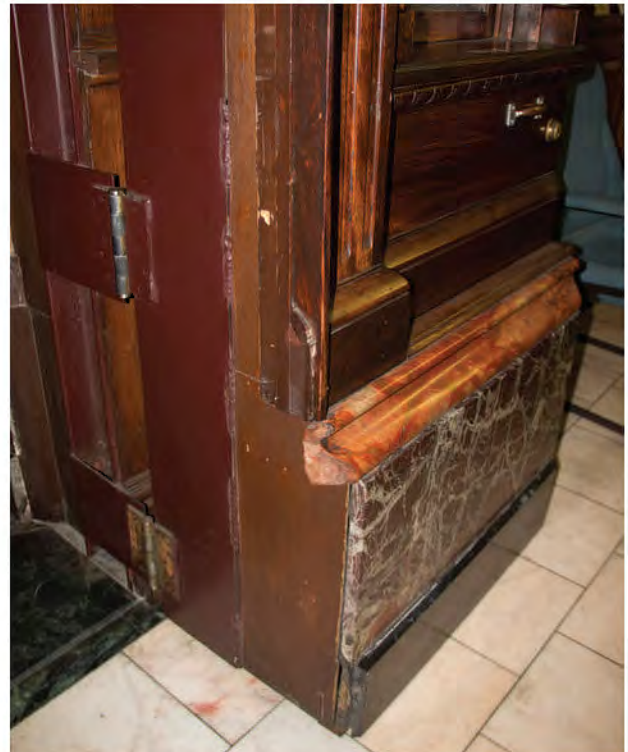
- Evidence of wear

FIGURE 53: Detail of Tower Lobby Feature Wall Hidden Door Hardware, 2012. Image Courtesy of OLBN Inc.

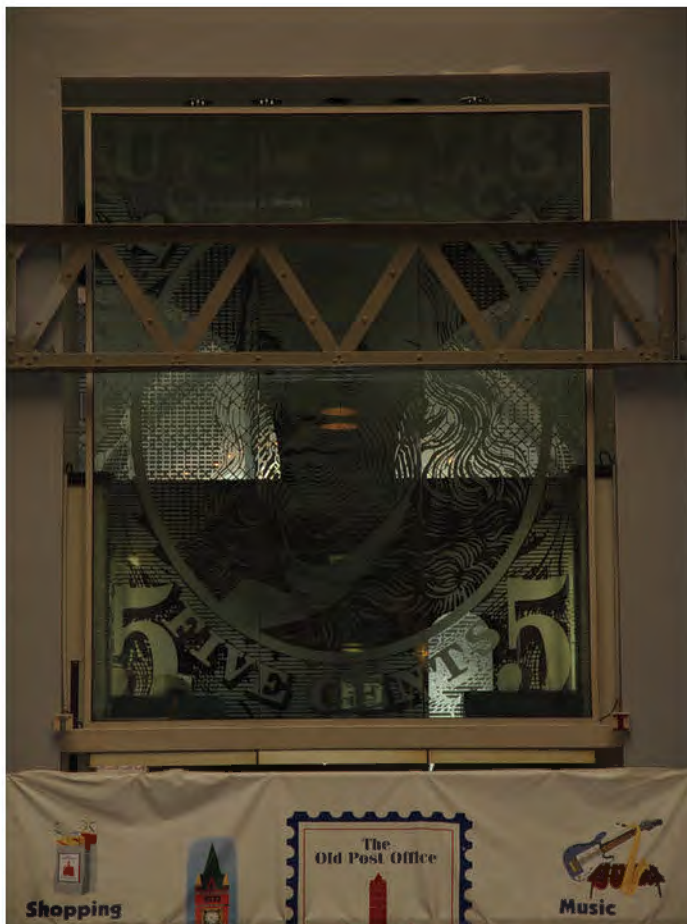
CONDITION: • Minor wear and impact damage

FIGURE 54: Detail of Tower Window, 2012. Image Courtesy of OLBN Inc.

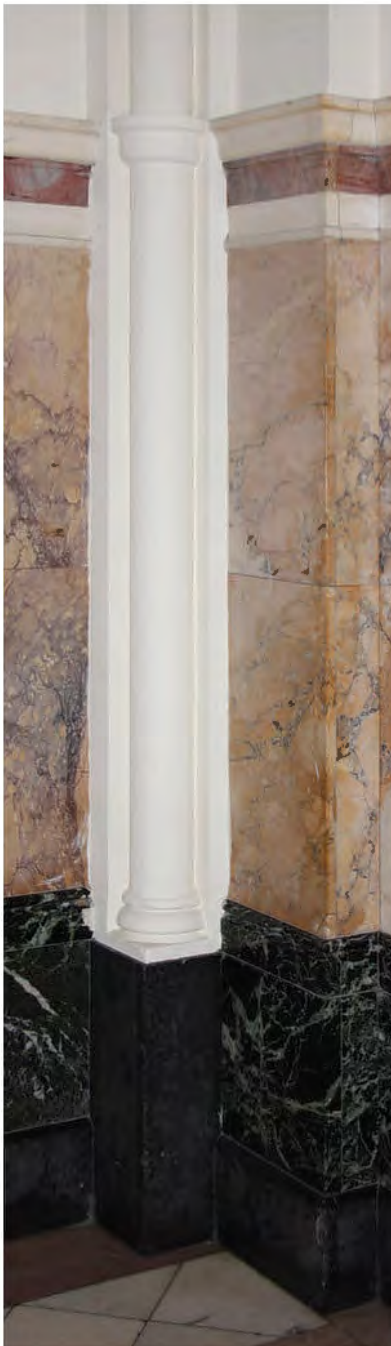
CONDITION: • The marble base shows some wear and impact damage. Rarely, pieces separated and missing, others replaced or filled in.

FIGURE 56 : Detail of North Wall Pilaster, 2012. Image Courtesy of OLBN Inc.

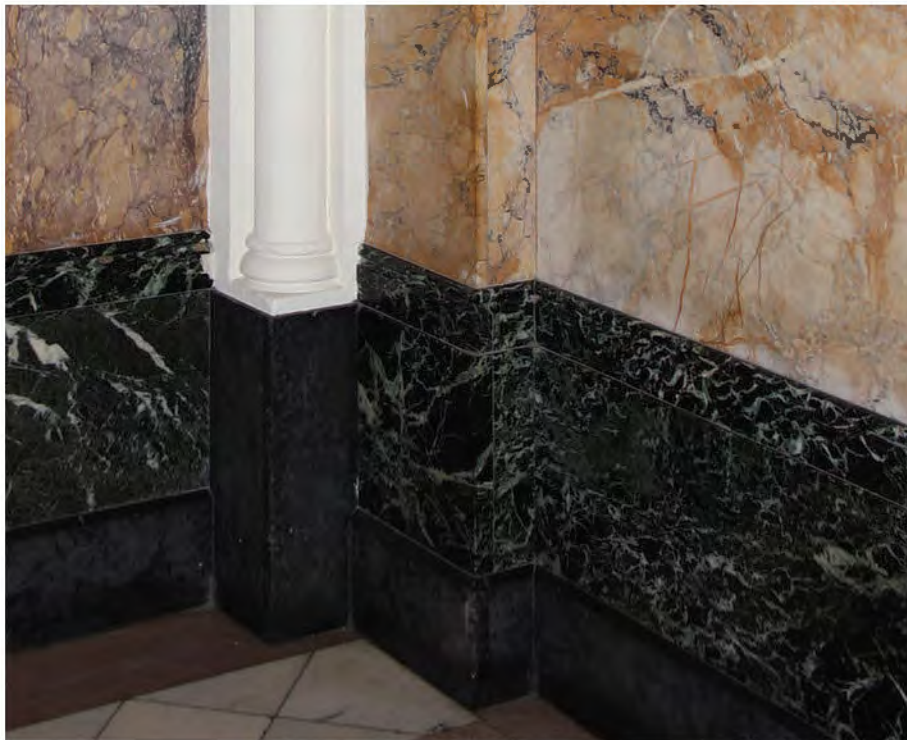
CONDITION: • Mild wear with some hair-line cracks. Some corner butt joints are slightly displaced and show damage.

FIGURE 57: Detail of North Wall Base, 2012. Image Courtesy of OLBN Inc.

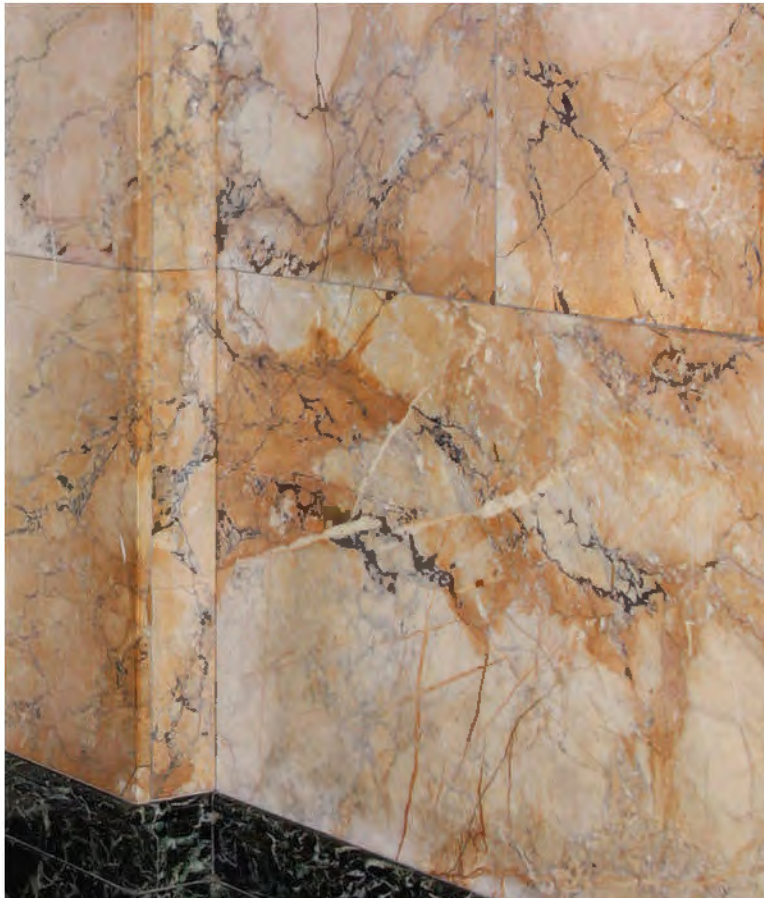
CONDITION: • Mild wear with some hair-line cracks

FIGURE 58: Detail of North Wall Wainscot , 2012. Image Courtesy of OLBN Inc.

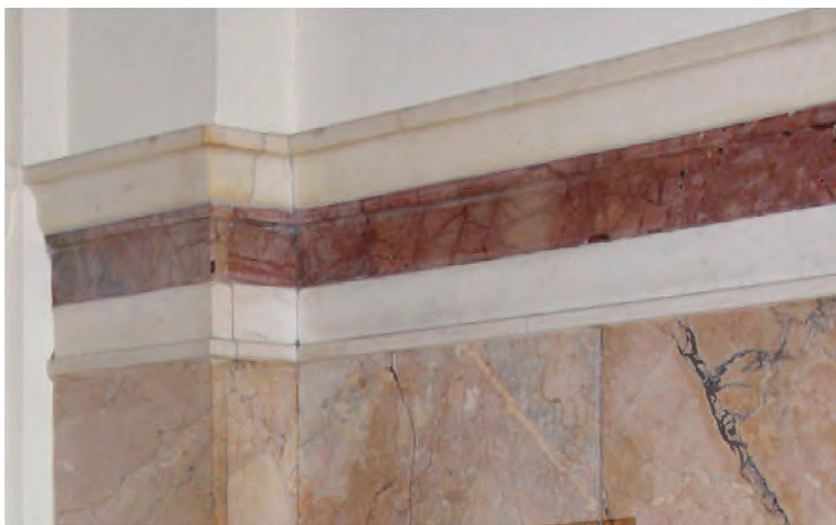
CONDITION: • Mild wear with some hair-line cracks. Some corner butt joints are slightly displaced and show damage.

FIGURE 59: Detail of North Wall Wainscot Cap, 2012. Image Courtesy of OLBN Inc.

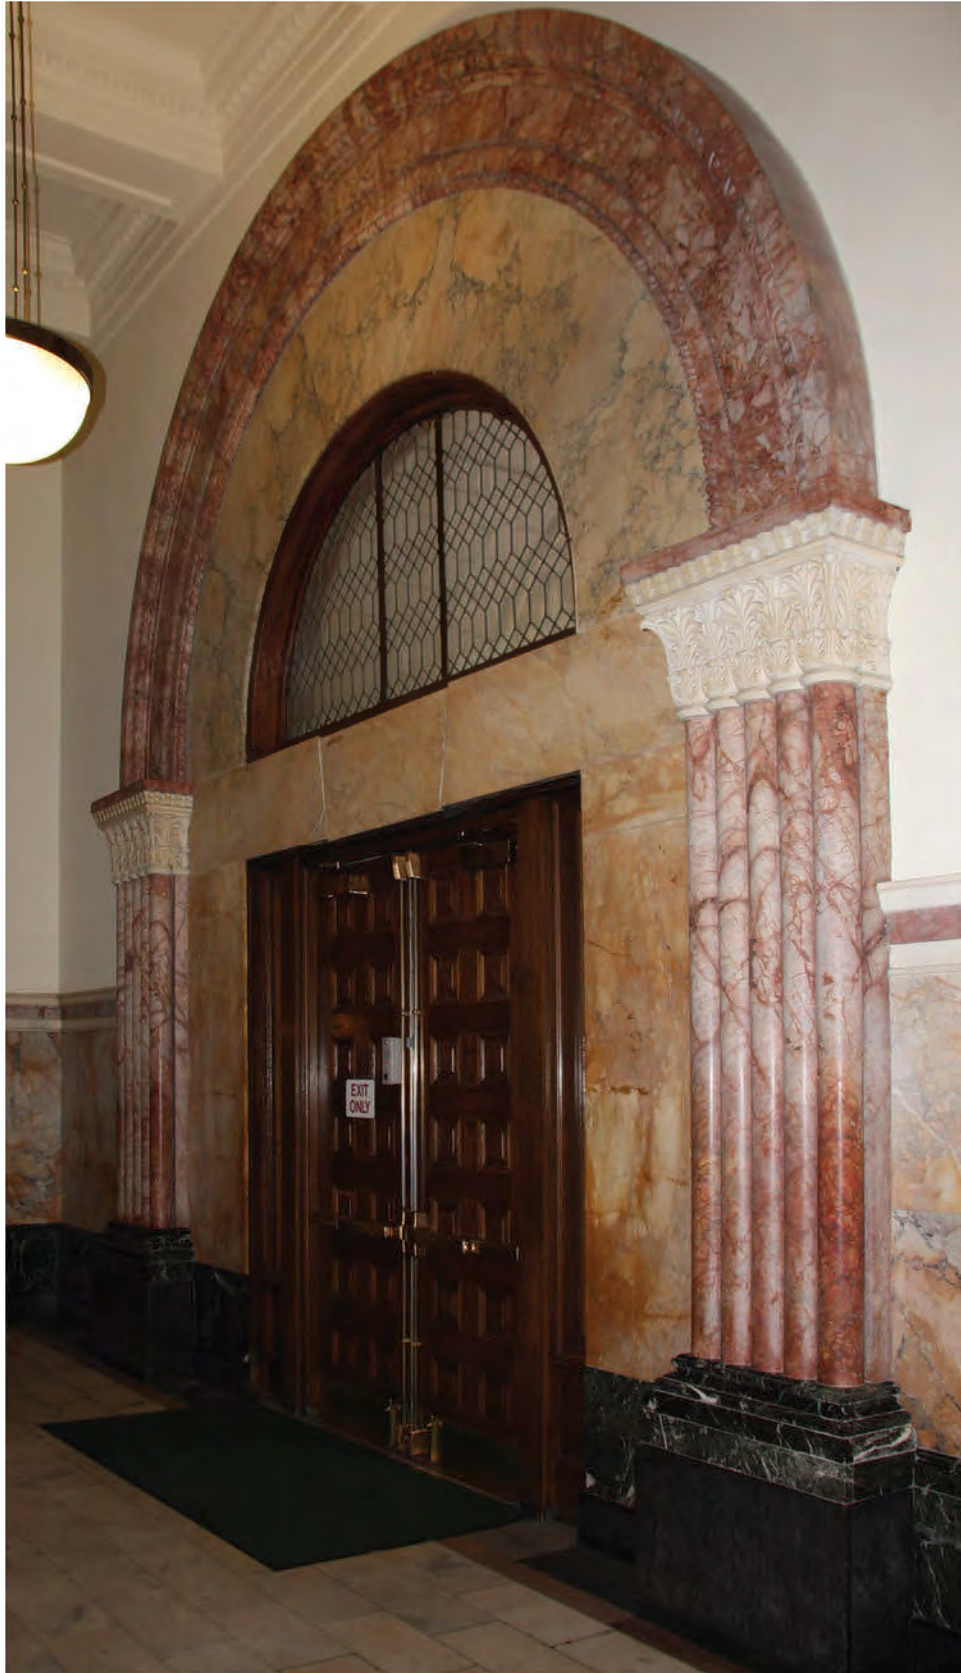
FIGURE 60: North Wall West Entrance, 2012. Image Courtesy of OLBN Inc.

- Mild to moderate wear on doors
- Some impact damage to marble plinth/base

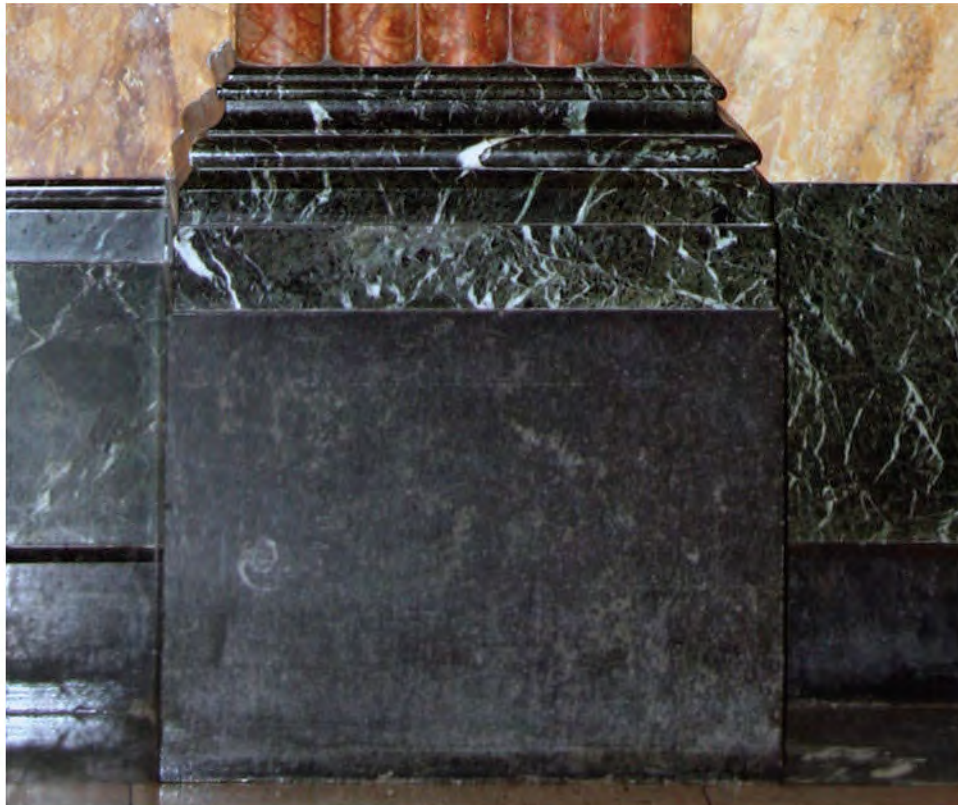
CONDITION: • Some impact damage to the plinth

FIGURE 63: North Wall West Entrance Composite Pilasters Base, 2012. Image Courtesy of OLBN Inc.

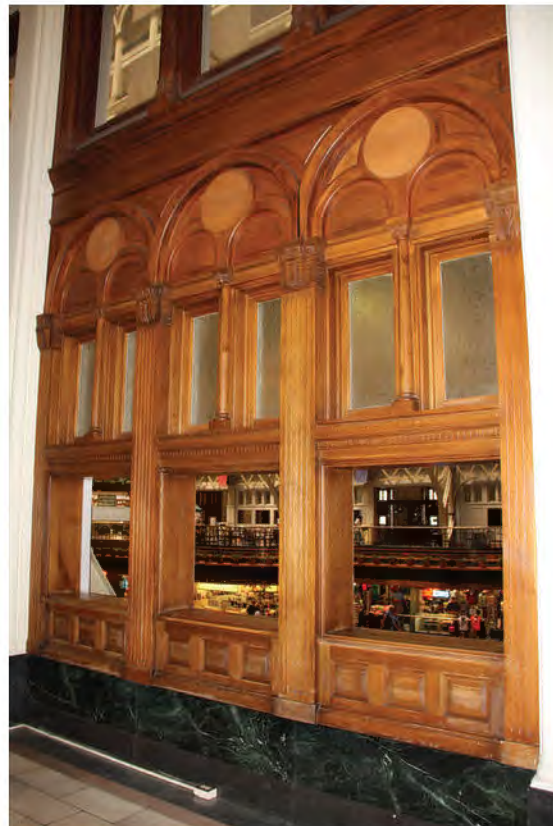
Marble Wainscoting Field

- Mild to moderate wear and impact damage
- In rare cases panels have been broken
- Some separated pieces missing
- Buildup of wax evident

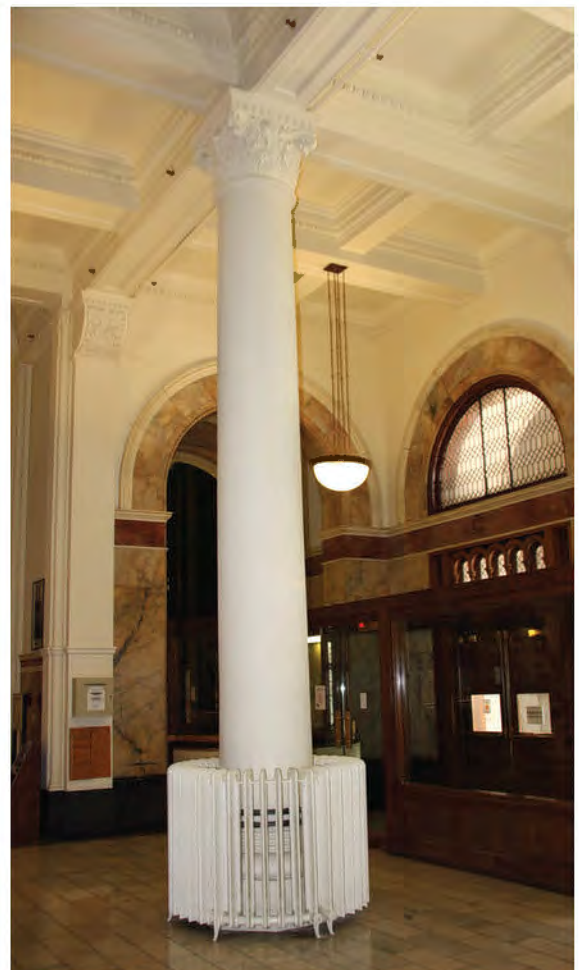
Cast Iron Radiator

- Survey required to determine quality of HVAC supply equipment.
- Overall condition of architectural radiator is good

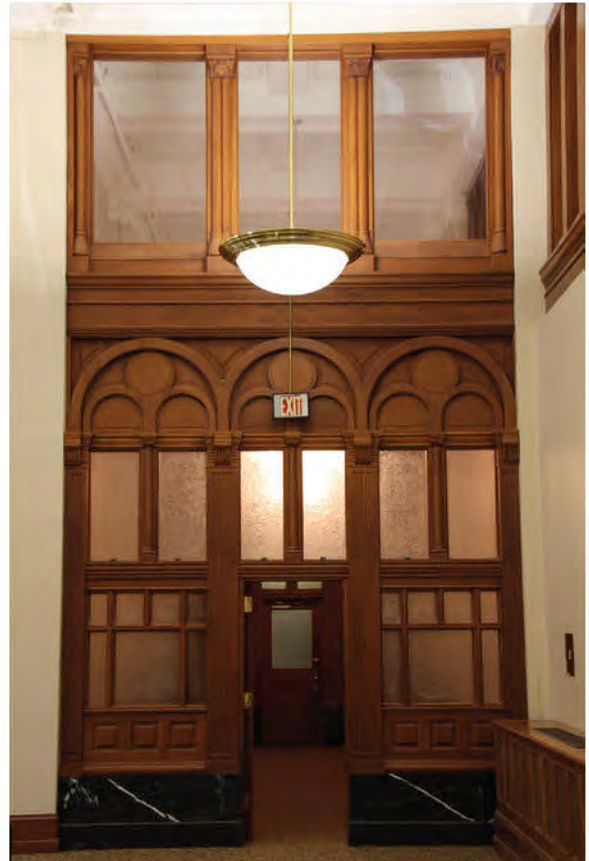
Oak Doors (Screen)

- Moderate wear in wood and finish from use and impact

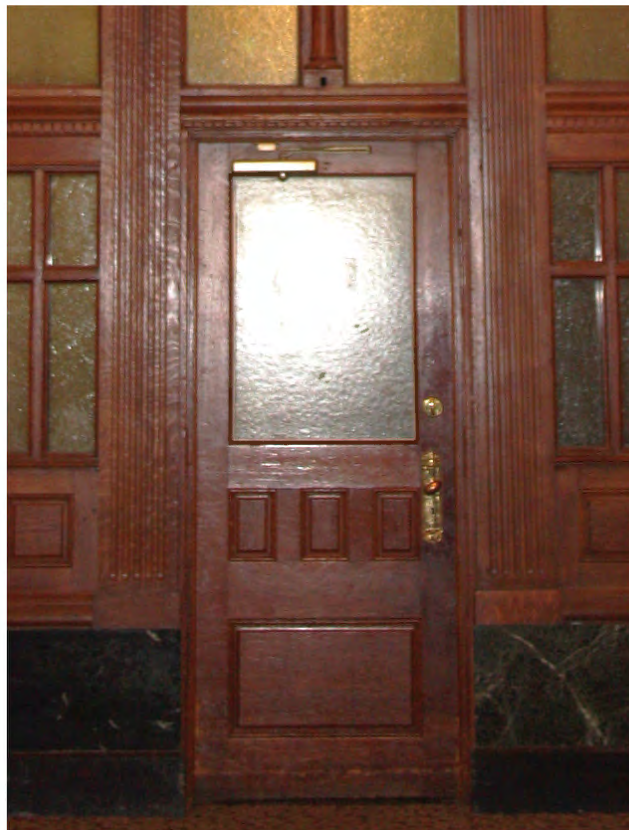
Corridor Doors

- Mild to moderate wear in wood, mostly in door surround
- Patina on glazing
- No evidence of cracked or broken glass

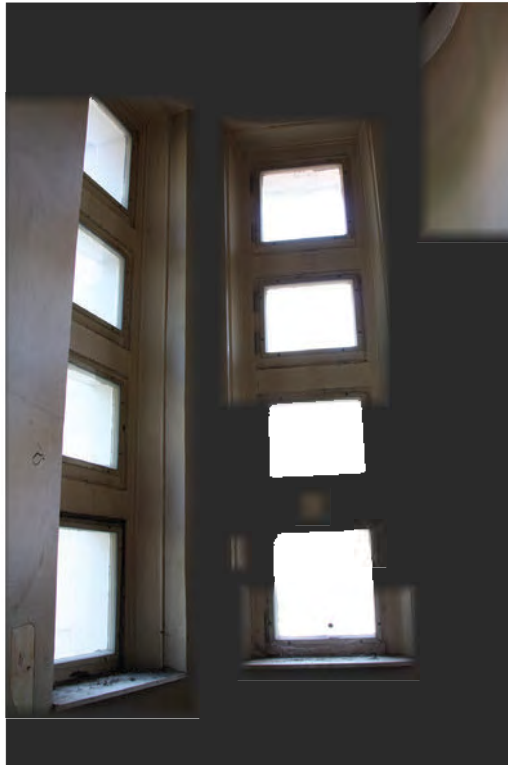
Fire Egress Stairs

CONDITION: • Evidence of water infiltration damage to drywall at SE stair core (9th floor)

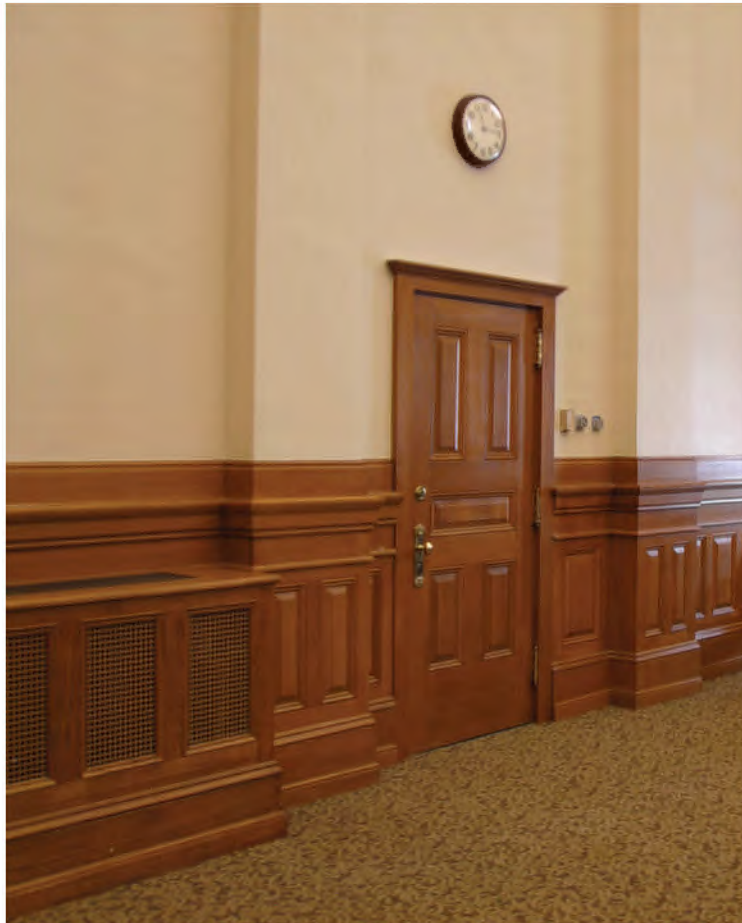
Oak Wainscoting (Original)

CONDITION: • Mild to moderate wear
• Cases of significant damage from impacts of occupants, furniture etc.

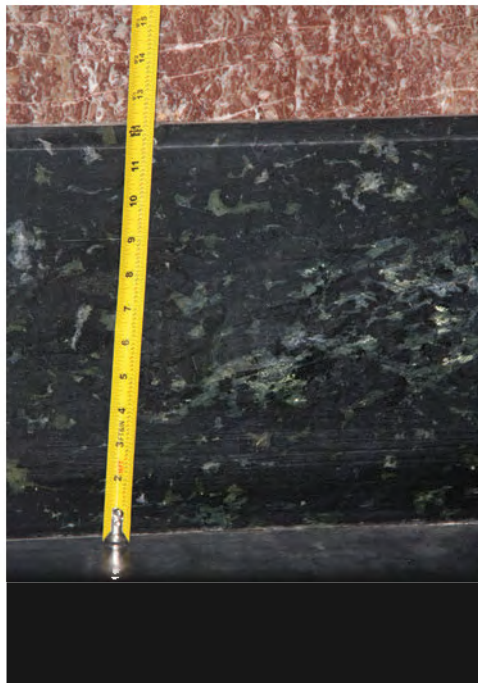
CONDITION: • Mild to moderate wear and impact damage
• In rare cases panels have been broken
• Some separated pieces missing
• Buildup of wax evident

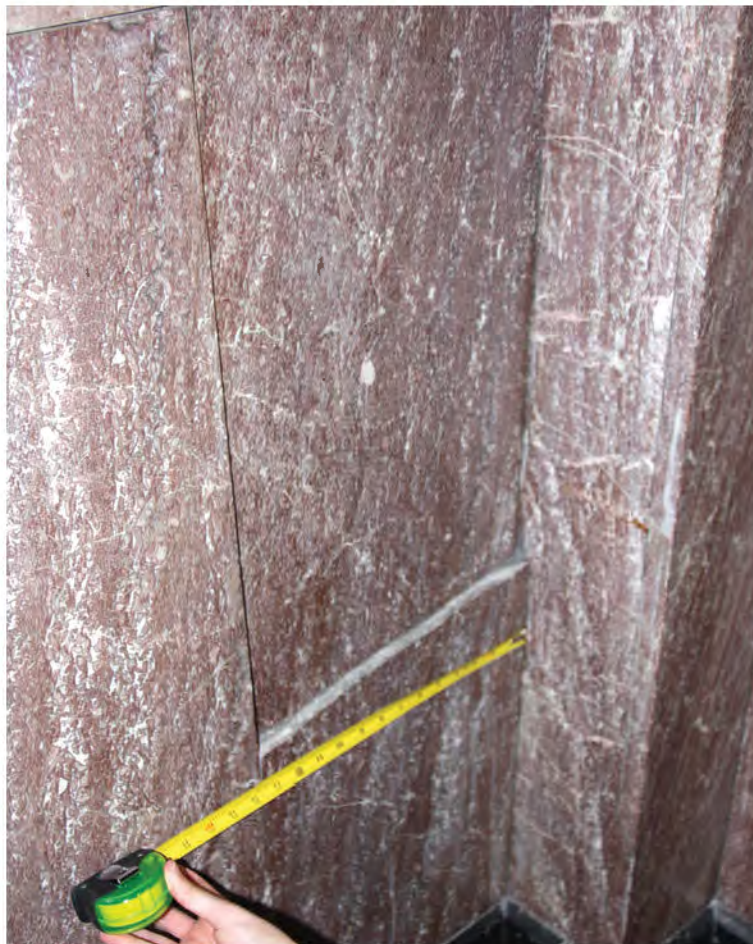
- Mild to moderate wear and some cracking.
- In rare cases, pieces of stone separated and missing.
- Buildup of wax evident.

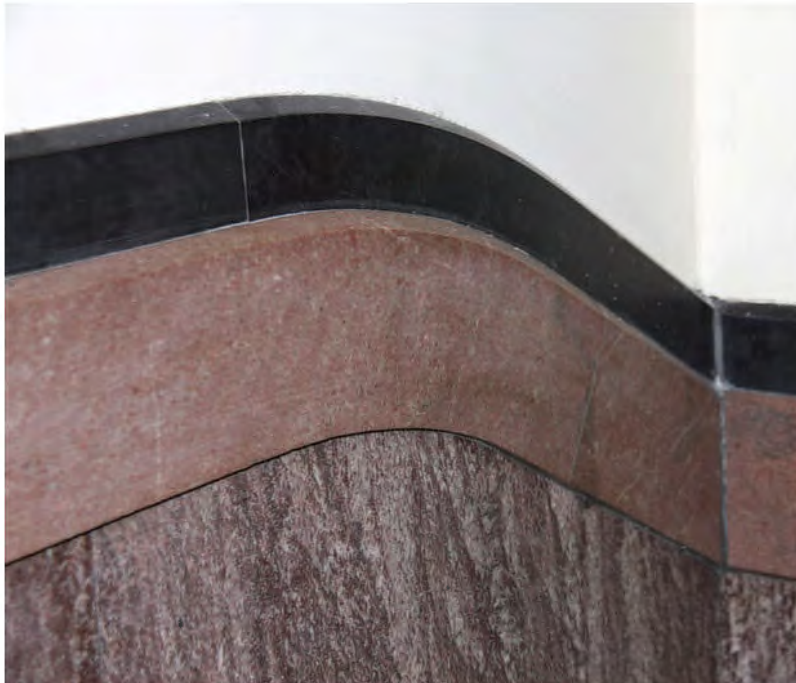
- Noticeable wear to marble treads
- Wear on wood handrails from frequent use

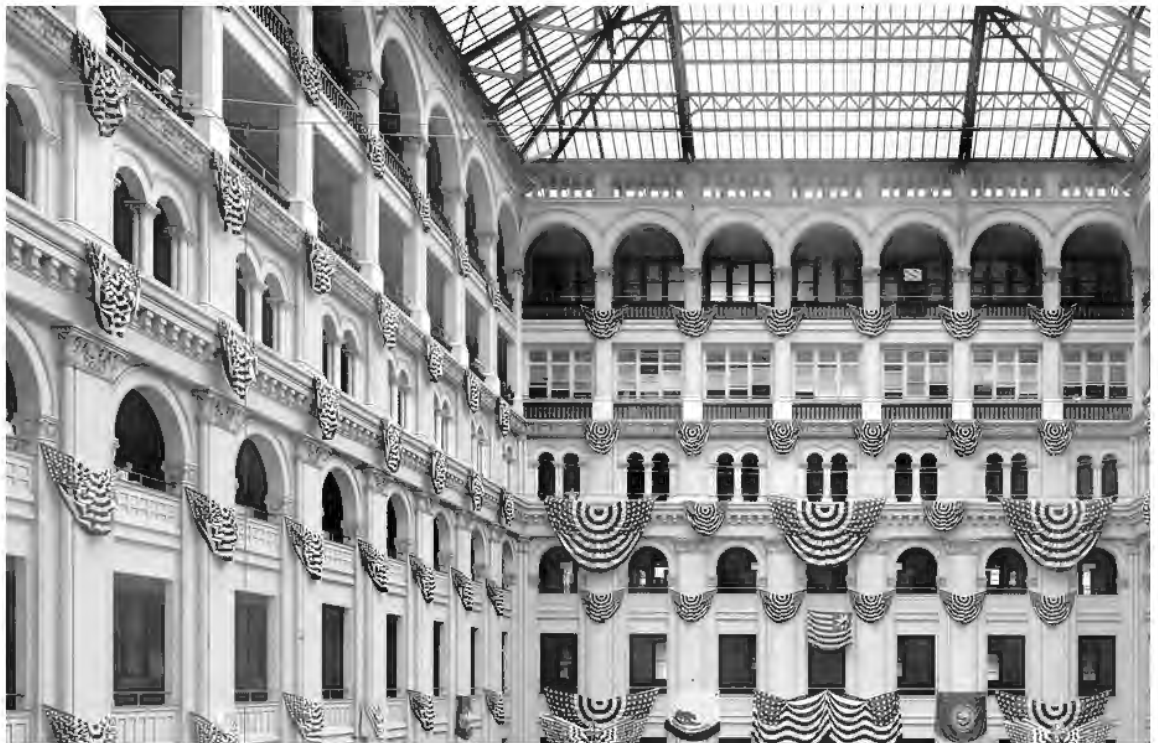
- Overall condition is good
- Some cases of warping and chipping have occurred
- Plaster in turrets have experienced mild to severe damage from water infiltration

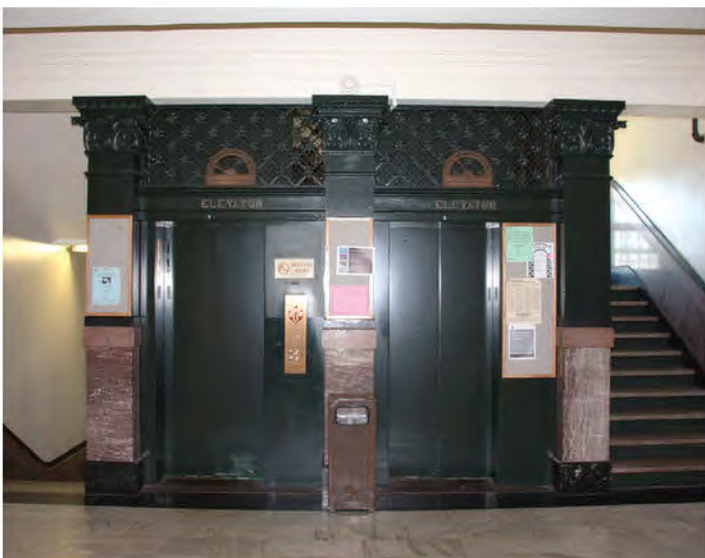
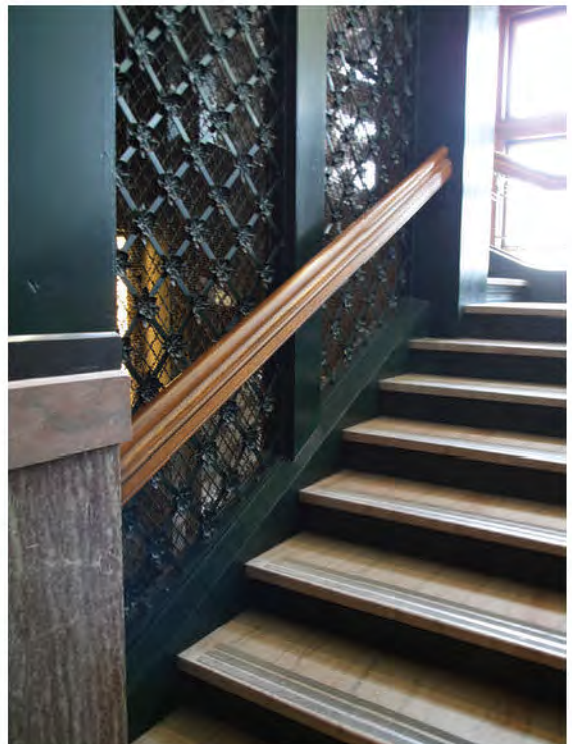
- Significant wear in wood stain
- Evidence of water damage

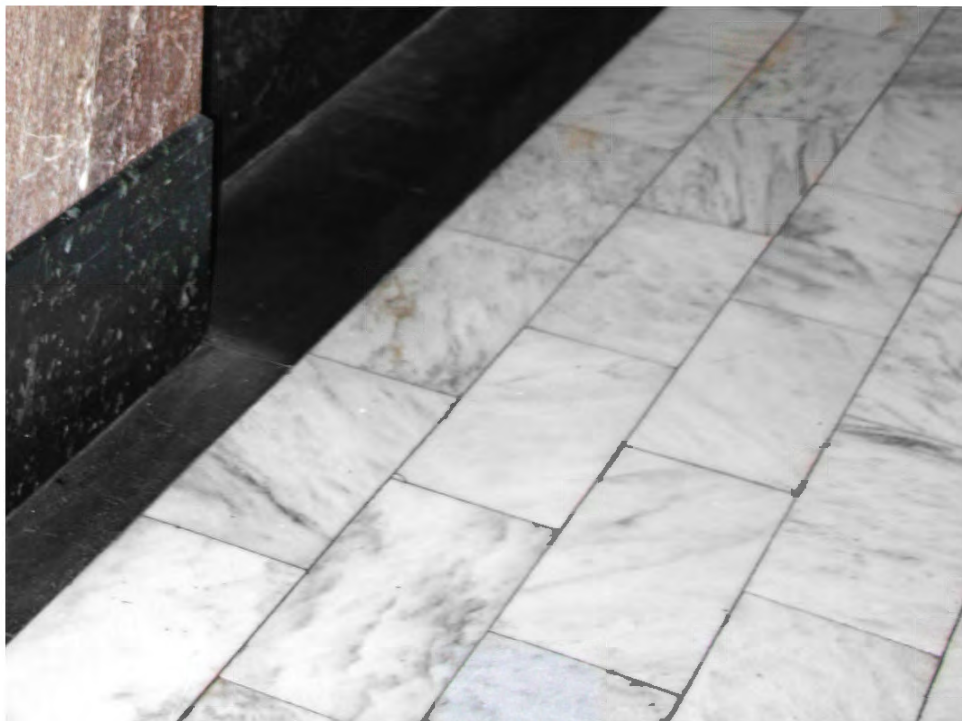
Marble Wainscot Dado Rail (Corridor)

- Mild to moderate wear and some cracking
- Some pieces around door trims separated and missing

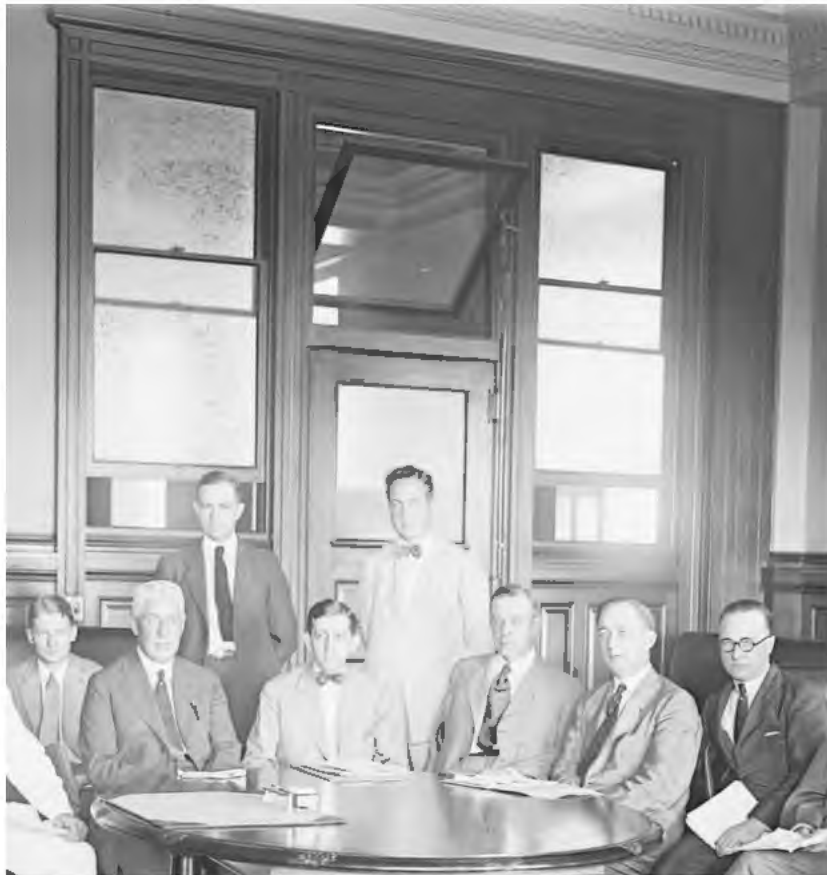
- Mild to severe wear from continued handling, impact damage, and rotation
- Hardware and glazing have patina from age
- Some glazing re-sealed with additional putty
- Glass at stairway doors since lettered with spray paint

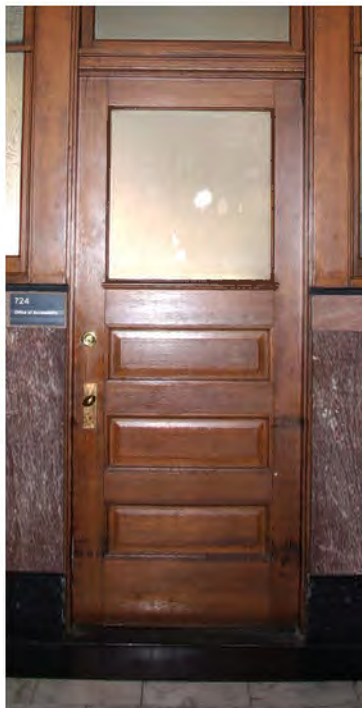
CONDITION: • Mild wear to wood and finish
