Description of document: General Services Administration (GSA) Architectural Assessment Report on the Old Post Office Building, 2012

OLD POST OFFICE
HSR

EXISTING EXTERIOR CONDITIONS SURVEY

EXISTING INTERIOR CONDITIONS SURVEY

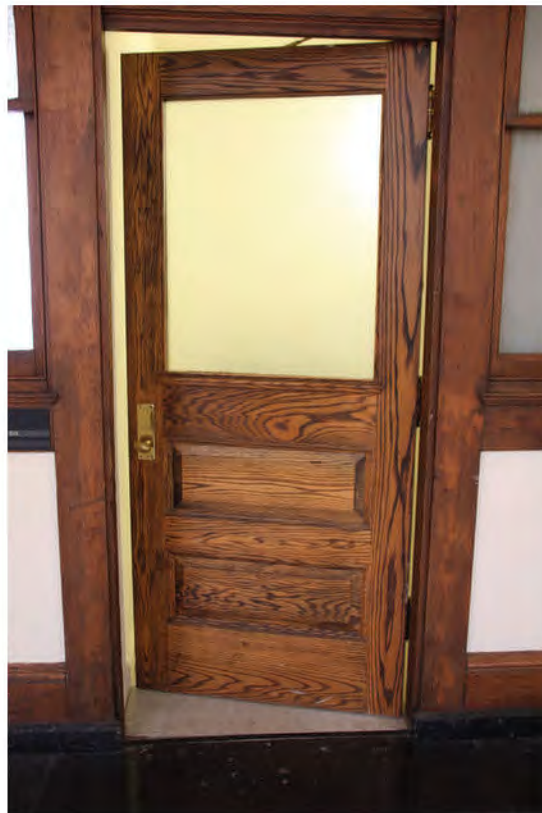
- Moderate wear from pedestrian traffic
- Some metal components missing
- Circuit breakers no longer operable

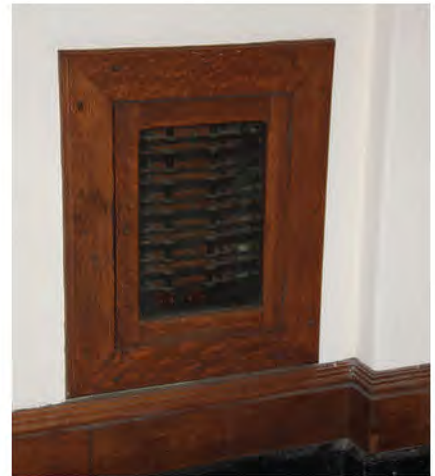
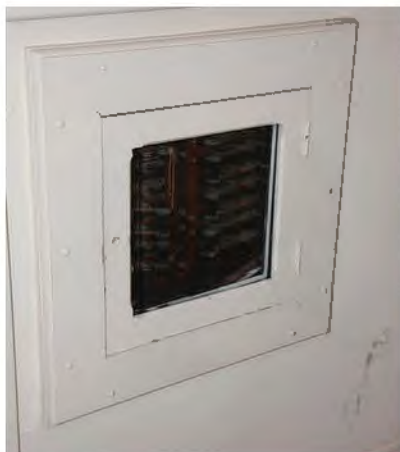
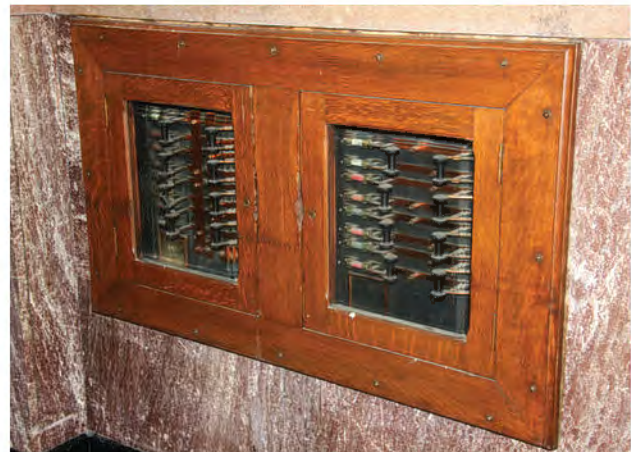
- Mild to moderate wear and impact damage
- Overall remarkably intact

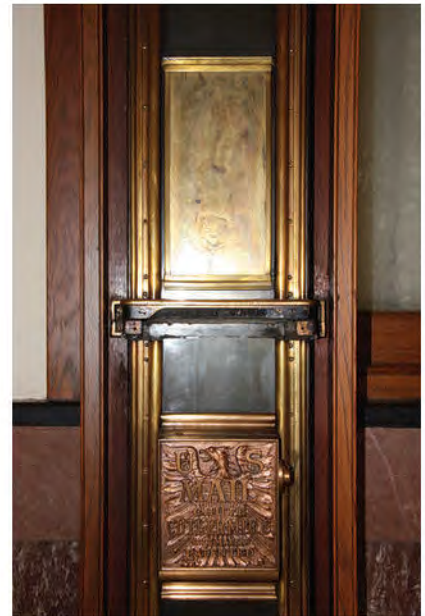
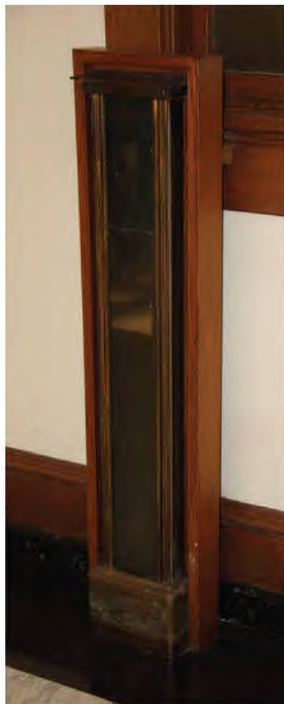
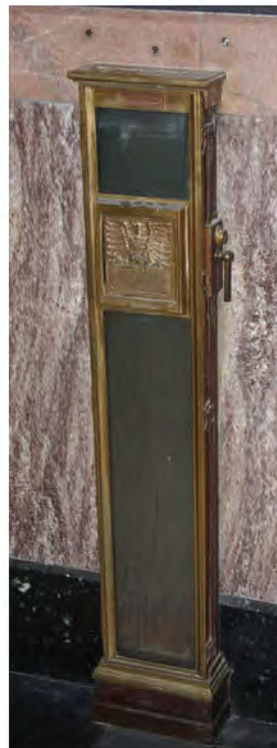
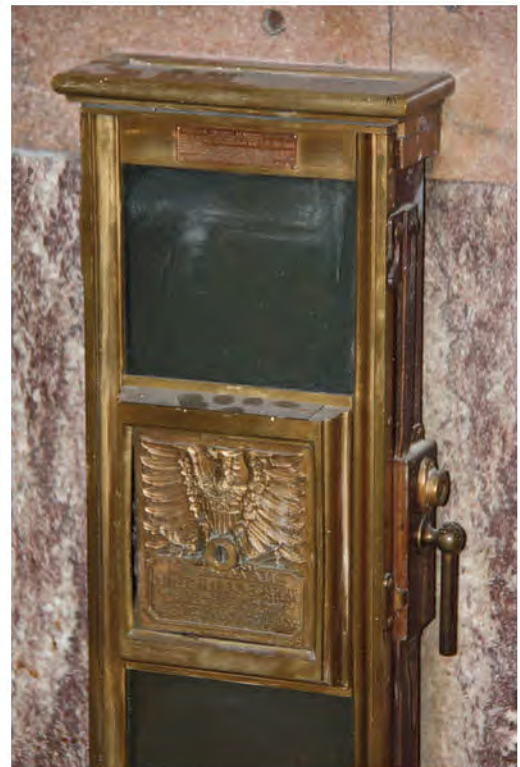
- Condition of disks good
- Possible spillover from repainting of adjacent wall surface
- Condition of internal wiring unknown, pending thorough survey

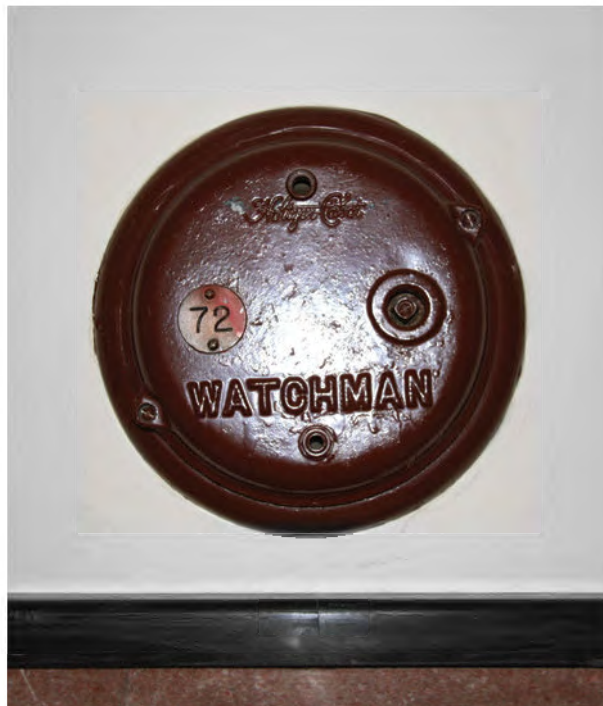
- Possible mild wear to plaster from impacts
- No evidence of moisture damage

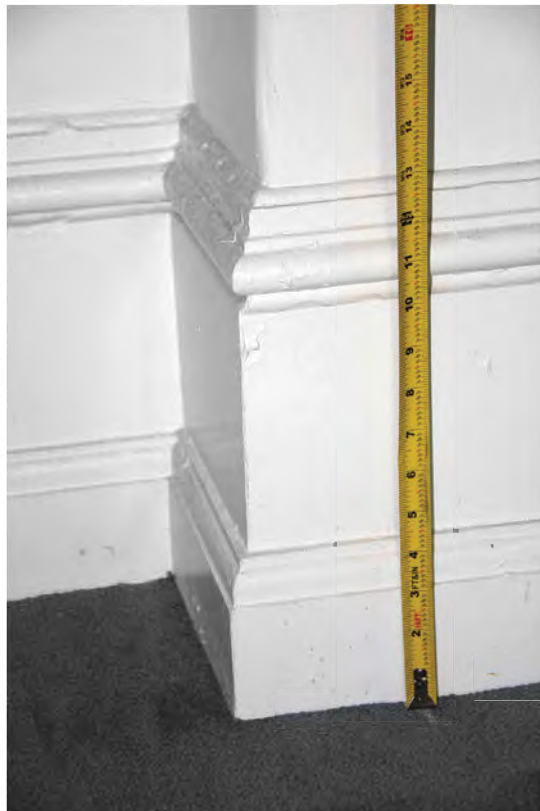
- Mild to moderate wear from continued use
- Some evidence of impact damage, particularly to lower portions of doors and surrounds

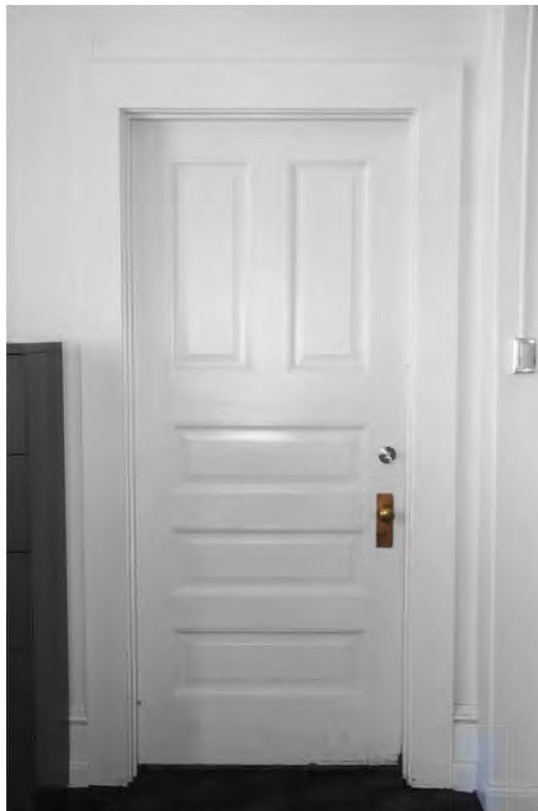
CONDITION: • Evidence of damage from impact of occupants and furniture

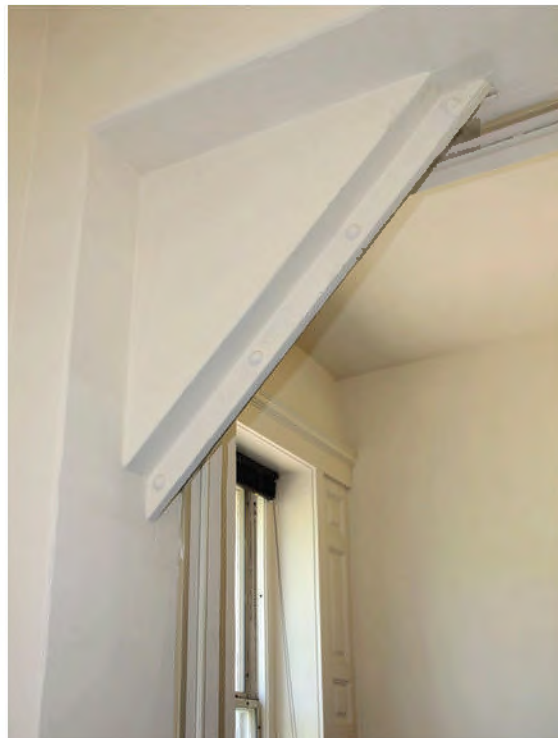
Suspended Ceiling Trunks

CONDITION: • Staining from particles in air supplies

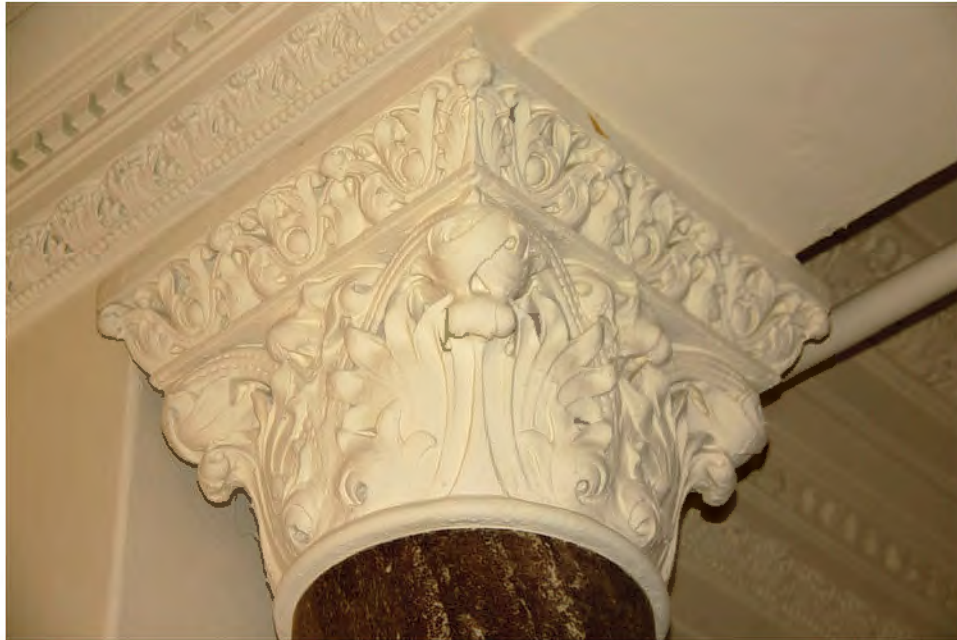
Crown Molding

- Condition of the plaster is generally good
- Some evidence of deterioration is present
- Some areas have suffered paint chipping

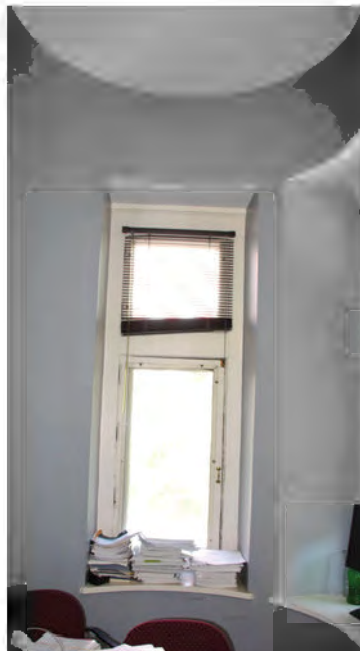
Turret Windows

- Multiple layers of paint (paint analysis pending)
- Locking hardware replaced
- Some glass panes replaced
- Storm windows added (1979)

- Severe water damage to exterior frames/paint, with mild damage on the interior side

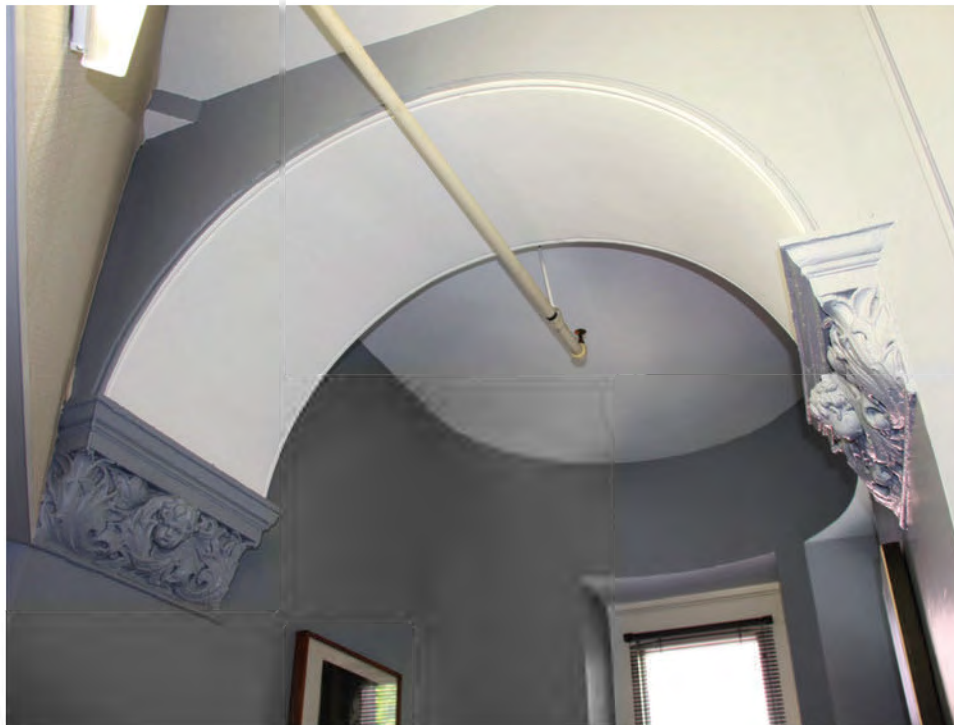
Turret Arches

- Possible cracking or chipping of paint
- Evidence of typical water damage at turret ceilings spreading to arch

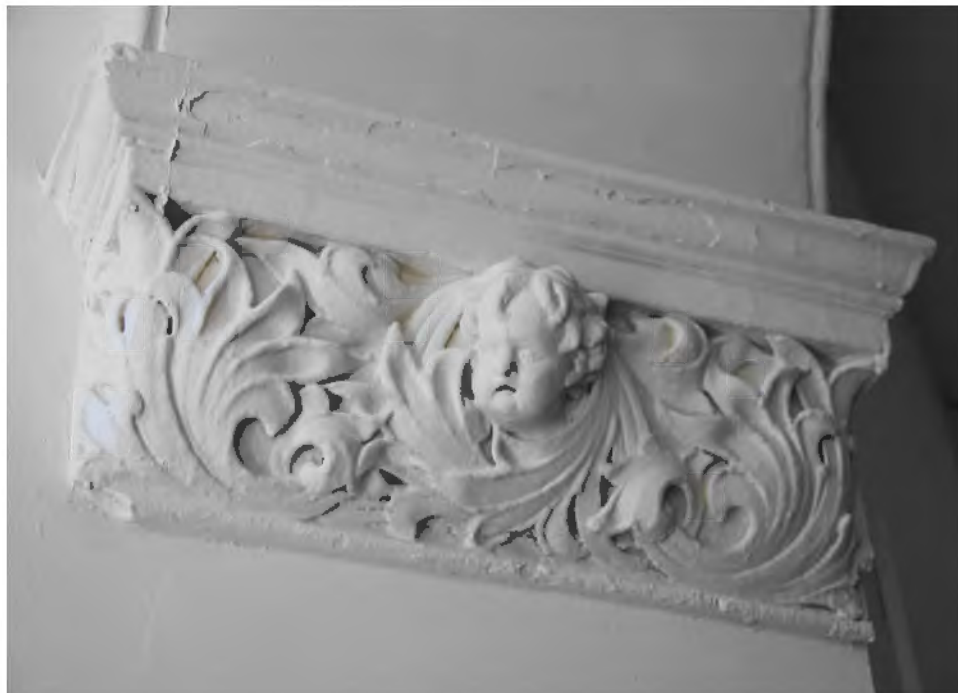
Plaster Corbels (Turret Arches)

DESCRIPTION: Detailed non-structural plaster corbel details accent each turret archway. In some cases, one or both corbels are missing, most likely due to severe damage. The corbels feature a central cherub face, surrounded by free form leaf patterns. The cap of the corbel has a cyma recta molding.

- Multiple layers of paint (paint analysis pending)
- Some corbels removed and original locations patched (condition and/or location of removed corbels unknown)

- Mild to severe damage to delicate plaster forms
- Some chipping apparent in paint layers

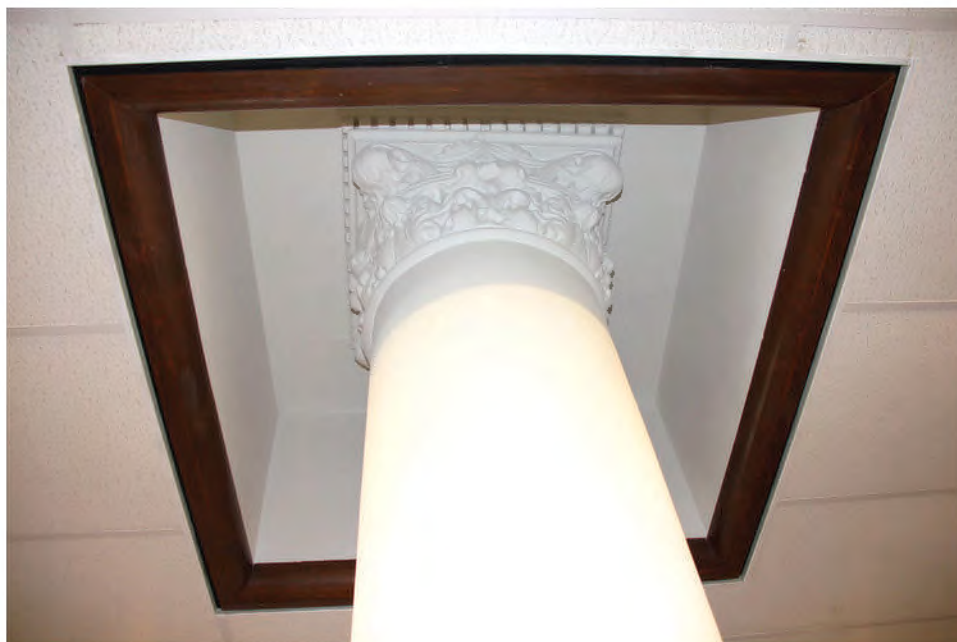
Rounded Columns

- Mild wear to plater
- Condition of hidden columns unknown

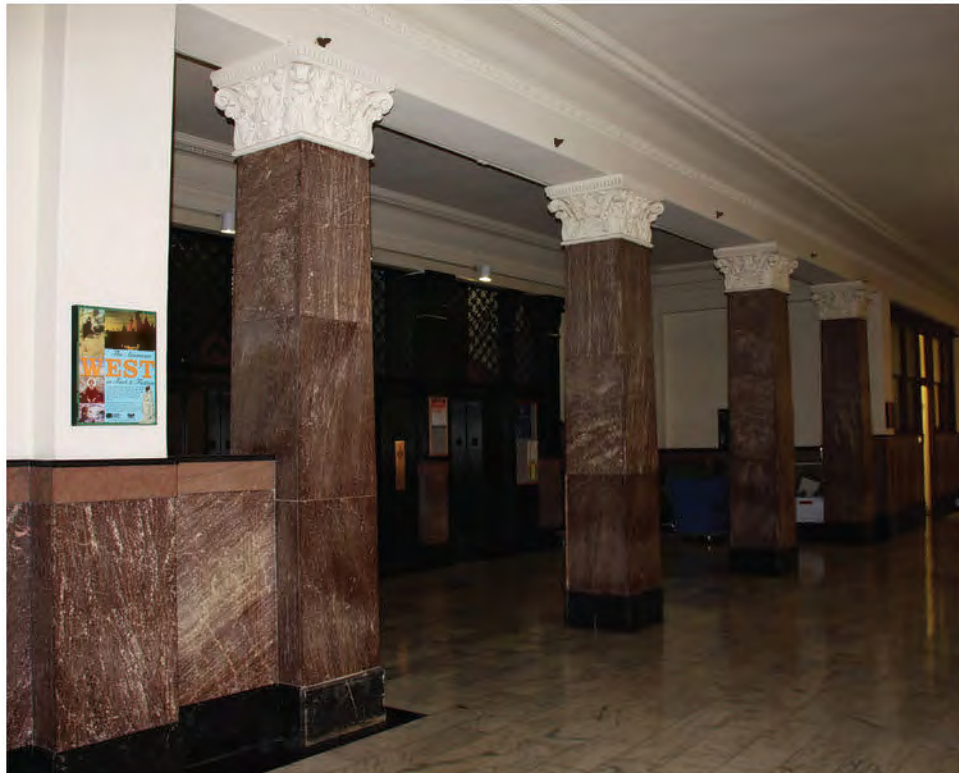
Square Marble Columns

ALTERATIONS: • Some repair to marble panels and baseboard

- Cases of mild wear and severe impact damage, mostly in lower portion and baseboard
- Some pieces separated and missing.

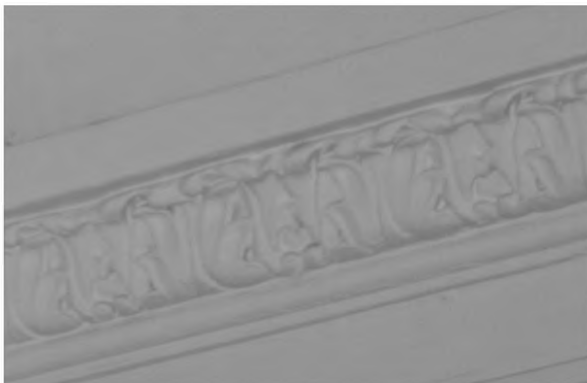
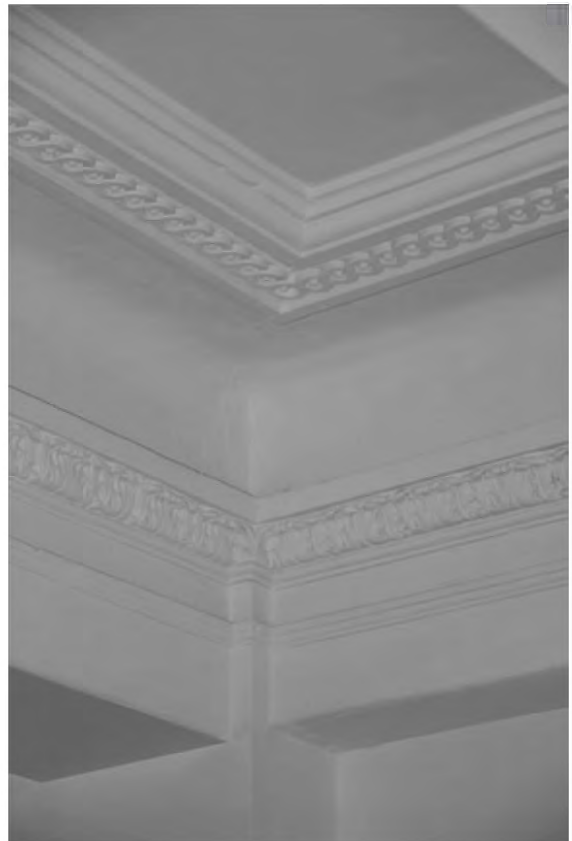
Crown Molding - Lobbies

- Condition of the plaster is generally good
- Some evidence of deterioration is present
- Some areas have suffered paint chipping

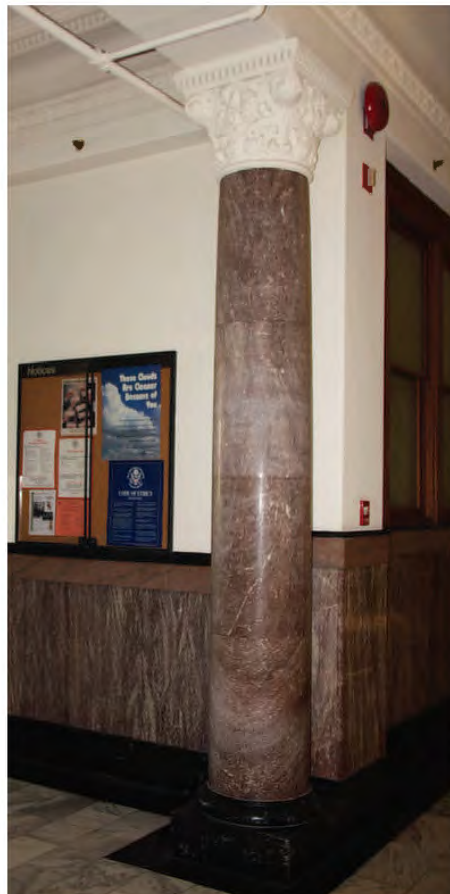
Round Marble Columns

CONDITION: • Moderate wear on marble pedestals

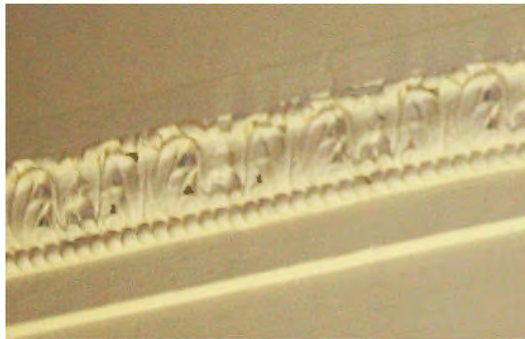
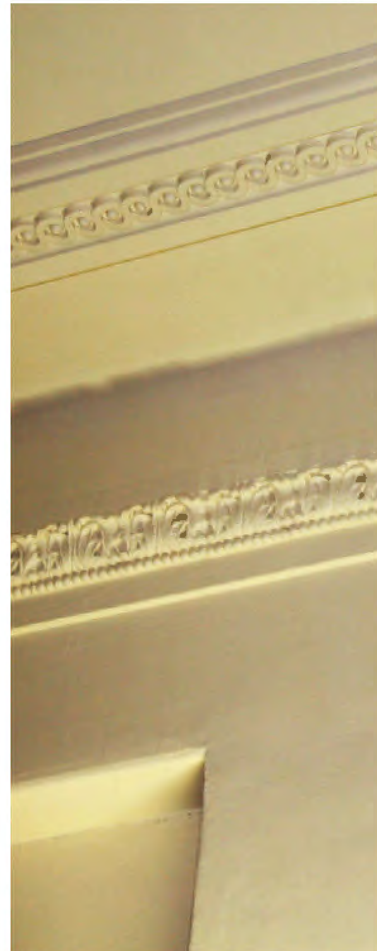
Crown Molding - Corridors

- Condition of the plaster is generally good
- Some evidence of deterioration is present
- Some areas have suffered paint chipping

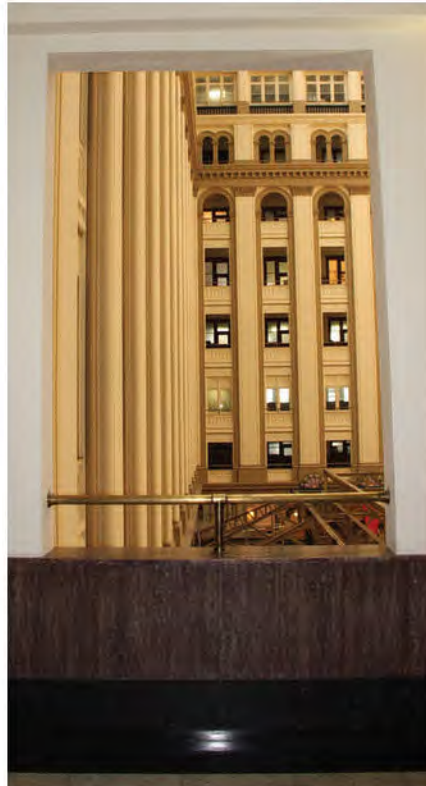
Cortile Opening

- Consistent cases of previous holes in marble sills patched with resin
- Rarely, cracking in paint

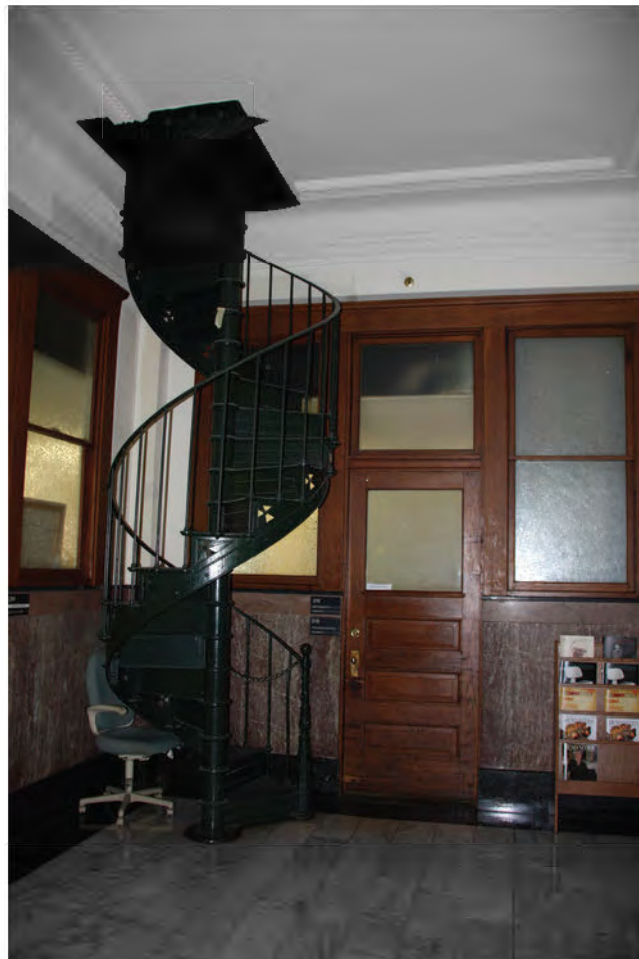
Spiral Staircase

- Mild to moderate wear from continued use.

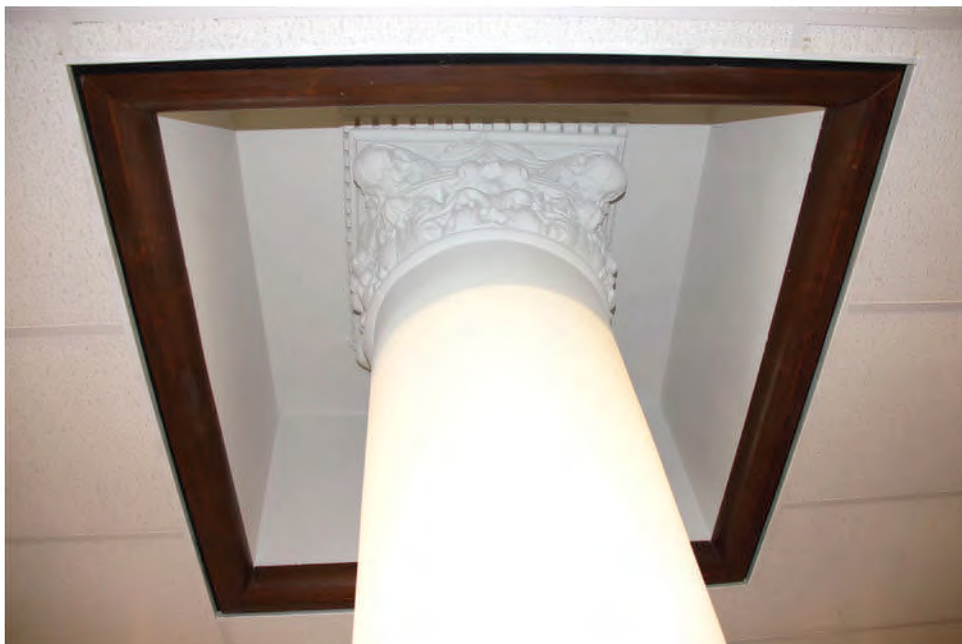
Rounded Columns

- Mild wear to plaster
- Condition of hidden columns unknown

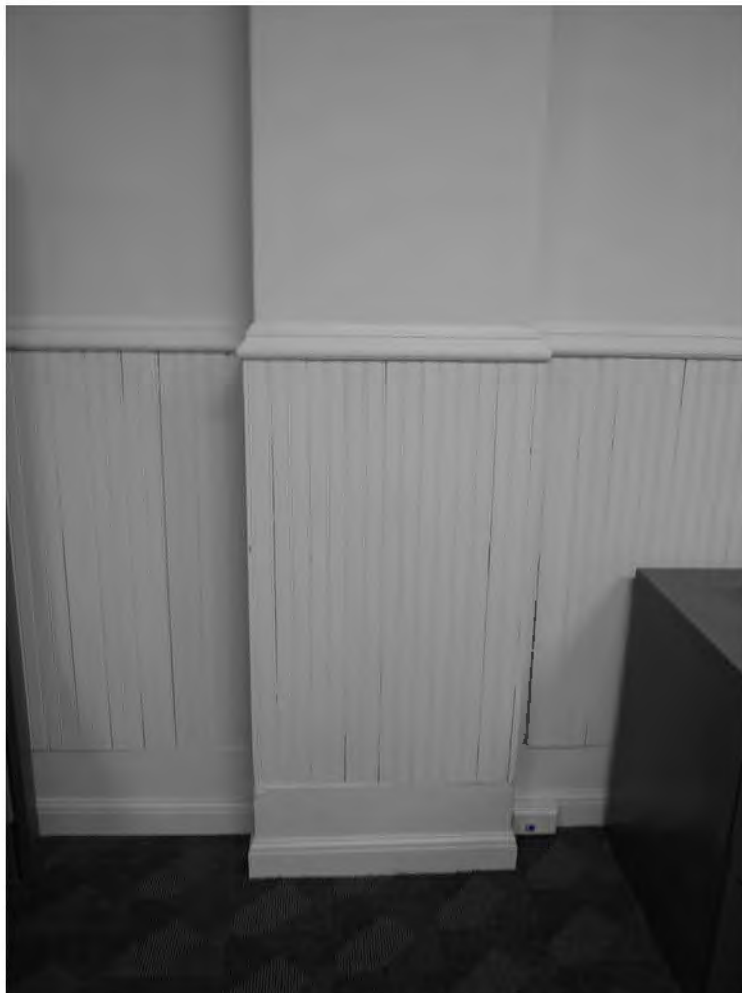
Beaded Board Wainscot**Zone 3**

CONDITION: • Moderate to heavy wear

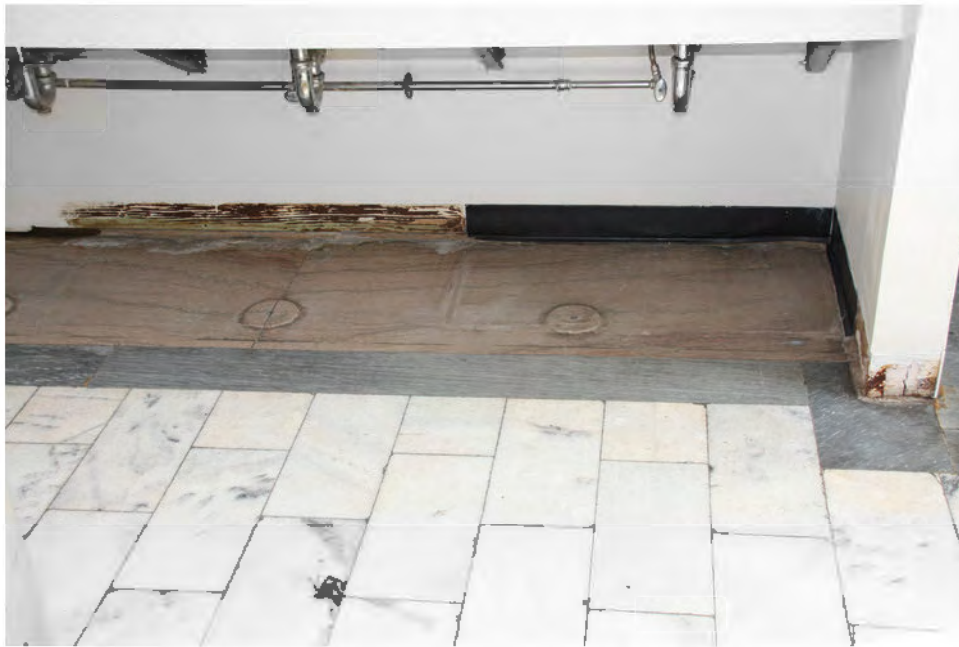
Marble Floor Troughs

CONDITION: • Mild wear
• Accumulated dust and dirt present

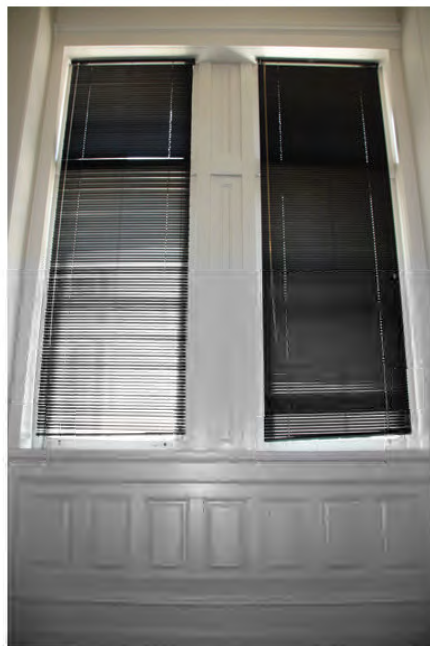
Exterior Windows

- Some damage to wood from office furniture, occupants
- Some hinge hardware painted over

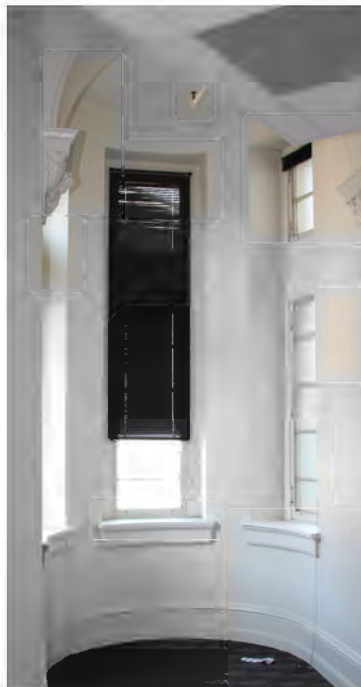
Turret Windows

- Severe water damage to exterior frames/paint with mild damage on the interior side

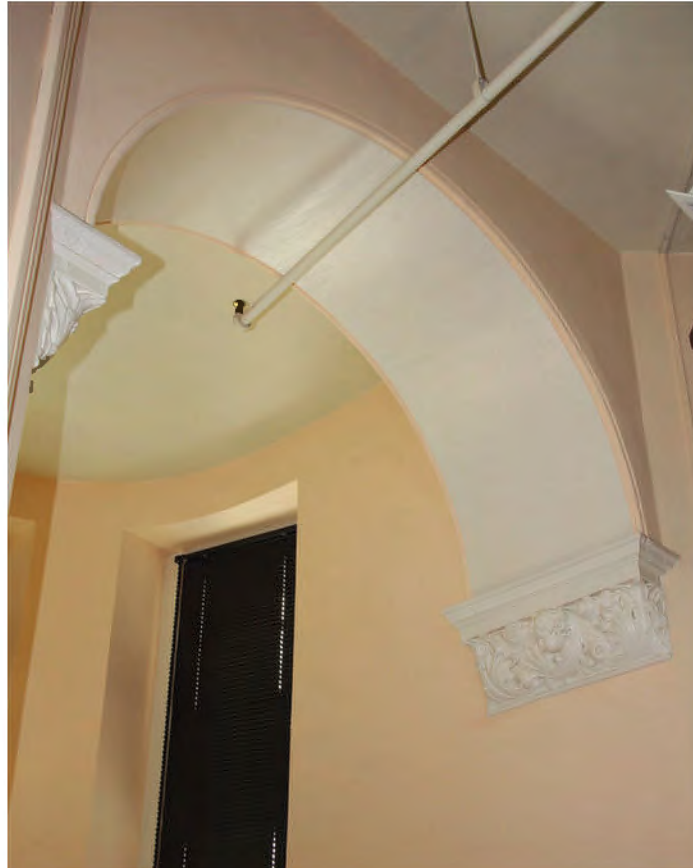
Turret Arches

- Possible cracking or chipping of paint
- Evidence of typical water damage at turret ceilings spreading to arch

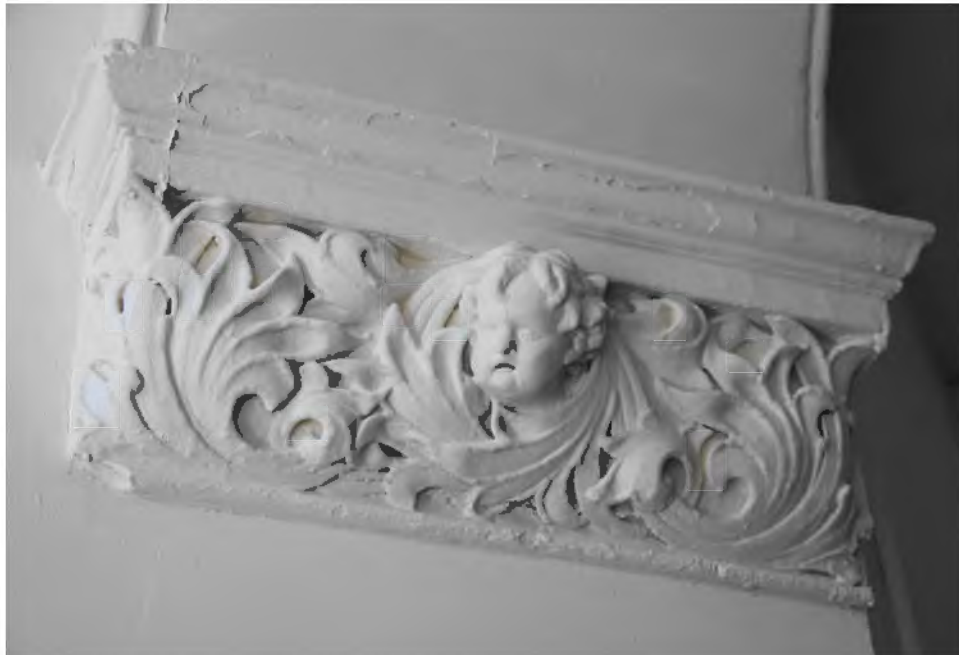
Decorative Plaster Brackets (Turret Arches)

DESCRIPTION: Detailed non-structural plaster brackets accent each turret archway. In some cases, one or both corbels are missing, most likely due to severe damage. The corbels feature a central cherub face, surrounded by free form leaf patterns. The cap of the corbel has a cyma recta molding.

- Mild to severe damage to delicate plaster forms
- Some chipping apparent in paint layers

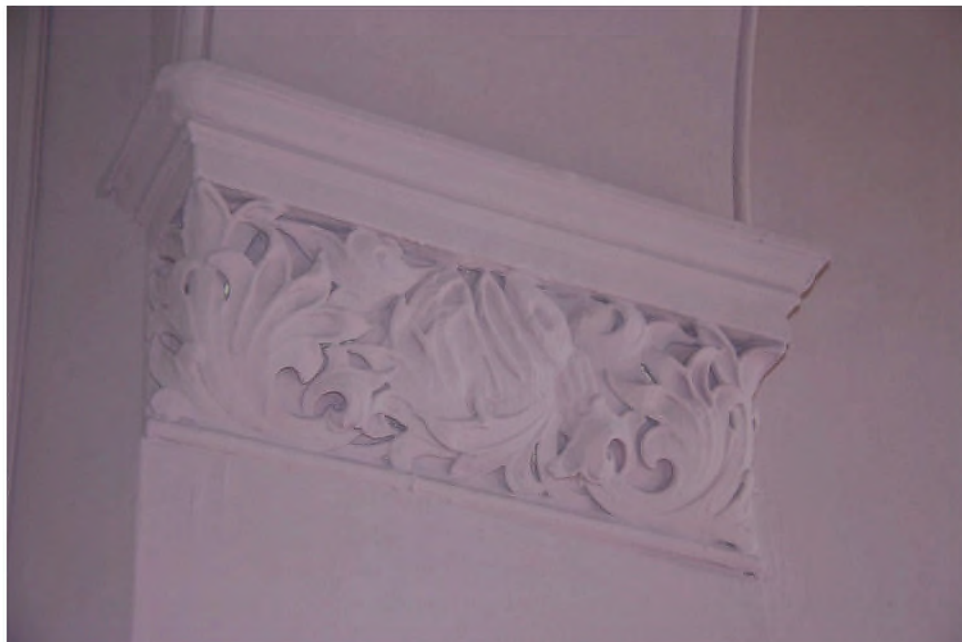
Altered Decorative Plaster Brackets (Turret Arches)

DESCRIPTION: Detailed non-structural plaster brackets accent each turret archway. In some cases, one or both corbels are missing, most likely due to severe damage. These corbels no longer feature a central cherub face, having been removed. The cap of the corbel has a cyma recta molding.

- Multiple layers of paint (paint analysis pending)
- Cherub faces removed
- Original locations patched (condition and/or location of removed cherub face unknown)

- Mild to severe damage to delicate plaster forms
- Some chipping apparent in paint layers

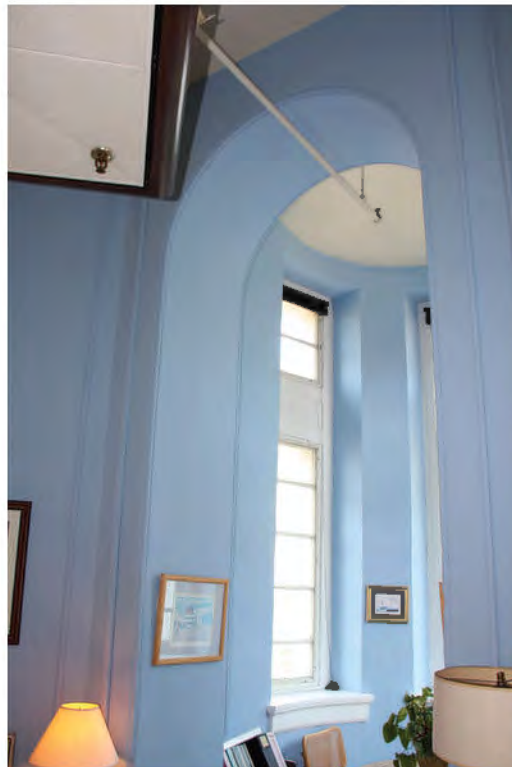
Turret Arches (Full)

- Missing ovolo details possibly due to omission in subsequent repairs/renovations
- Multiple layers of paint (paint analysis pending)

- Mild wear/damage to plaster
- Possible water damage due to proximity to turrets

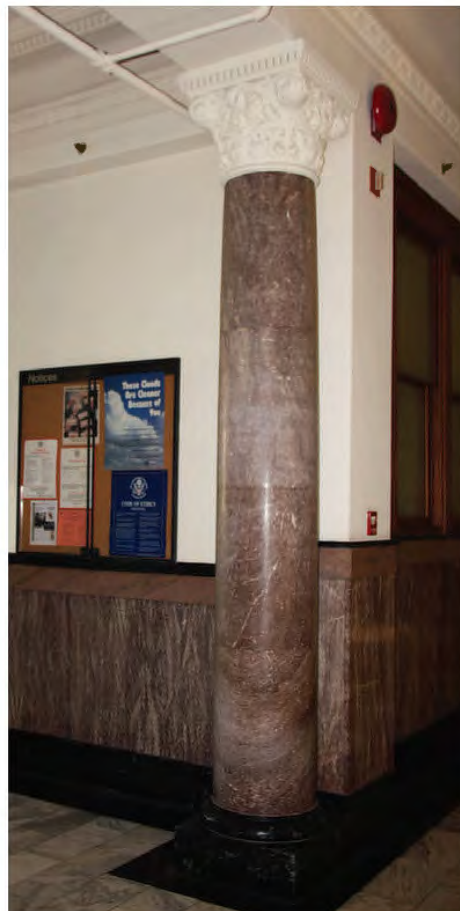
Round Marble Columns

CONDITION: • Moderate wear on marble pedestals

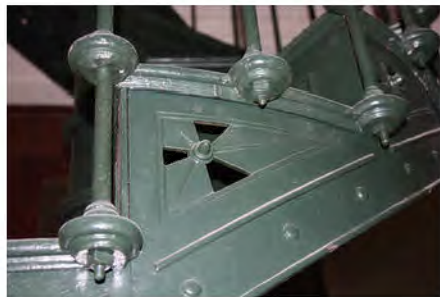
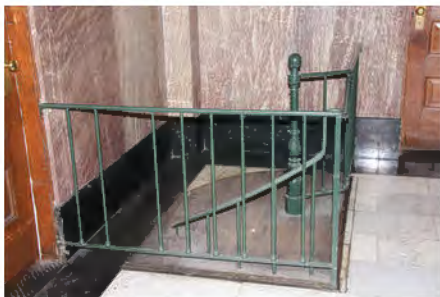
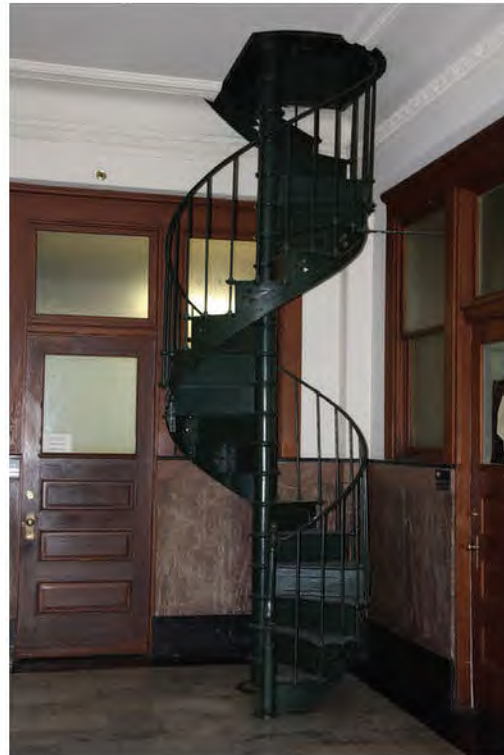
Spiral Staircase

CONDITION: • Mild to moderate wear from continued use.

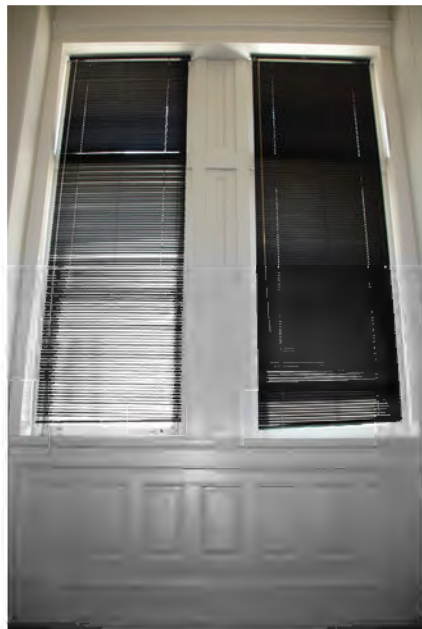
Turret Windows

- Some damage to wood from office furniture, occupants.
- Some hinge hardware painted over

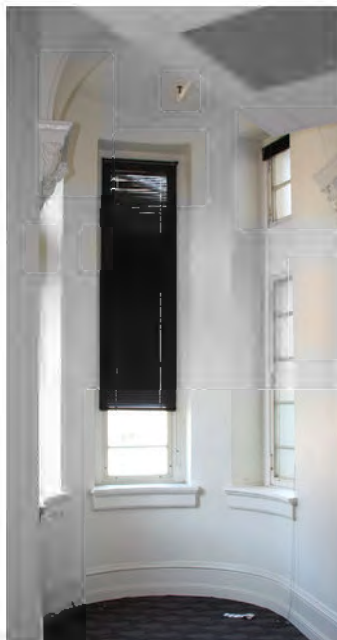
Turret Arches

- Possible cracking or chipping of paint
- Evidence of typical water damage at turret ceilings spreading to arch

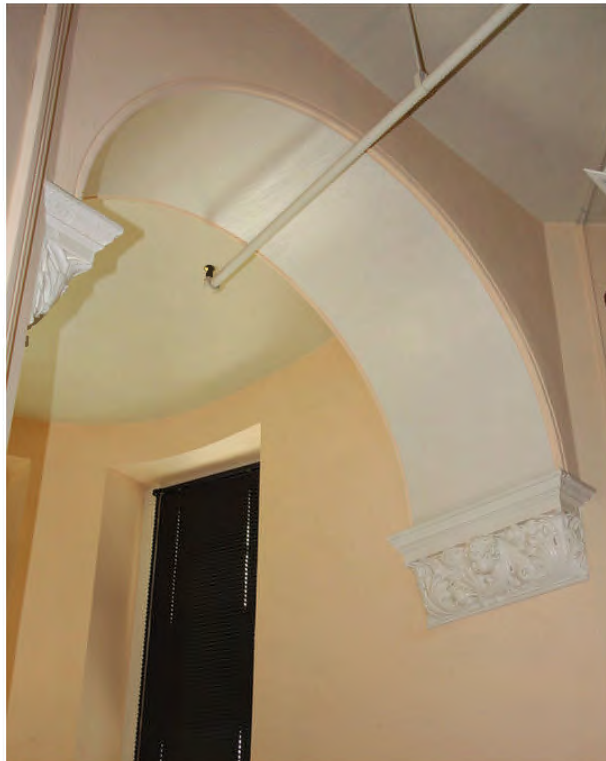
Turret Arches (Full)

- Possible cracking or chipping of paint
- Evidence of typical water damage at turret ceilings spreading to arch

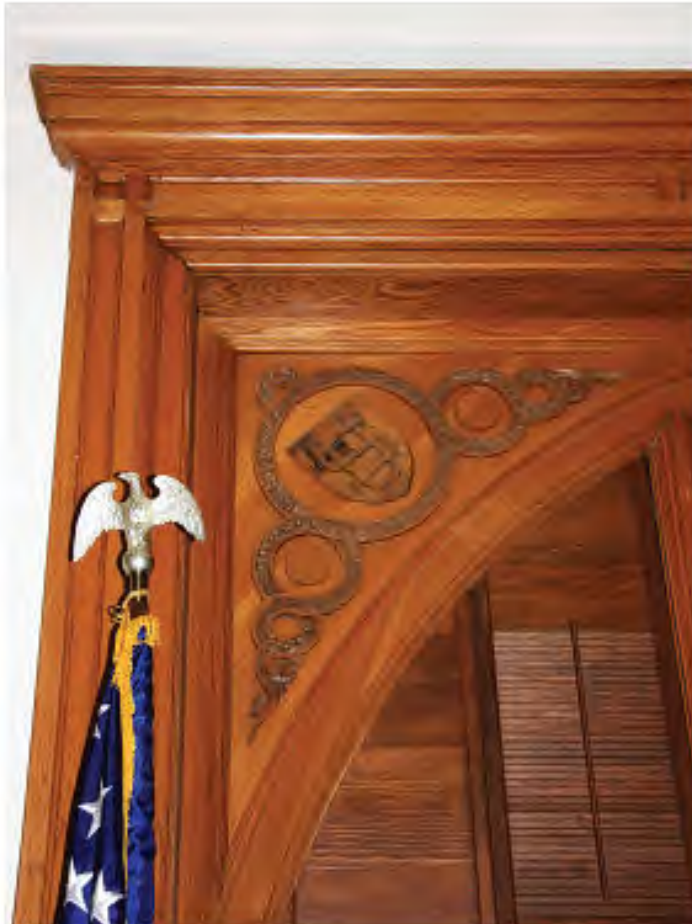
Oak Panelled Wainscoting

CONDITION: • Evidence of current and previous impact damage
• Mild to moderate wear in wood

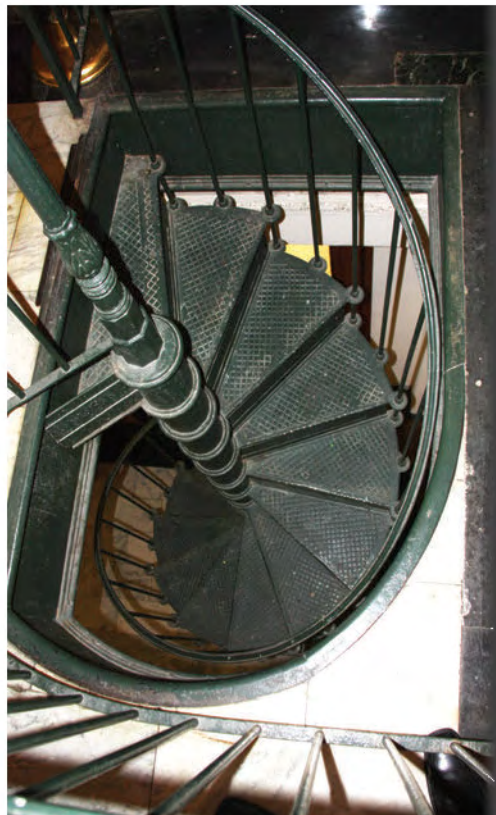
Spiral Staircase Newels

CONDITION: • Possible deterioration of metal
 • Lack of maintenance and cleaning evident.
 • Some paint chipping
 • Revealing unfinished iron beneath

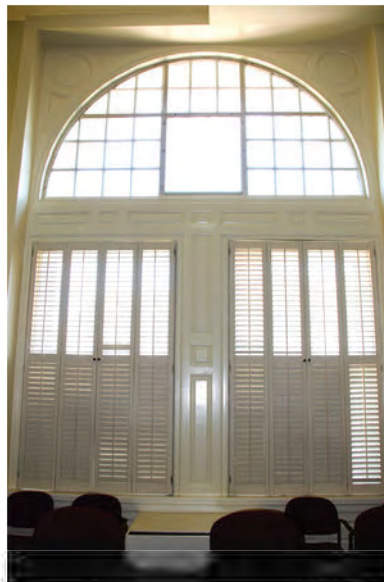
Exterior Windows

- Severe water damage to exterior frames/paint, with mild damage on the interior side

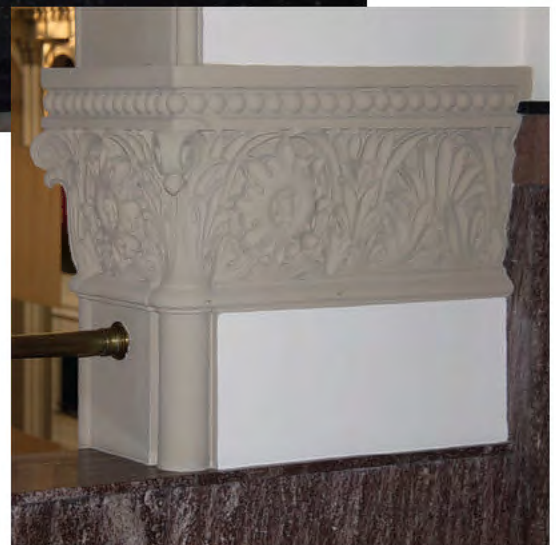
Cortile Opening

- Consistent cases of previous holes in marble sills patched with resin.
- Rarely, cracking in paint.

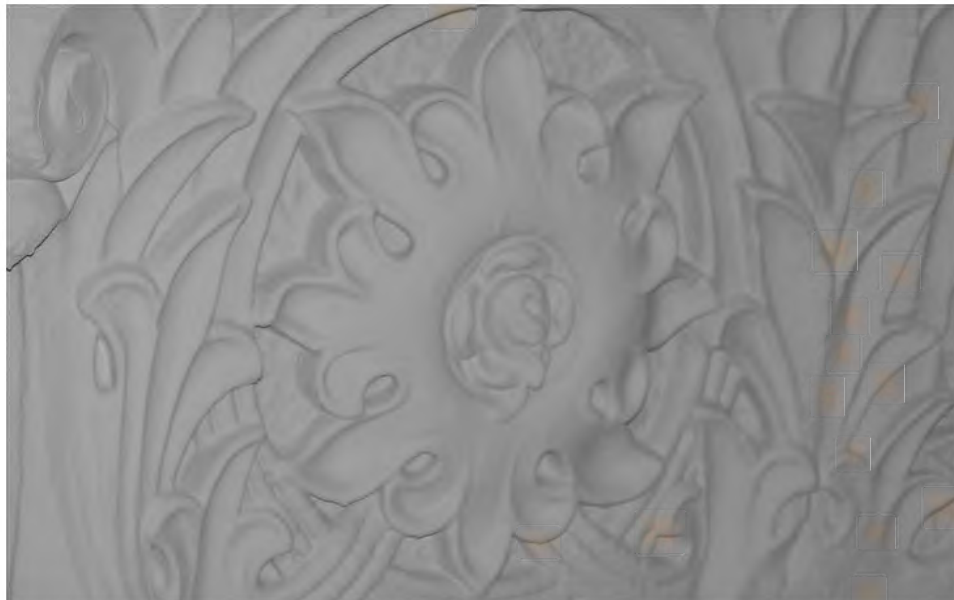
Crown Molding

- Condition of the plaster is generally good; some evidence of deterioration is present, and some areas have suffered paint chipping.

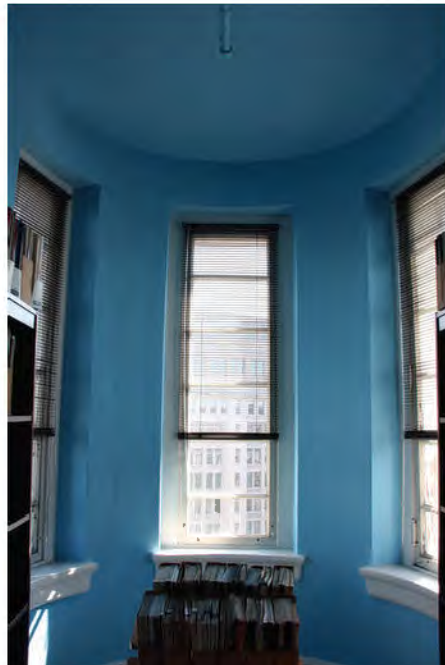
Turret Arches

- Possible cracking or chipping of paint;
- Evidence of typical water damage at turret ceilings spreading to arch

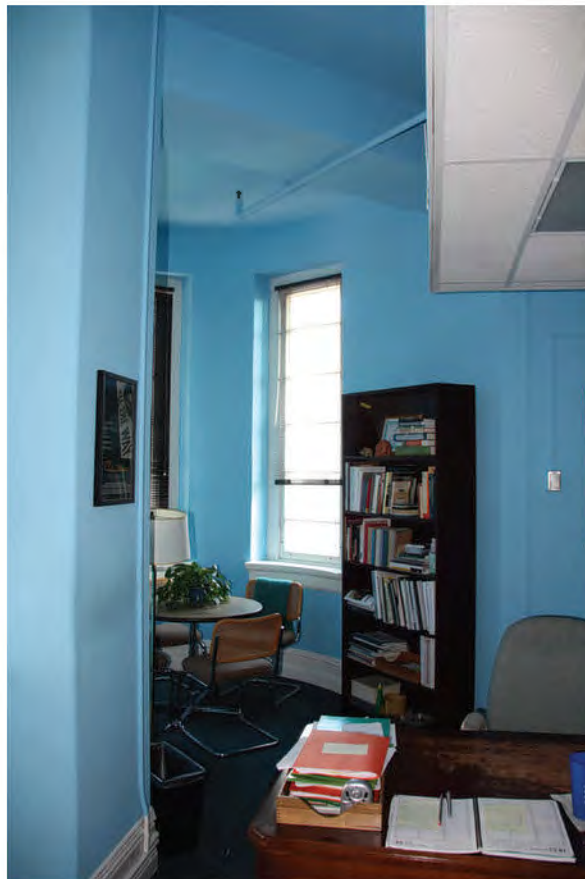
Turret Doorway

CONDITION: • Mild wear/damage to plaster
• Possible water damage due to proximity to turrets.

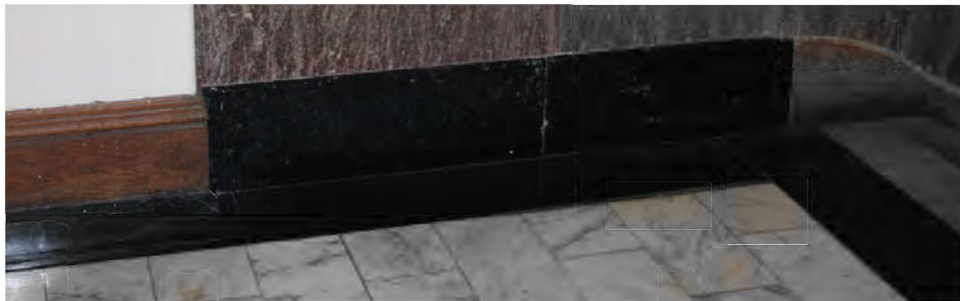
Baseboard

- Frequent cases of wear and impact damage.
- Some pieces separated and missing, others replaced or filled in.
- Buildup of wax evident.

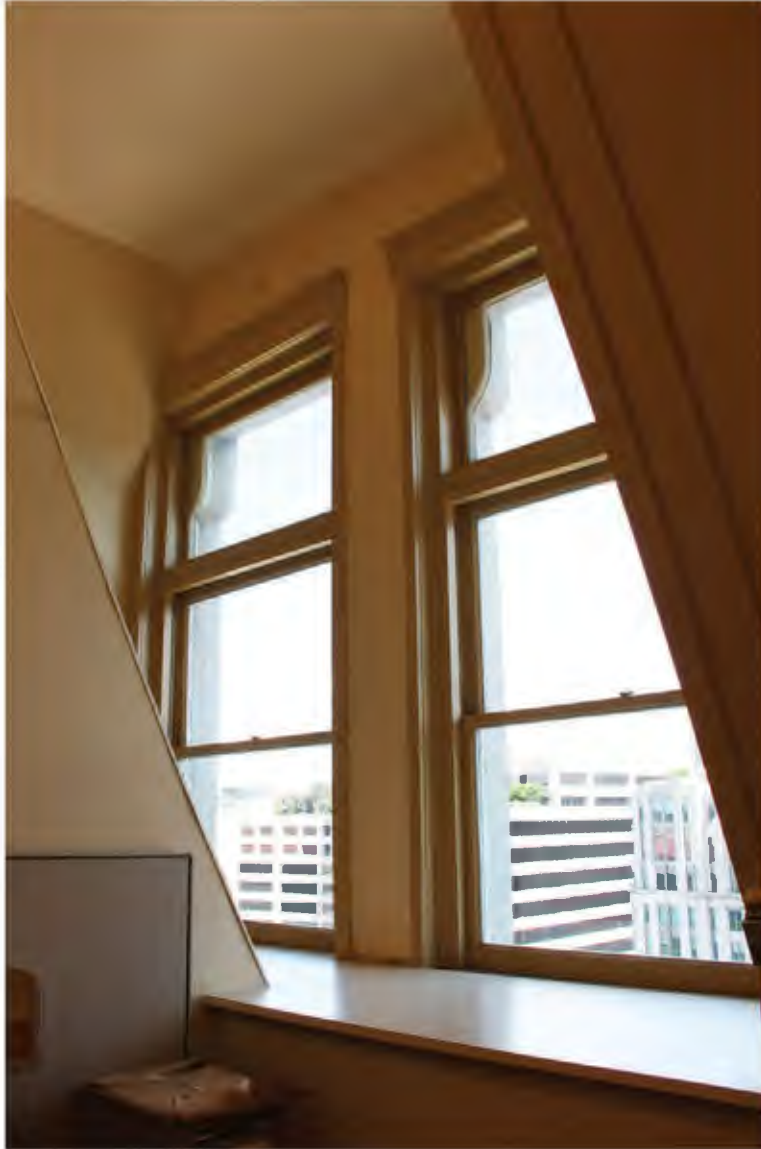
Exterior Windows - Tower

- Some damage to wood from office furniture, occupants.
- Some hardware painted over.
