Description of document: General Services Administration (GSA) Architectural Assessment Report on the Old Post Office Building, 2012

OLD POST OFFICE
HSR

EXISTING EXTERIOR CONDITIONS SURVEY

EXISTING INTERIOR CONDITIONS SURVEY

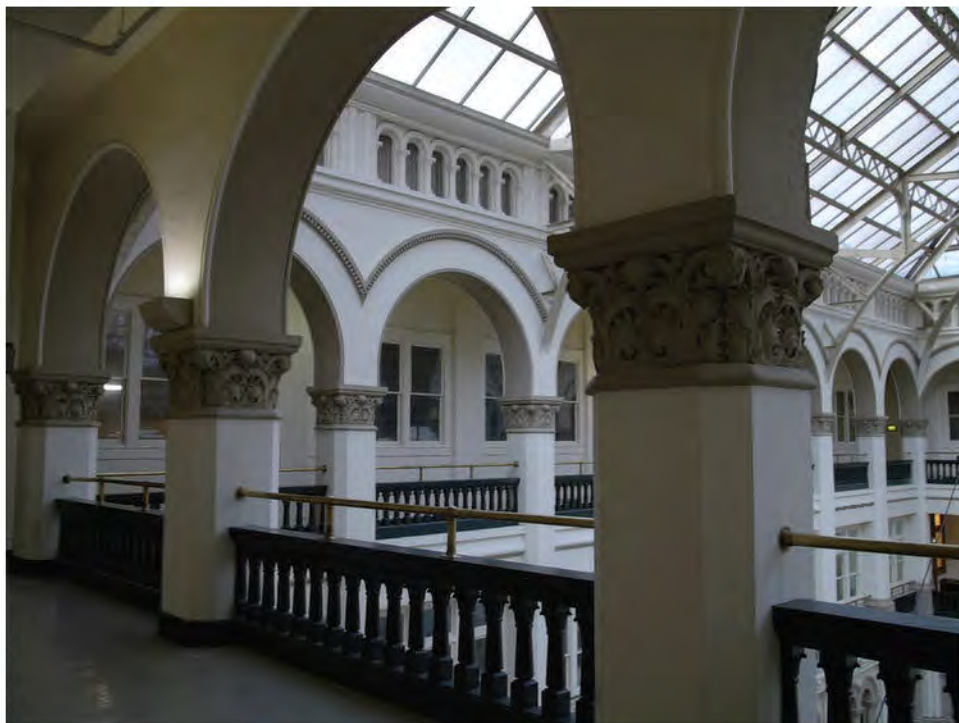
Corinthian Capital

CONDITION:

- Mild wear

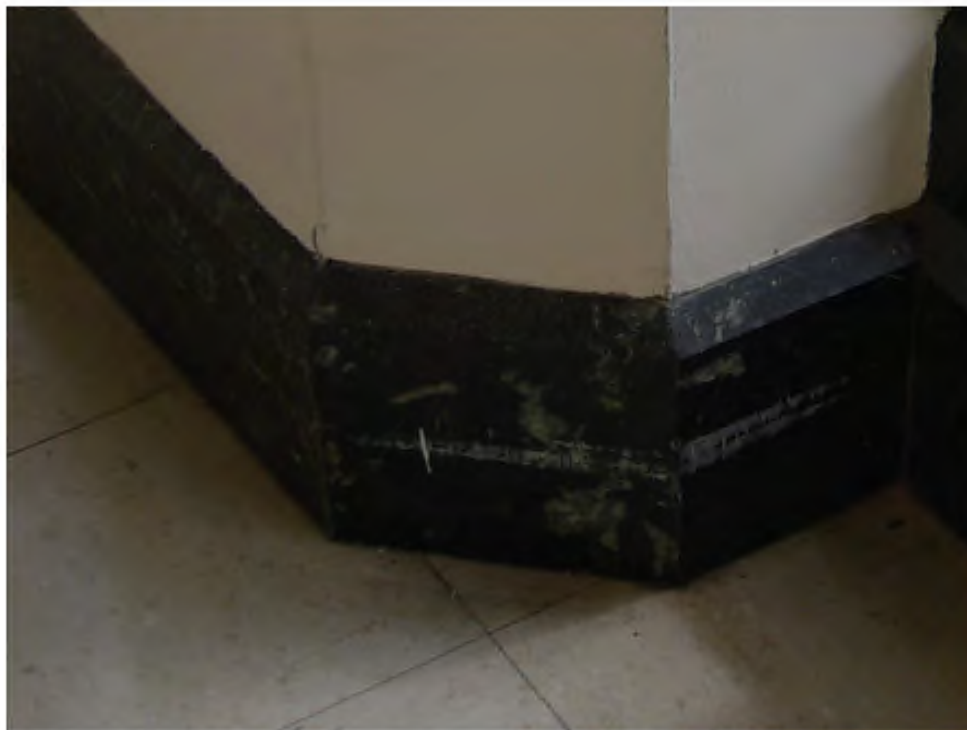
Baseboard

ALTERATIONS: • Evidence of spot repair over the years
• Multiple applications of wax

CONDITION: • Frequent cases of wear and impact damage.
• Some pieces separated and missing, other replaced or filled in.
• Buildup of wax evident.

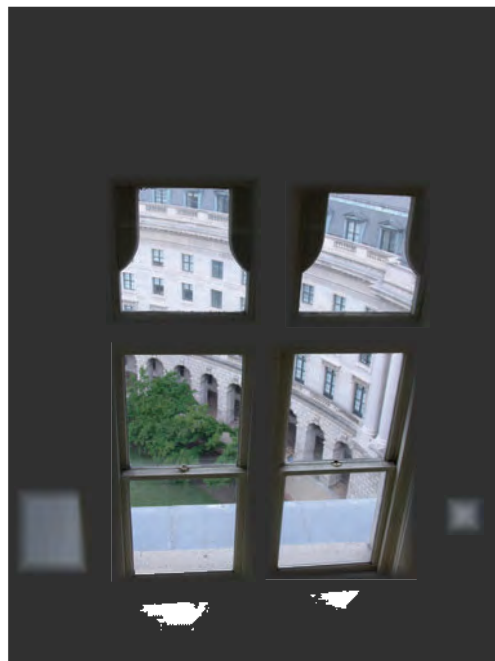
Exterior Windows

CONDITION:

- Severe water damage to exterior frames/paint, with mild damage on the interior side

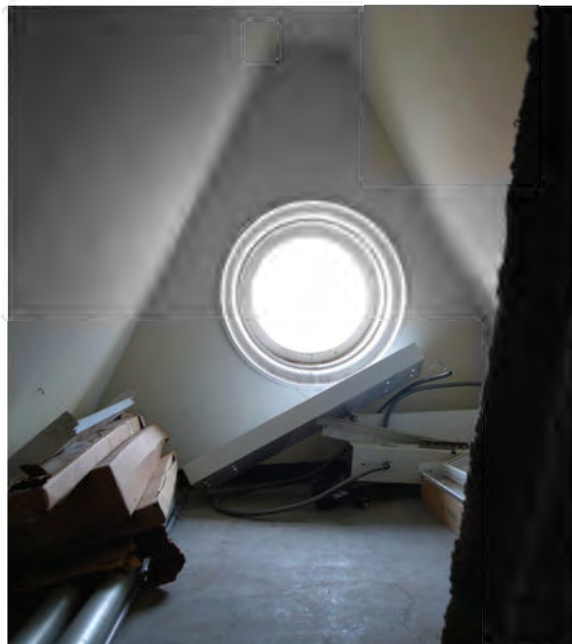
Exterior Windows

CONDITION:

- Severe water damage to exterior frames/paint, with mild damage on the interior side

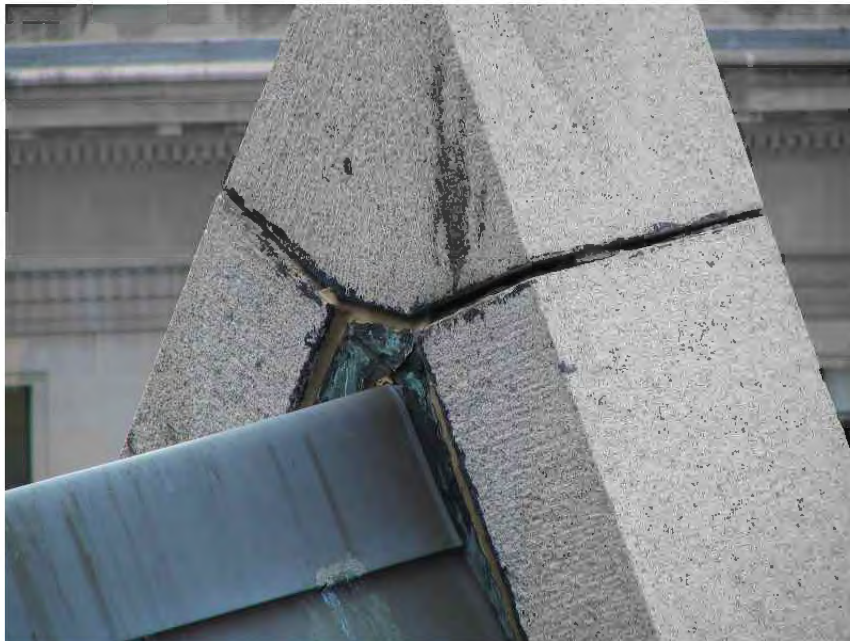
FIGURE 4: Dormer Parapet Wall With Open joints, 2006. Photo Courtesy of T. McDowell.

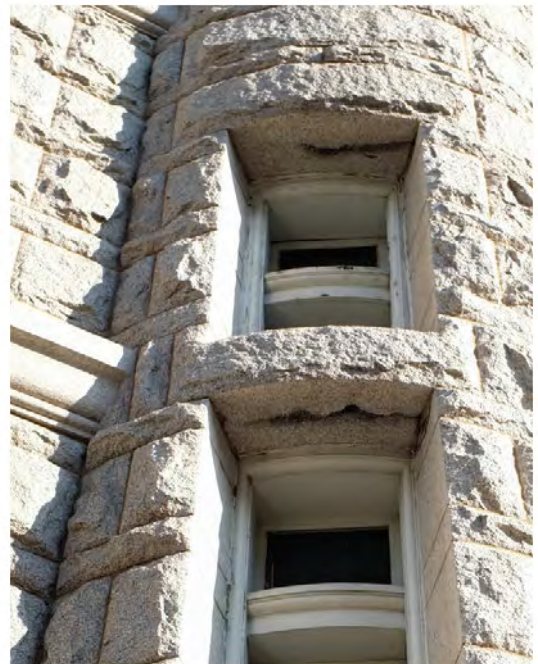
✦ **Staining and wash streaks:** These indicate patterns of water washing over the granite. The acids that are present in rainwater react with the mortar’s calcium carbonate, changing the calcite to gypsum, which is soluble in water. On the vertical masonry surfaces since are regularly exposed to rain, the gypsum formed on the surface dissolves and washes away leaving exposed clean stone. However, in protected locations such as the underside of cornices or soffits, where the stone surface is not exposed to running water, air pollutants stick to the white gypsum, forming a dark crust, which is in most cases harder and less water-vapor permeable than the stone beneath.

FIGURE 5: Pennsylvania Avenue West Corner Turret Staining and Wash Streaks, September 2012. Photo Courtesy OLBN Inc.

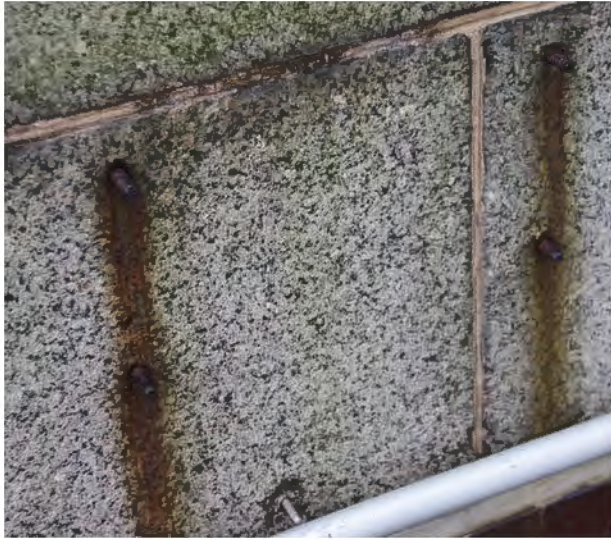
✦ **Rust stains:** Some of the ferrous metal anchors attached to the cladding have rusted. They are not only staining the masonry, but in time, as they progressively deteriorate, they could allow water to penetrate the masonry.

FIGURE 6: Pennsylvania Avenue West Wall Rust Staining, September 2012. Photo Courtesy OLBN Inc.

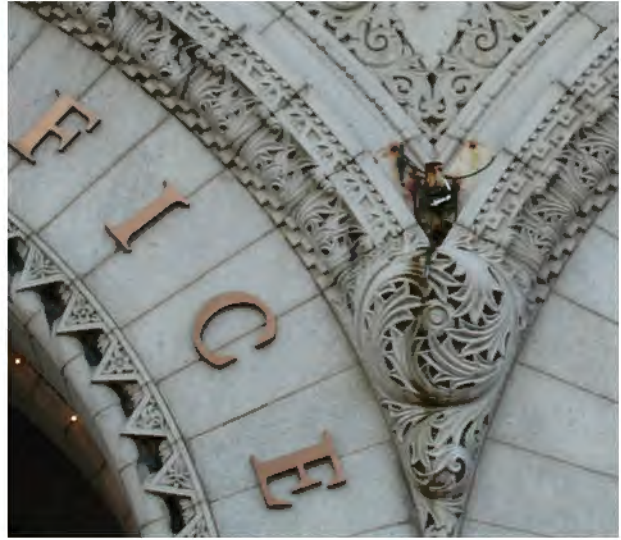
FIGURE 7: Pennsylvania Avenue Portico Rust Staining, September 2012. Photo Courtesy OLBN Inc.

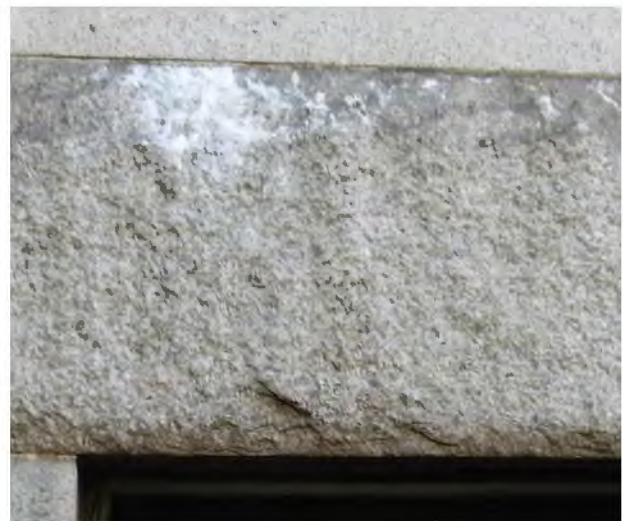
✦ **Mineral deposits:** These indicate that a mineral, which is being dissolved in most cases from the mortar, is crystallizing on the masonry surface as the water in which it is dissolved evaporates.

FIGURE 8: Pennsylvania Avenue Wall Mineral Deposits, September 2012. Photo Courtesy OLBN Inc.

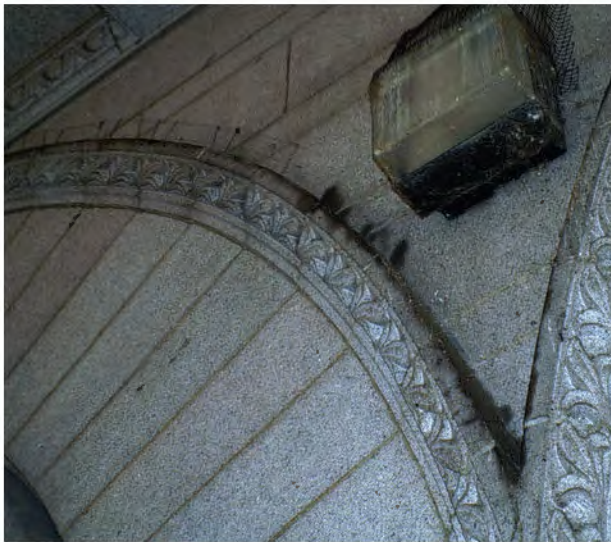
✦ **Pigeon guano:** Pigeons nest and roost in some of the porticos' archways leaving guano that is unsightly and unsanitary. Guano can stain masonry and contains nutrients that support biological growth. Some of the wire netting installed to prevent pigeons from nesting within the archways' transoms is not in good condition and allows pigeons to inhabit those spaces. Other bird control devices anchored along the extrados of the porticos's interior arches work as intended, although bird debris are accumulating between the spikes.

FIGURE 9: Pennsylvania Avenue Portico Pigeon Guano, September 2012. Photo Courtesy OLBN Inc.

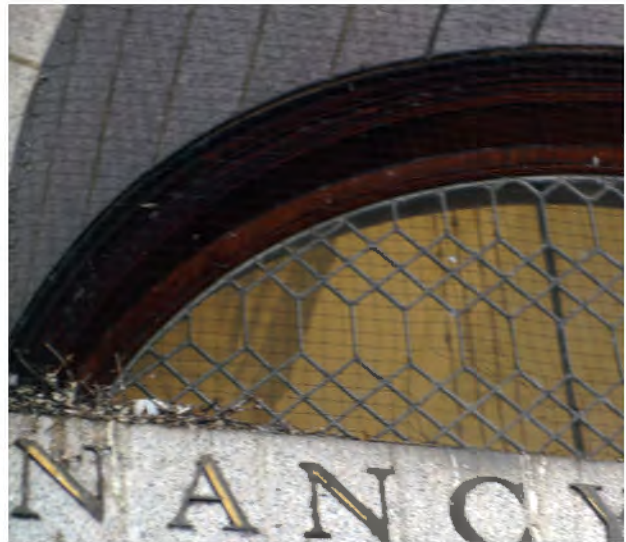
FIGURE 10: 11th Street Portico Pigeon Guano, September 2012. Photo Courtesy OLBN Inc.

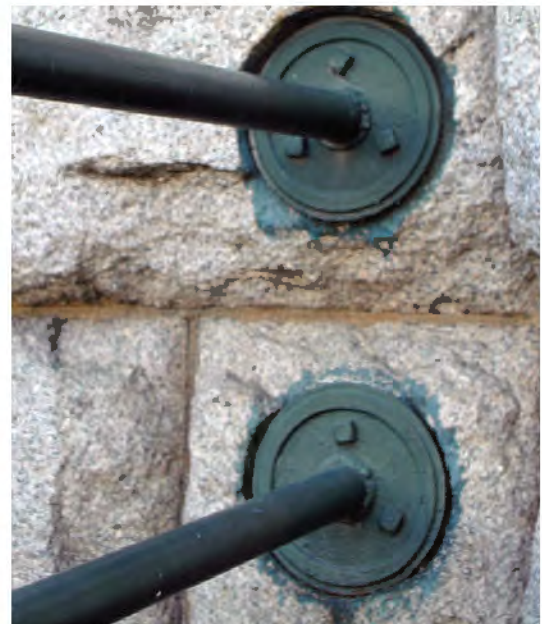
✦ **Paint:** There is a small amount of over-paint resulting from the last painting of the moat railings.

FIGURE 11: 12th Street Paint on the Granite Wall, September 2012. Photo Courtesy OLBN Inc.

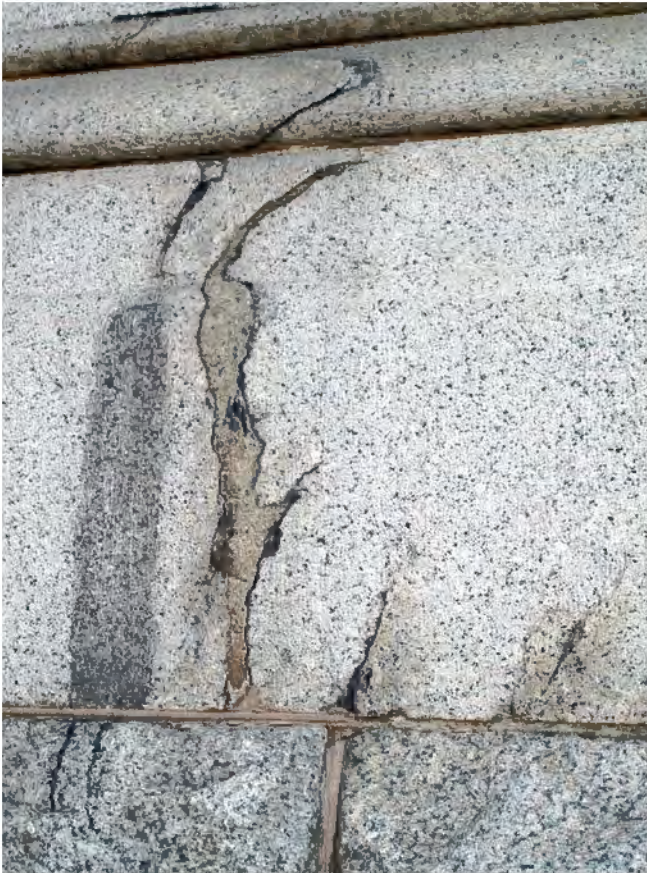
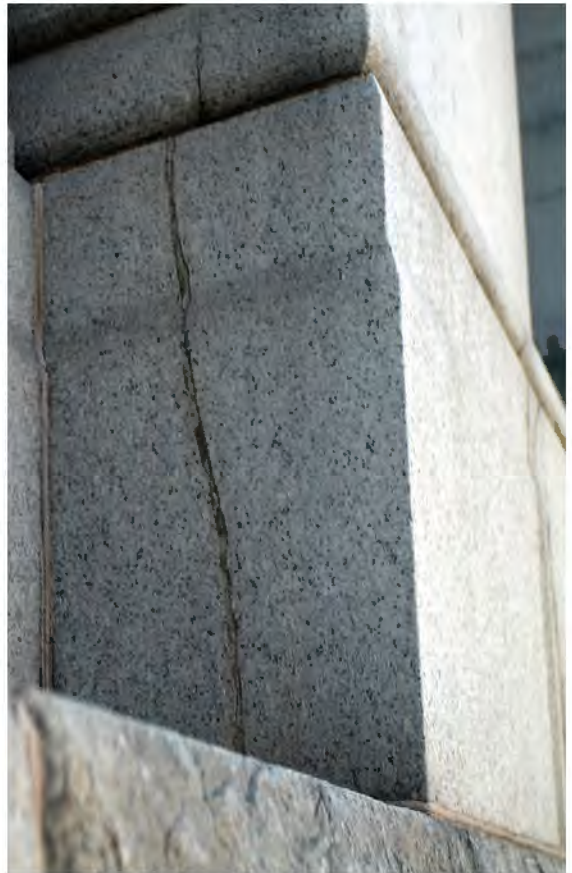
✦ **Failed Repair Campaigns:** There have been different campaigns to repair cracks and fissures that formed on masonry units. During one of those, some deteriorated stone units were patched using composite patching mortar. The composite patches do not match the adjacent stone in color or texture. Without testing the patching material, it is not possible to know whether it is as water-vapor permeable as the original stone. However, since most of the patches have deteriorated and separated from the stone leaving a gap for water to enter, the conclusion is that the patches are harder and less water-vapor permeable than the compromised stone.

FIGURES 12 & 13: 11th Street Portico Failed Repair Campaigns, September 2012. Photo Courtesy OLBN Inc.

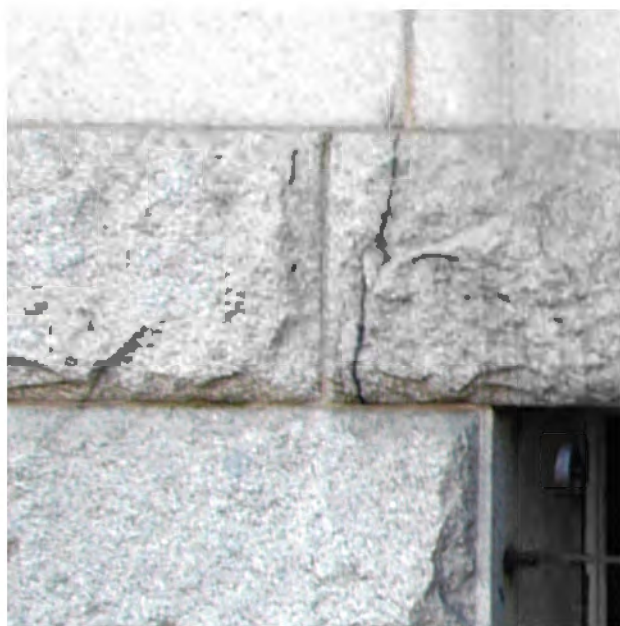
❖ **Cracks and Fissures:** Currently, there are again a few cracks and fissures in some of the stone units, indicating that the units are experiencing stresses beyond their capacity caused by minor shifting of the masonry, as was evaluated in 2006. Water, entering the stone at cracks and fissures, expands during its transformation to ice. Forces exerted during each freeze/thaw cycle stress the stone and cause cracks to increase in width, ensuring that more water will enter in the future.

FIGURE 15: Crack Above Basement Window,, September 2012. Photo Courtesy OLBN Inc.

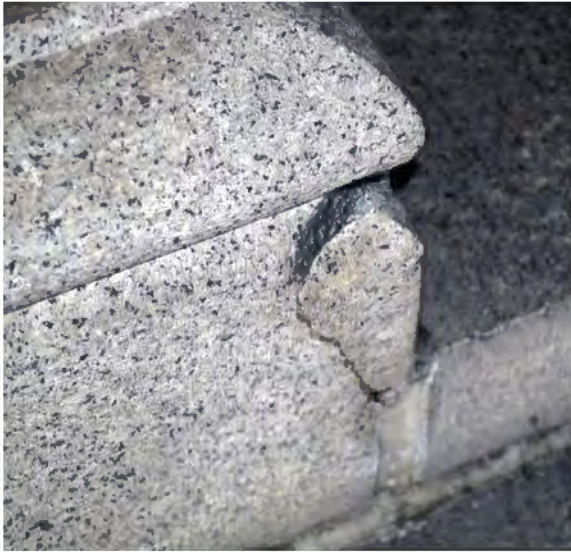
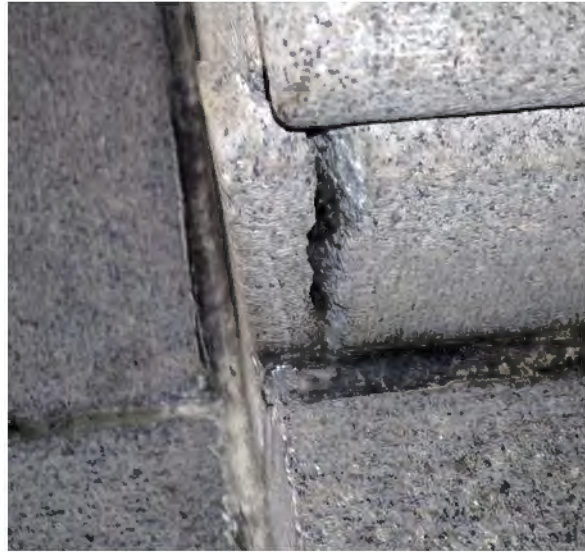
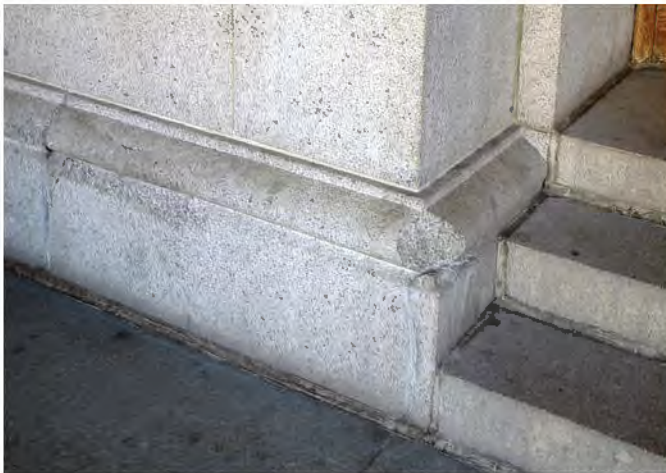
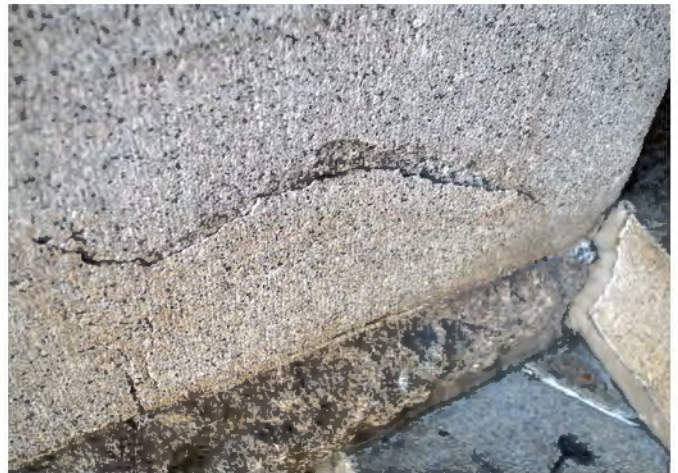
❖ **Spalling:** In a few locations sections of stone that have spalled, broken off but are still in place, but in some locations fragmented pieces of the granite are missing. This damage occurs where the stone is accessible to pedestrian traffic and de-icing salt is used. The structure of the granite is weakened by the dissolved de-icing salt, which is carried through the material in water and crystallizes inside the material near the surface as the water evaporates, as the salt crystals expand this builds up shear stresses which break away from the surface. The stone is then susceptible to damage from impact, as there are weak bonds at some locations in the material.

❖ **Fragmented Pieces:** In one location at the 12th Street portico, a fragmented piece of stone has been re-attached using a binding compound that does not match the stone in color or texture. Additionally, the binding material is separating from the adjacent stone, indicating that it is less water-vapor permeable than the compromised stone.

FIGURES 16, 17, 18 & 19: 11th Street Portico Cracks, Breaks & Spalling, September 2012. Photo Courtesy OLBN Inc.

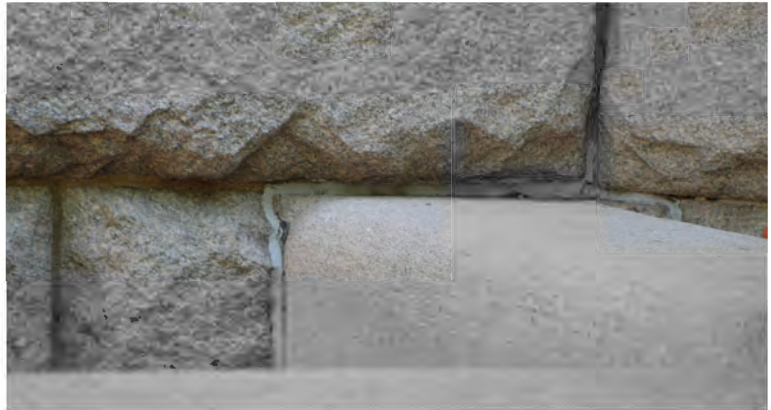
❖ **Failed Re-pointing Campaigns:** There is evidence of several re-pointing campaigns. In very few cases, the existing mortar was not matched, instead the joints in which the mortar had presumably failed, were filled or coated with a relatively water-vapor-impermeable compound. This type of compound, even if installed properly, is an inappropriate filler for joints. That is to say, even if this type of sealant is properly applied, it will prevent water from entering the joints and will not allow water or water vapor entering from other locations to exit the masonry at the joint. The trapped moisture can freeze, exerting pressure that will eventually damage the granite slabs. Same case scenario will occur if the joints were filled with a relatively water-vapor impermeable mortar.

FIGURE 21: 12th Street Failed Re-pointing Campaign, 2012. Photo Courtesy OLBN Inc.

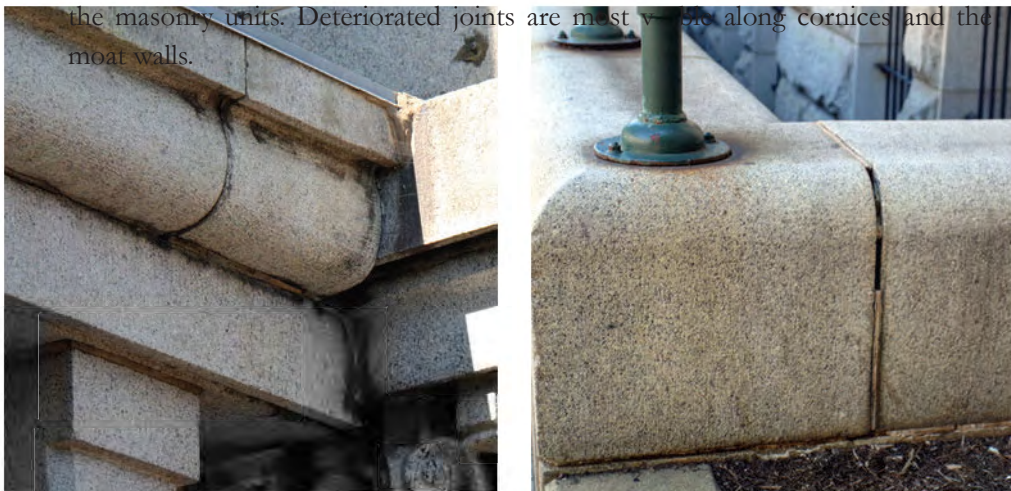
❖ **Missing & Eroded Mortar:** There are a few instances where joints are in poor condition; in some cases the mortar is deteriorated while in others is missing, allowing water to enter the masonry. As in the previous case, the water is then subject to the expansive forces of freeze-thaw cycles, and over time deteriorates the masonry units. Deteriorated joints are most visible along cornices and the moat walls.

FIGURES 22 & 23: Missing and Eroded Mortar, 2012. Photos Courtesy OLBN Inc.

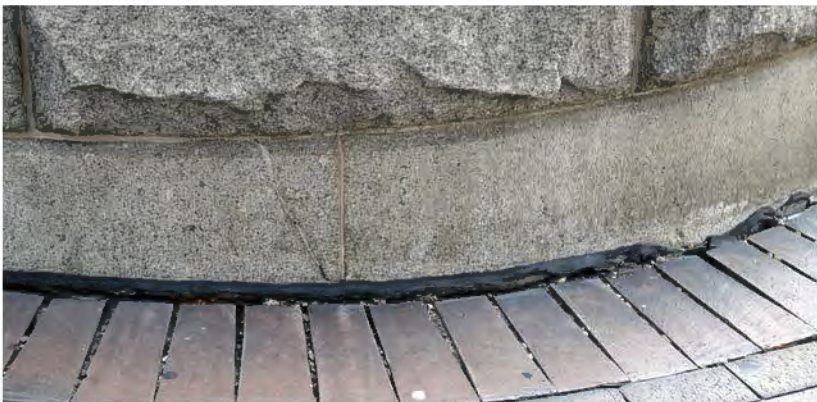
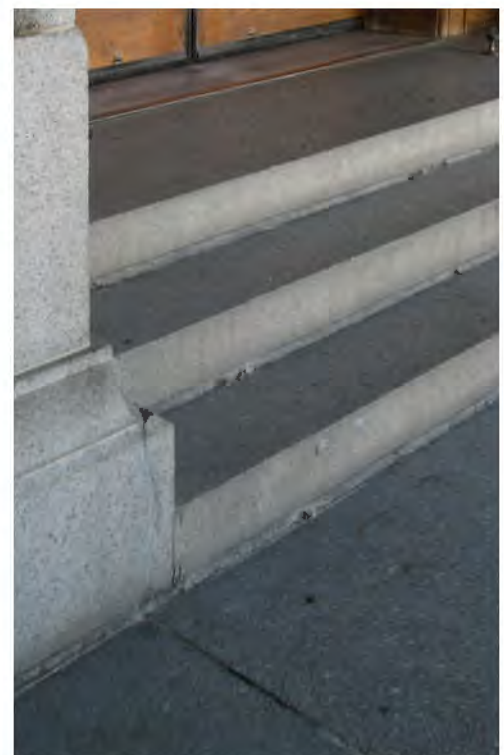
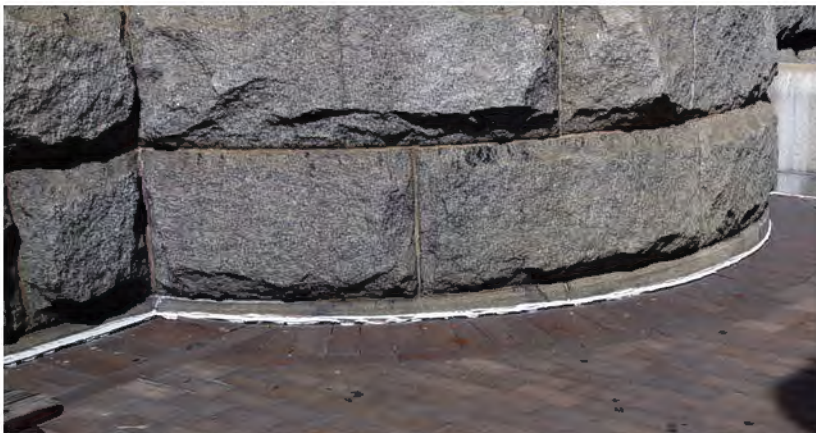
✦ **Bituminous Joints:** The bituminous joints along the base of the building, which cover the original mortar joint, is failing in several locations, specially along the north elevation. This condition allows for water to enter the structure. Additionally, the physical color, and profile of this bituminous joint is not uniform, varying from one section to another.

The bituminous joints along the granite slabs that form the 12th Street entrance are failing in several locations. This condition allows for water to enter the structure.

FIGURES 24, 25 & 26: Inappropriate Bituminous Joints Found Around the Perimeter of the Building, 2012. Photos Courtesy OLBN Inc.

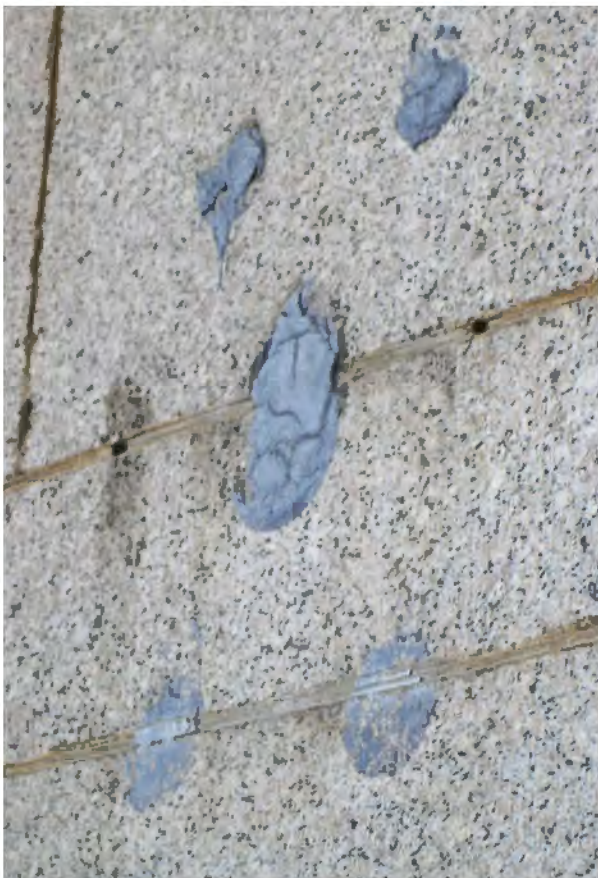
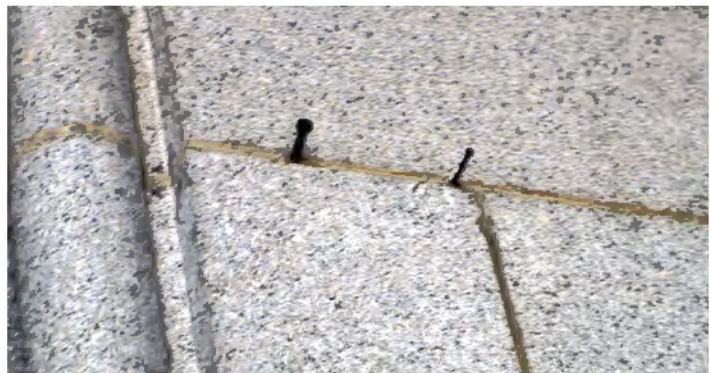
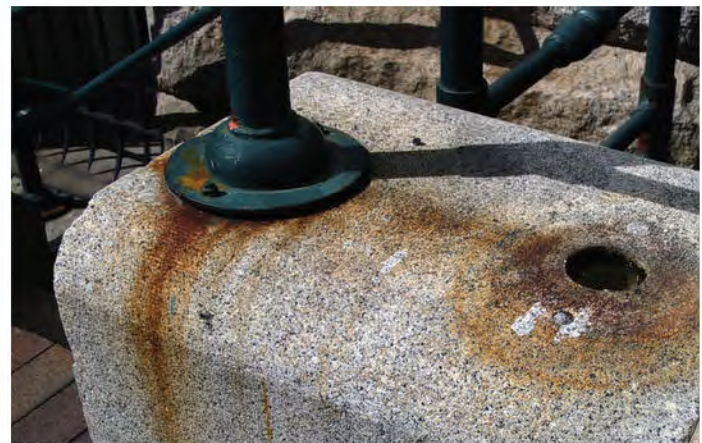
❖ Other adverse issues affecting the masonry are related to the anchoring into the masonry and subsequent removal of signs, light fixtures and flag stanchions among others. The abandon fasteners, and in some cases the holes created, allow for rust to stain the granite and water to penetrate the stone. In a few instances, the holes have been filled with filler compound that does not match the stone or the mortar in color or texture, and which hardness or water-vapor permeability without further testing is not known.

FIGURES 27, 28 & 29: Ferrous Anchors That Have Not Been Removed From The Masonry Wall Can Deteriorate The Granite, 2012.
 Photos Courtesy OLBN Inc.

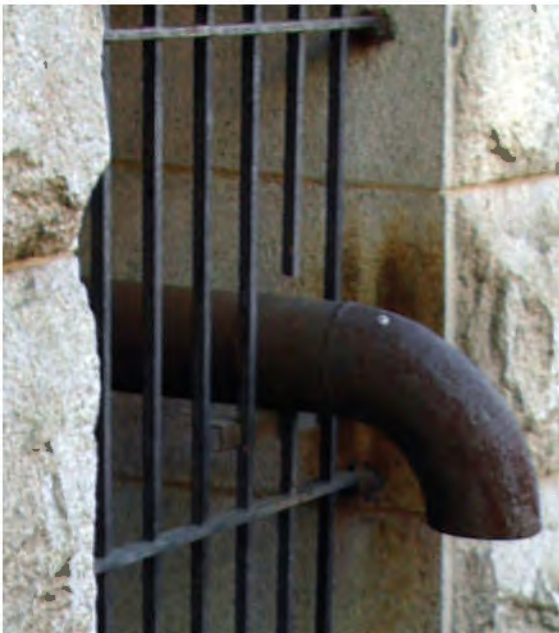
Other evidence of exterior corrosion is found across the Pennsylvania Avenue elevation where all the flag pole holders and miscellaneous ferrous fasteners attached to the granite walls are rusted, staining the stone.

FIGURE 31: Pennsylvania Avenue Window Guard. Its Anchoring Points Are Corroded, 2012. Photo Courtesy OLBN Inc.

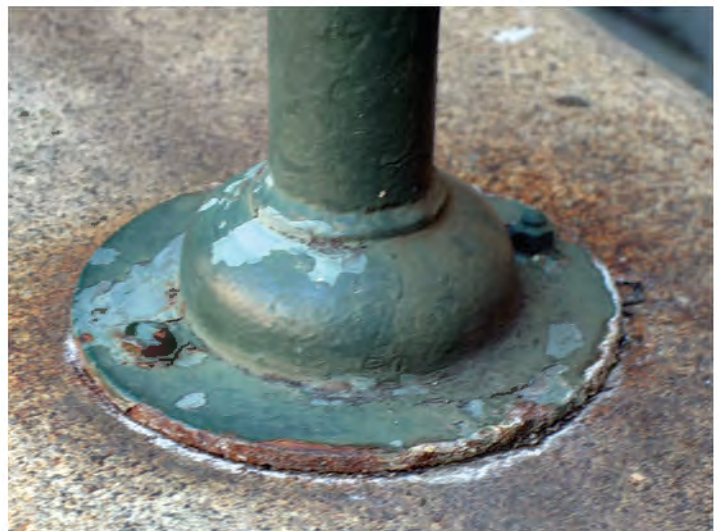
FIGURE 32: 12th Street Moat Railing Post Showing Paint Failure and Corrosion at the Base, 2012. Photo Courtesy OLBN Inc.

✦ **Paint:** The paint is failing or missing in the several sections of moat railing and basement window guards. Additionally, painted features and elements both exterior and interior, show dents, pits, scratches and paint build-up. In some instances is worn off.

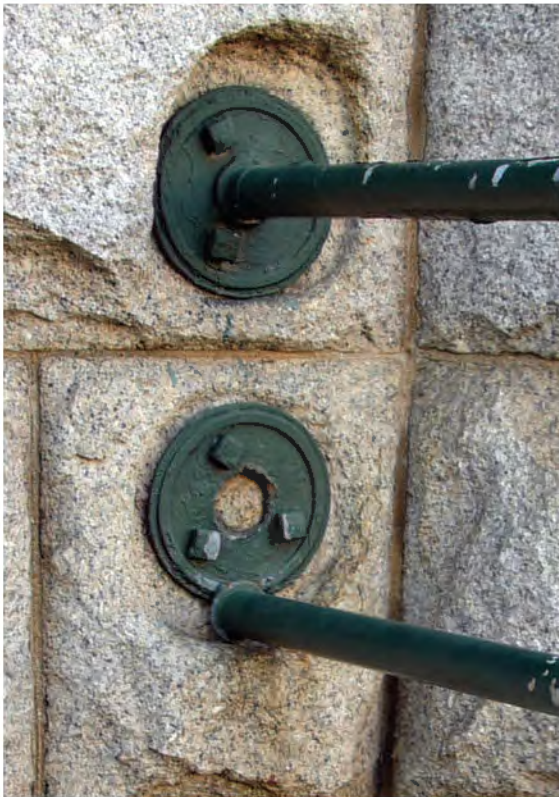
✦ **Breakage:** Limited breakage has occurred to one horizontal rail of the West Elevation moat railing.

FIGURE 33: 12th Street Broken Moat Railing, 2012. Photo Courtesy OLBN Inc.

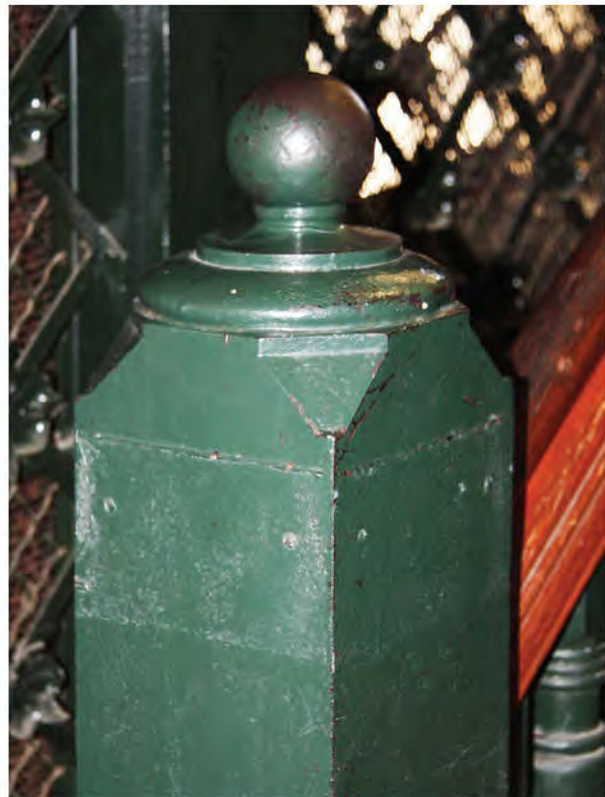
FIGURE 34: 12th Street 1st Floor Newel Post, 2012. *The paint has chipped and the red lead primer coat is starting to show in some parts, in others it has rubbed off.* Photo Courtesy OLBN Inc.

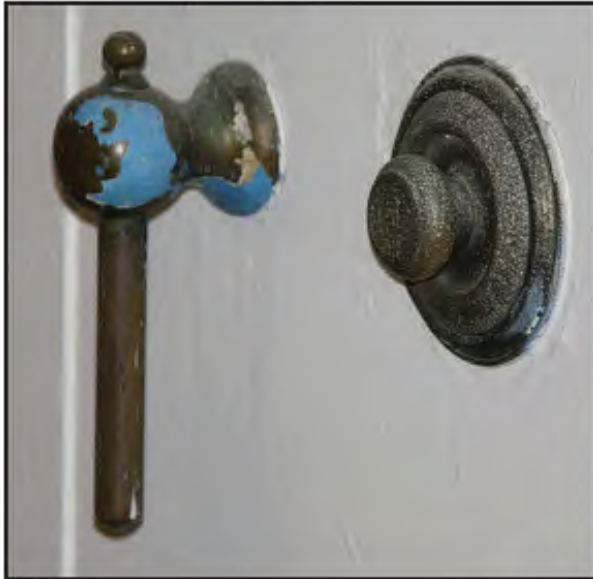
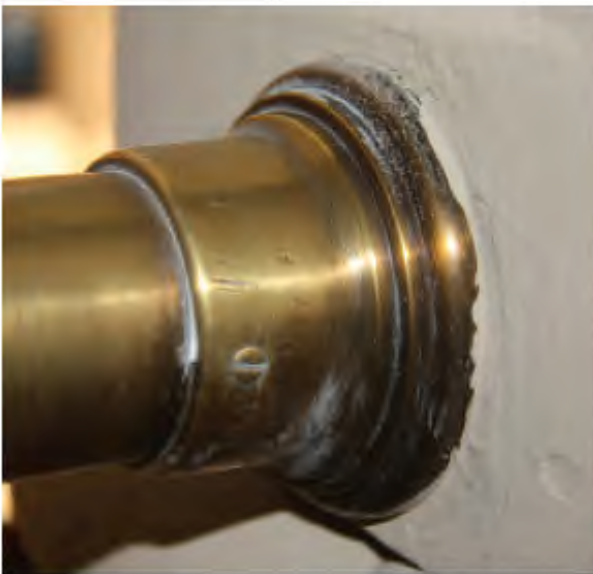
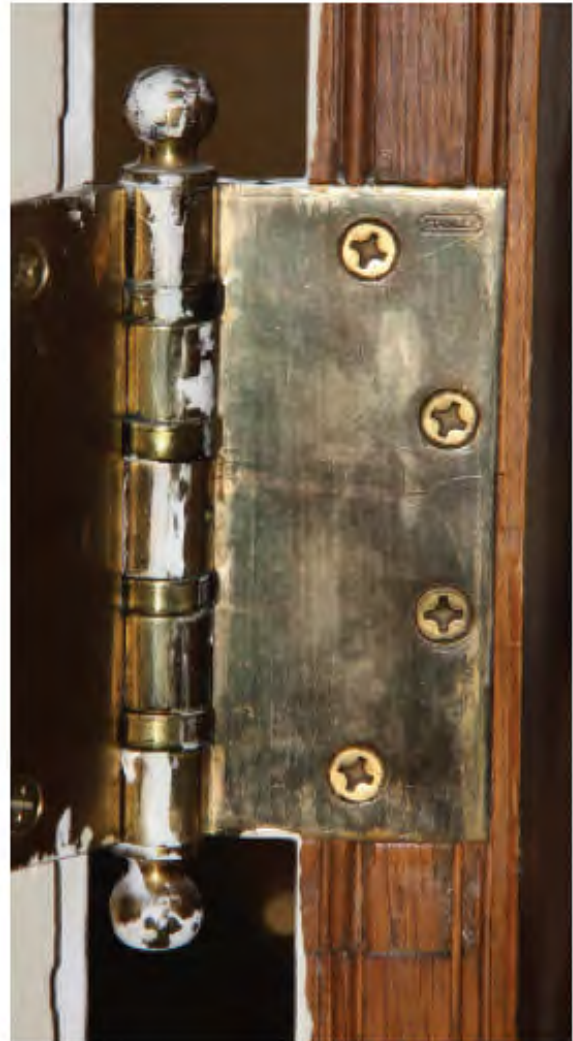
FIGURES 35, 36 & 37: Interior Features Showing Over Paint, 2012. Photos Courtesy OLBN Inc.

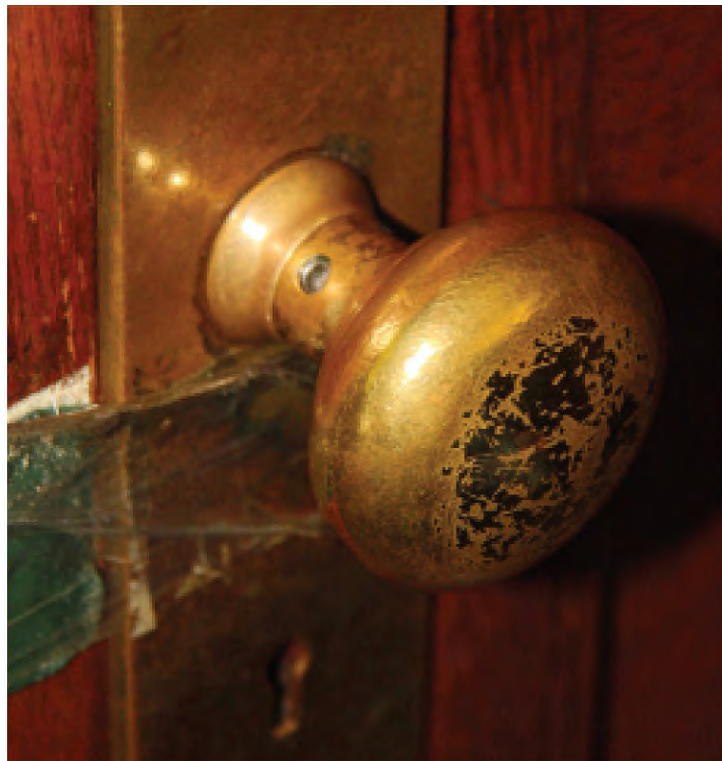
The most common deficiencies types found throughout the building's brass and bronze components are dents, pits, scratches, tarnish and paint spillover. Non-ferrous metals are easily deteriorated by the chemicals in the environment.

FIGURE 38: Interior Office Door Knob Showing Tarnish, and Overall Poor Condition, 2012. Photo Courtesy OLBN Inc.

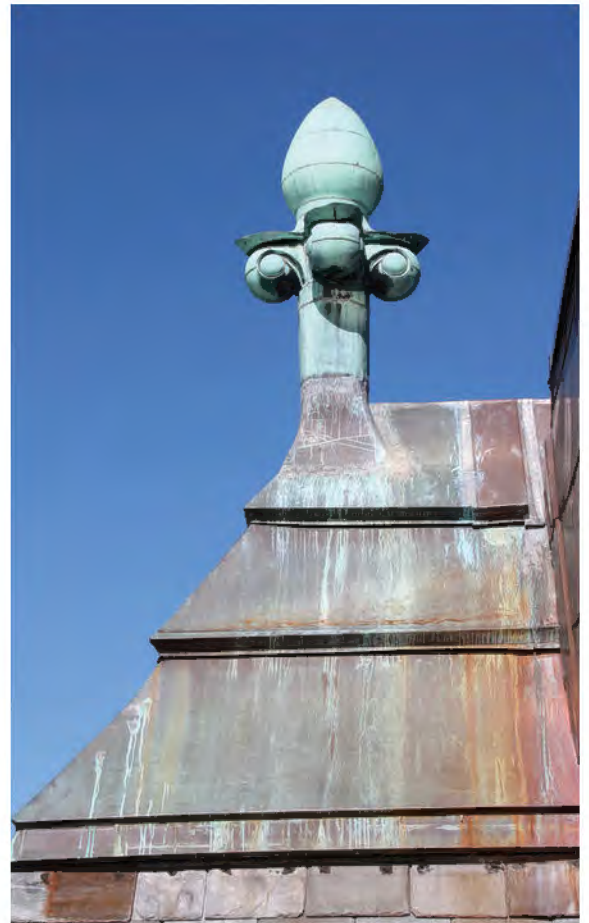
The the copper ridges are heavily stained not only by runoff from the corroding material in the sheet copper finial, but also by water that entered through open seams, now corrected since there is evidence of relatively new solder joints, which produced corrosion on the underside of the metal.

FIGURE 39: Copper Roof Finial on the Main Roof Ridge, 2012. *The Open Seams have been corrected since there is evidence of new solder joints, and old corrosion on the roof's copper gable.*
Photo Courtesy OLBN Inc.

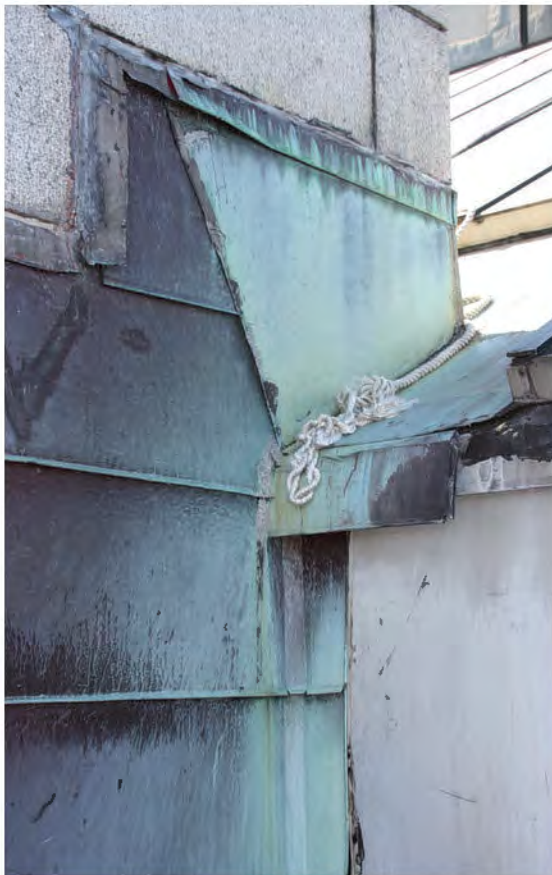
✦ **Flashing:** The flashings on the slate roofs appear to be in generally good condition, since most of the deteriorated copper flashing was corrected in 2006. In some locations the flashing was replaced, in others the damage was corrected by soldering the open seams. There are a few locations where a bituminous coatings applied to old flashings where it meets the building, most likely to correct interior leakage. There are no pieces of flashing missing.

FIGURE 40: Copper Flashing against Clock Tower Wall, 2012. *Some of the copper flashing folds and seams have been sealed with a bituminous coating, indicating the presence of leaks.* Photo Courtesy OLBN Inc.

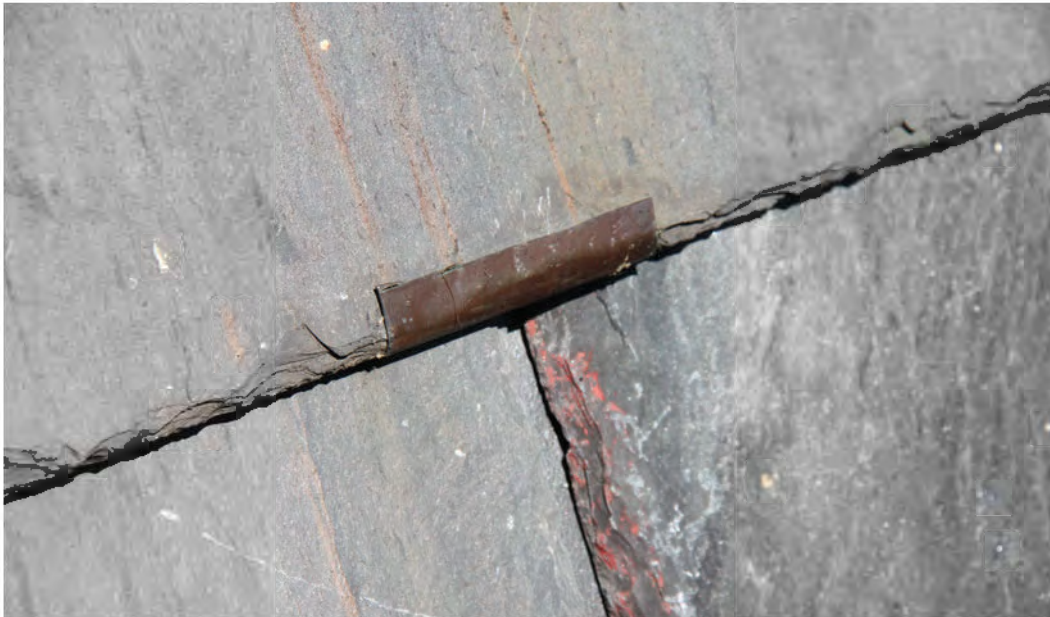
✦ **Replacement Shingles Installation:** Some of the slate shingles have been replaced with shingles that generally match the original shingles. The steep slope of the roof ensures that most of the water runs off without penetrating below the shingles as long as the shingles are sound and anchored in position. Most of the replacement slate shingles appear to have been installed properly, with a nail through the joint between the two shingles above. However, some shingles were installed using a sheet metal tab turned up over the bottom edge of the shingle, which is a type of repair not recommended where snow and ice can cause the tab to straighten out so that the shingle slips out of position.

FIGURE 49: Shingle Installed Using A Sheet Metal Tab Turned Up Over The Bottom Edge Of The Shingle, 2012. *This is a type of repair not recommended where snow and ice can cause the tab to straighten out so that the shingle slips out of position.* Photo Courtesy OLBN Inc..

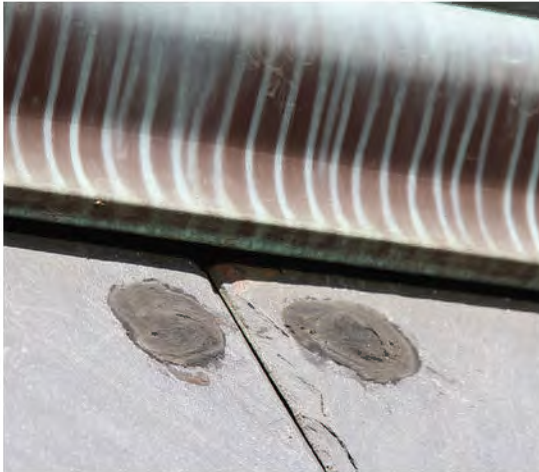
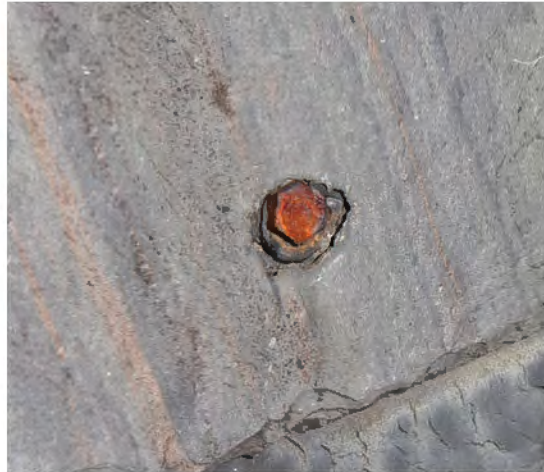
✦ **Improper Repairs:** A few instances were observed where shingles were face nailed to the substrate. In some cases patching compound was applied over the nail head, most likely after the nails popped up, and in others the rusted nail head remains without being corrected.

FIGURES 50 & 51: Improper Slate Repair u Face nailing the slates to the sheathing, 2012. Photos Courtesy OLBN Inc..

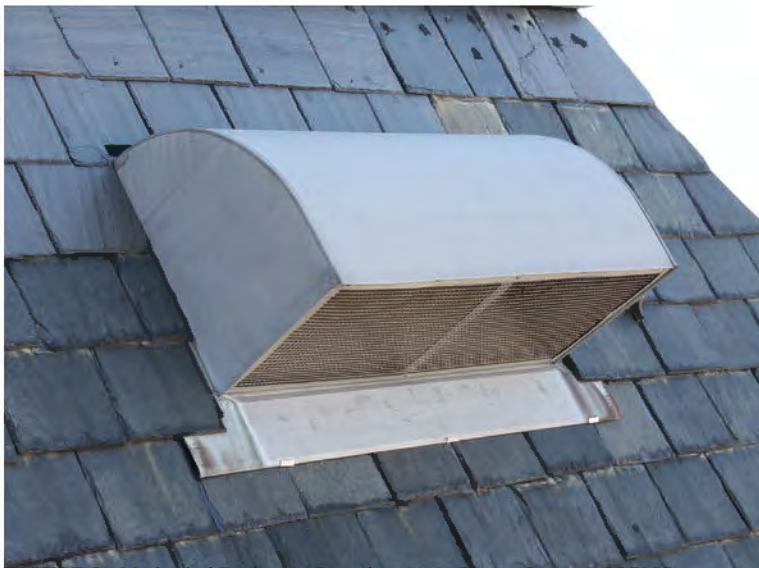
✦ **Mechanical equipment Intrusions:** Roof penetrations were created to accommodate mechanical exhaust vents. These cut outs create opportunities for snow and ice to accumulate affecting the integrity of the surrounding shingles.

FIGURE 52: Mechanical Equipment Intrusion, 2012. Photo Courtesy OLBN Inc..

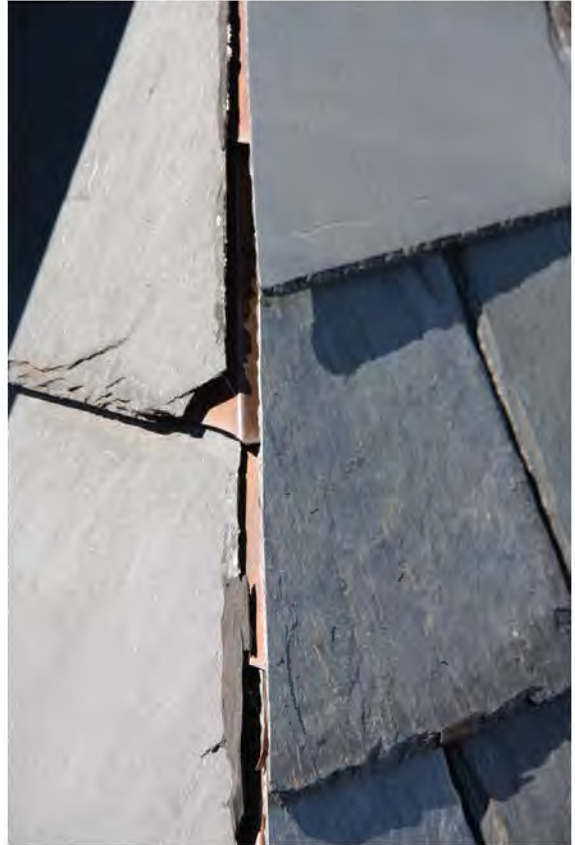
❖ **Open Hips:** There are open hips where the shingles have moved and potentially can allow water penetration.

FIGURE 53: Open Slate Hip, 2012. Photo Courtesy OLBN Inc..

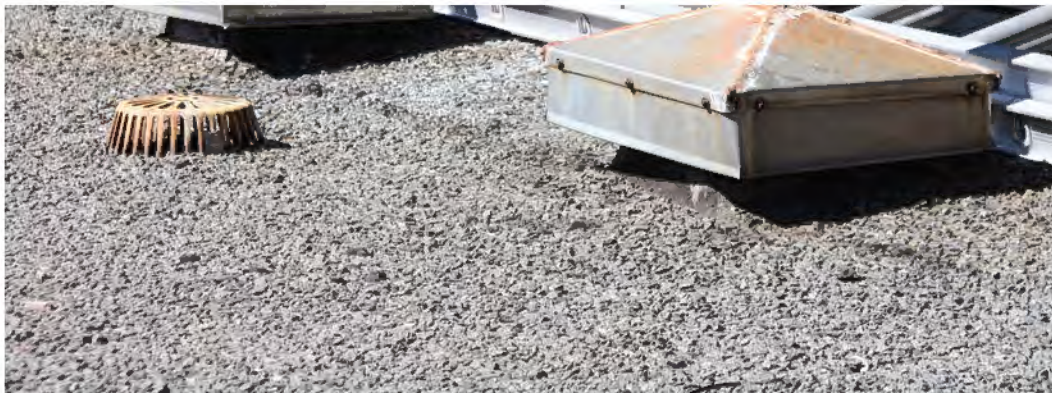
❖ **Built up Roof Penetrations:** There are deteriorated sections of flashing at many of the roof penetrations for plumbing vents and mechanical equipment, that pepper the flat sections of the roof. The loose and compromised flashing exacerbate the condition of the roofing membrane.

FIGURE 54: There Are Many Roof Penetrations Throughout The Built Up Roof Area, 2012. Photo Courtesy OLBN Inc..

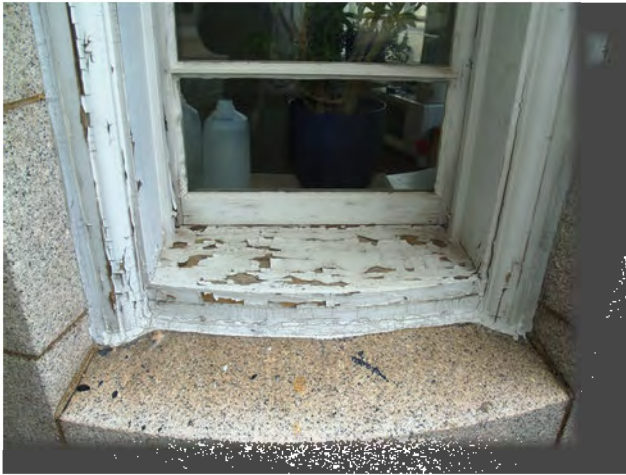
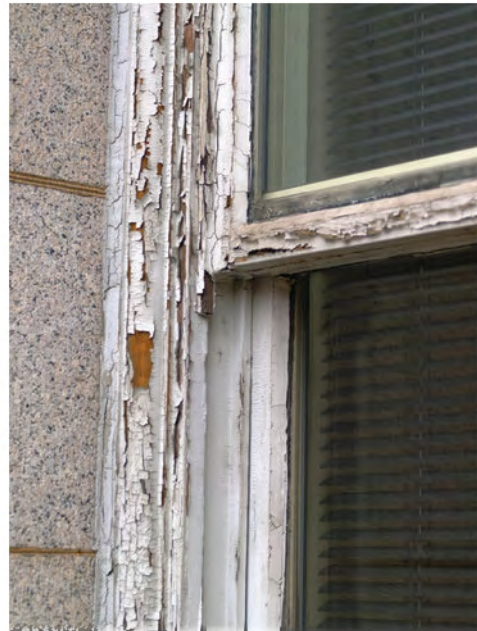
✦ **Paint:** The painted surfaces on many frames and sashes are exhibiting crazing and signs of paint failure. Others, the majority, have already failed; there is peeling, chipped and missing paint.

FIGURES 57 & 58: Windows Failing Paint, 2012.
Photos Courtesy OLBN Inc..
