Description of document: General Services Administration (GSA) Architectural Assessment Report on the Old Post Office Building, 2012

OLD POST OFFICE
HSR

EXISTING EXTERIOR CONDITIONS SURVEY

EXISTING INTERIOR CONDITIONS SURVEY

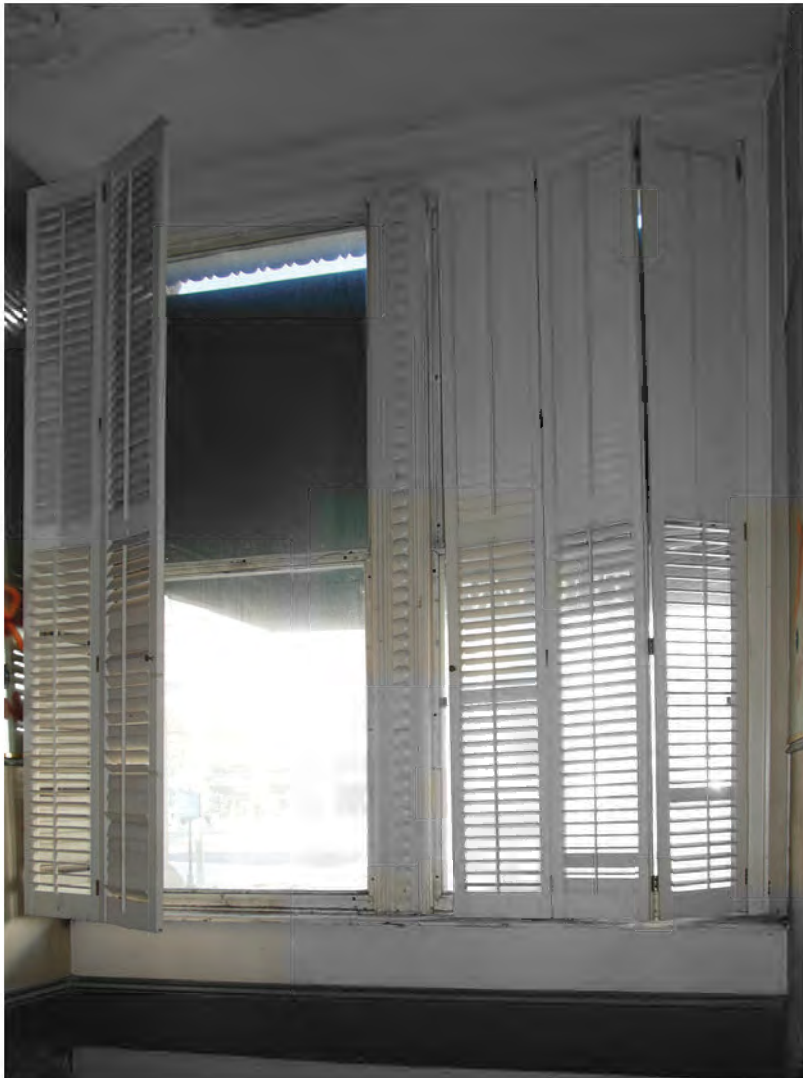
✦ **Additions:** Interior shutters and storm windows have been added in many locations. Exterior awnings have also been added to the north, east and west elevations' first floor windows.

FIGURE 60: Interior Shutters Added in 1979, 2012. Photo Courtesy OLBN Inc..

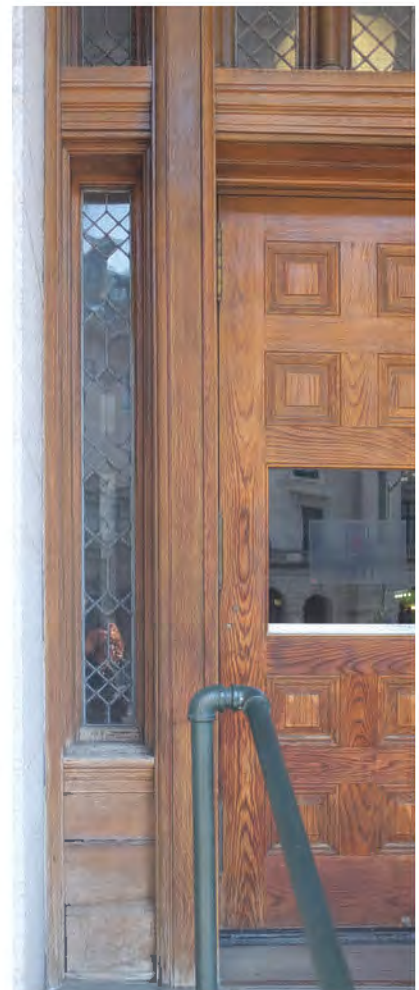
✦ **Sidelight Condition:** The sidelights are in generally good condition, but there is damage and deterioration below the glass panels, where water can rise through the end grain of the wood. Joints between some of the wood boards glued together to form the sidelights bottom rails have begun to fail, allowing the wood panels to separate.

FIGURE 61: Exterior Door Sidelight, 2012. *There is damage and deterioration below the glass panels, where water can rise through the end grain of the wood.* Photo Courtesy OLBN Inc..

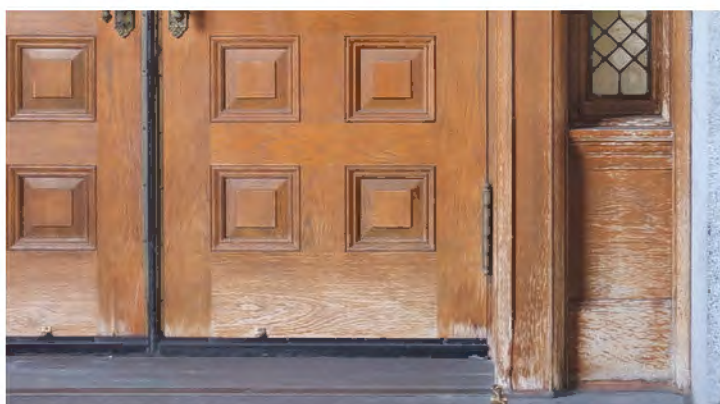
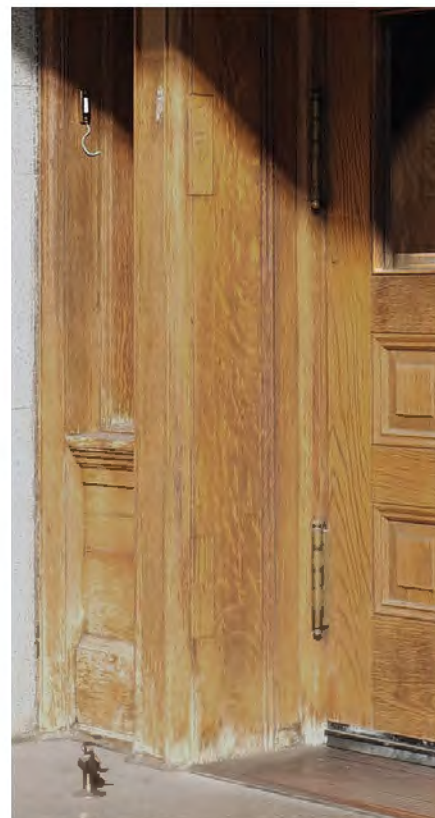
❖ **Frames:** Wood at the bottom of some frame members have started to rot, leaving holes, and small sections of wood are missing. Some ends of stiles are split. The finish on certain areas of the frames is uneven and dirty.

FIGURES 62 & 63: Door and Frame Condition, 2012. *There are signs of weathering, particularly near the bottom the doors, where water can splash on the surfaces.* . Photos Courtesy OLBN Inc..

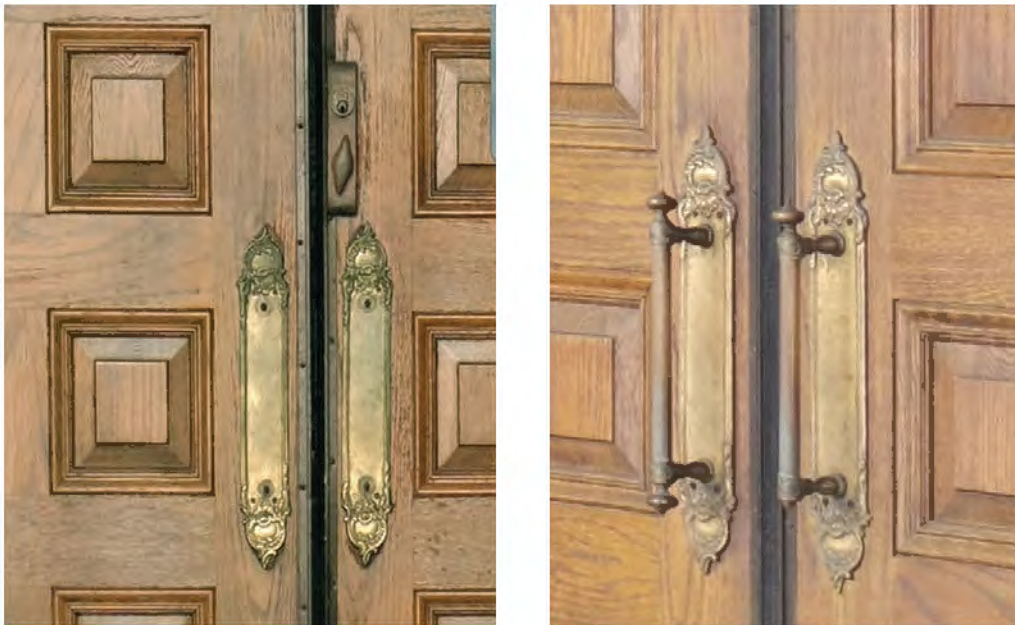
❖ **Hardware:** The replacement hardware on the wood doors is generally a copper alloy metal, generally referred to as bronze, but probably technically brass. Finishes on the hardware vary. There are various degrees of patina—sometimes bronze-colored and sometimes varying stages of the typical green corrosion product of unprotected copper alloys exposed to the atmosphere. In some locations, the orig-

FIGURES 64 & 65: Exterior Door Hardware, Showing Different Stages Of Weathering, 2012.
Photos Courtesy OLBN Inc..

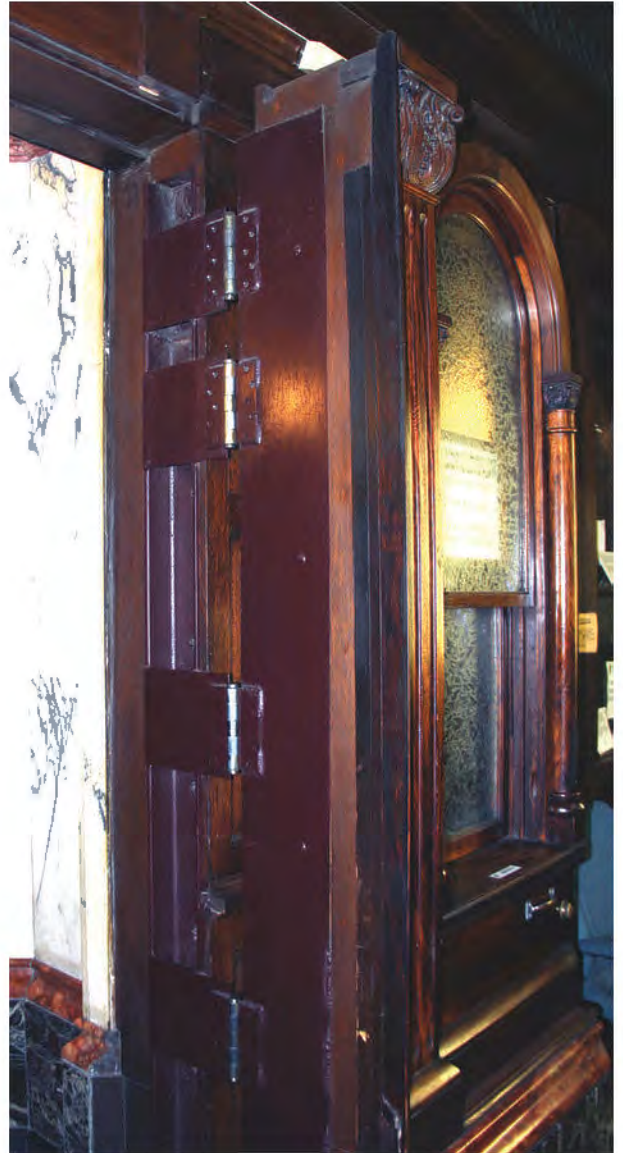
✦ **Alterations:** During the 1979 renovation, the eastern bay of the was converted into a door to access the newly created postal boutique. For this purpose, the entire section of wall from the entablature down, was cut off from the rest of the feature wall and re-assembled. Steel plates were used to hold the wall parts together, while closing the exposed edges. In order to install hinges strong enough to move the heavy wall, an steel “C” channel with welded extension tabs was bolted to the central masonry pilaster. Five steel hinges bolted to the tabs and the wall’s edging plate allow for the massive door to swing into the postal store.

FIGURE 66: Mahogany Feature Wall Showing Hinges Installed in 1979, When a Section of the Door Was Converted into a Door, 2012. Photos Courtesy OLBN Inc..

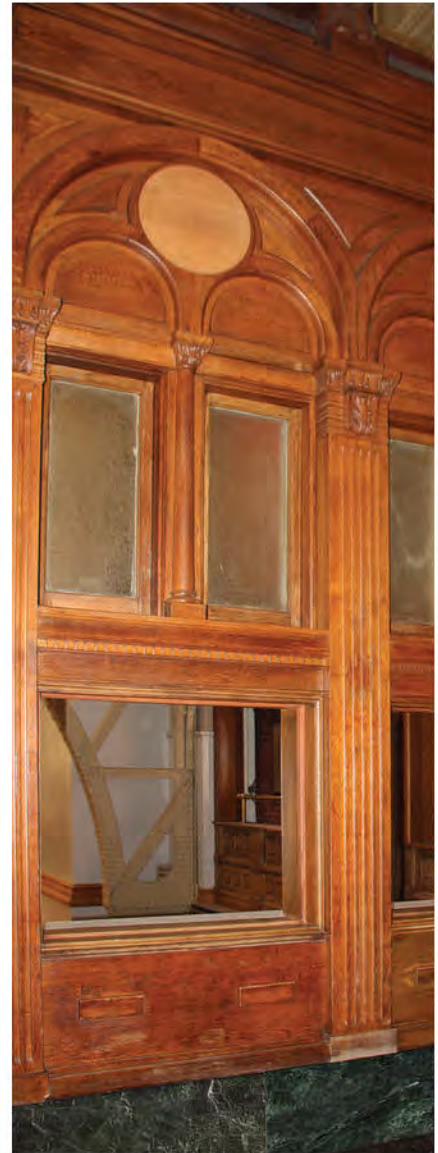
✦ **Screens Condition:** The condition of the original screens varies; the upper sections are in good condition, the joints between the casings, mouldings, fluting, plinths, curved work and cornices are tight and there are no loose wood work. The only deficiencies found affecting the upper section of the screens are the expected wear from aging and some minor unevenness of the worn out finish and dirt accumulation. The lower sections of the screens shows severe wear and mechanical impact.

✦ **Mechanical Damage:** Cracked, scratched, broken, chipped and worn pieces associated with impact damage can be seen on the surface of the screens lower sections window sills, paneling and trim

FIGURE 67: Original Oak Screen Wall from the 12th Street Corridor, 2012. Photos Courtesy OLBN Inc..

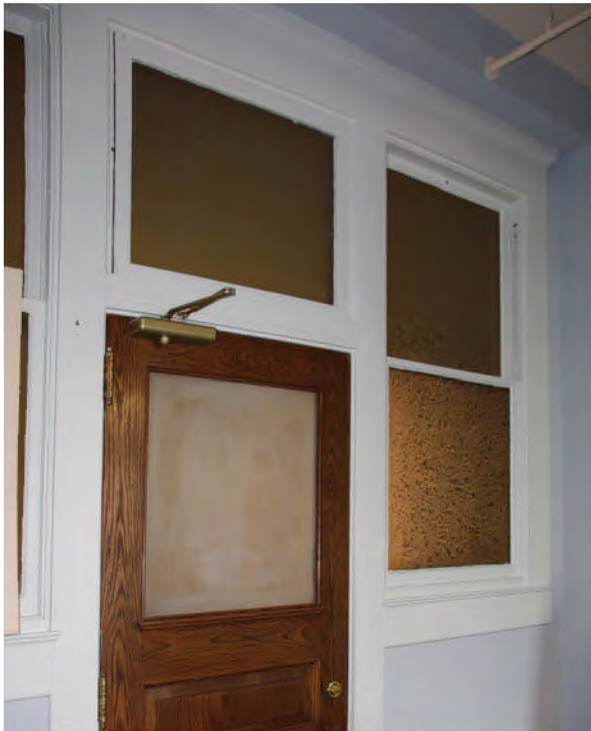
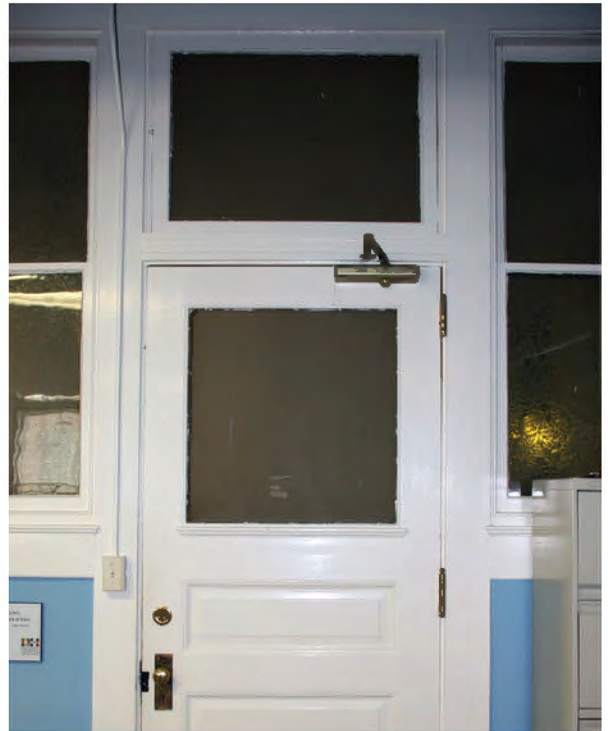
FIGURES 69 & 70: 4th Floor Offices Showing Different Treatment of the Cortile Corridor Wall, Office Side, 2012.
Photos Courtesy OLBN Inc..

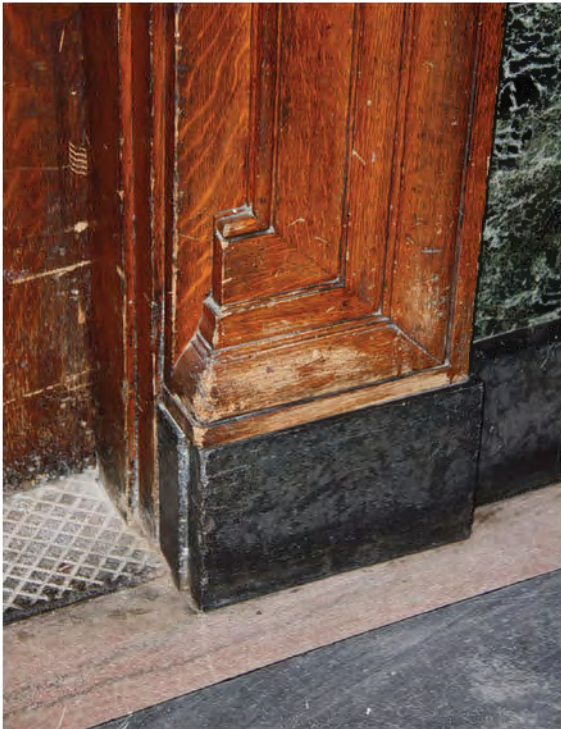
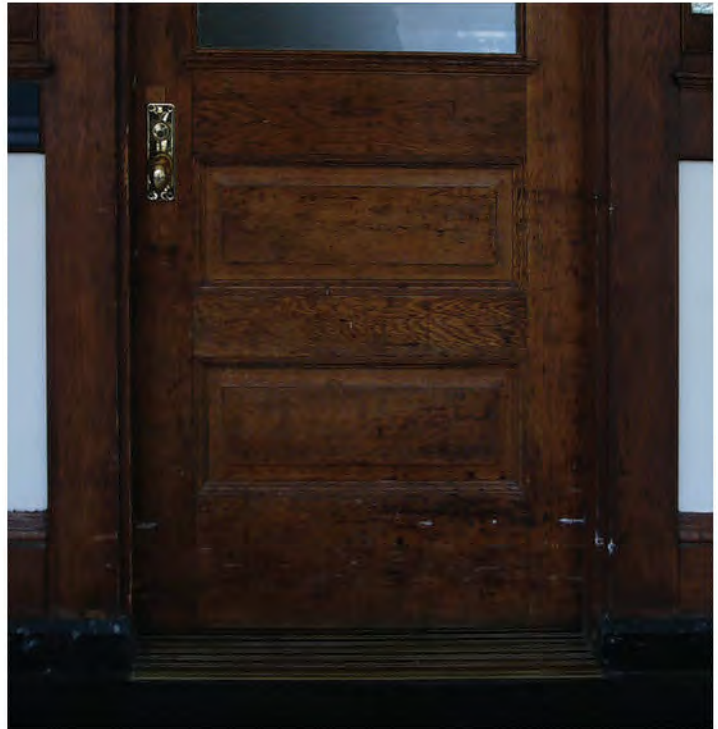
✦ **Door Assemblies Condition:** The doors and their casing are in good condition despite showing signs of wear from use. The finish on the doors is worn and dirty, particularly at the bottom. Some of the wood members have nicks, gouges, and other physical damage. In a few locations, the wood is cracked and broken. Wood near the bottoms of the doors and trim has been scratched and dented by equipment that hit them.

FIGURES 71 & 72: Condition of the Lower Sections of Some of the Doors' Rails and Jamb, lining the Cortile Corridor, 2012. Photos Courtesy OLBN Inc.

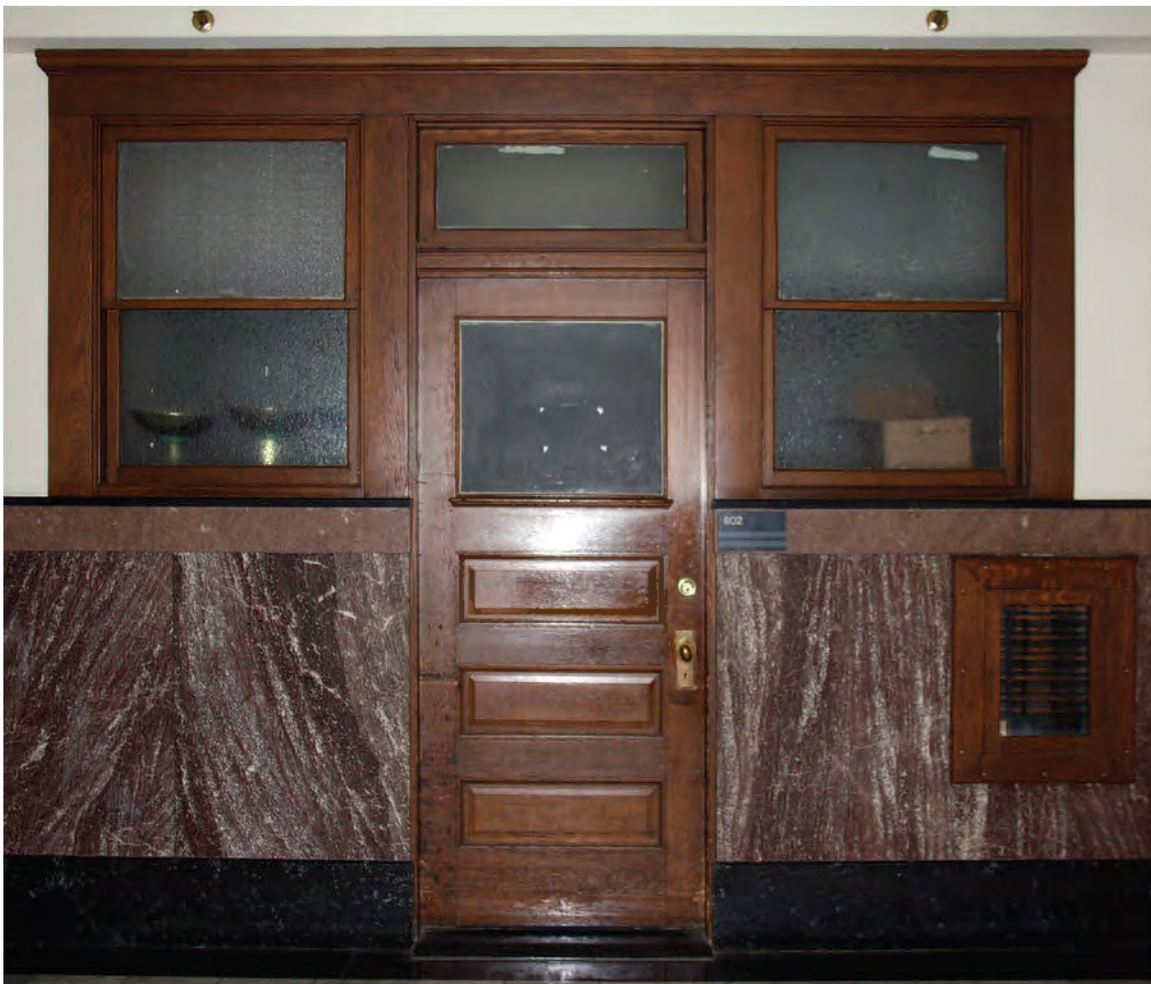
FIGURES 73: Office 602, Door, Windows and Casing Remain as They Were Originally Built, 2012. Photos Courtesy OLBN Inc..

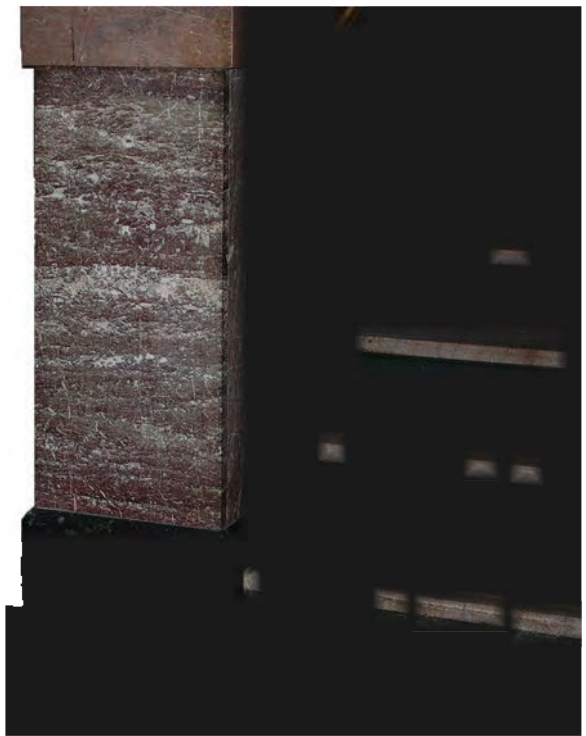
✦ All of the ornamental elements at the Old Post Office entrance and circulation lobbies are in good condition, showing minor signs of wear, such as small chips and hair line cracks. The marble elements are well maintained, free of staining and soiling.

The stair treads are in good condition, showing normal to heavy wear, some chips and minor cracks. Anti slip strips have been installed on each tread.

FIGURE 74: First Floor Newel Post , 2012. Photo Courtesy OLBN Inc..

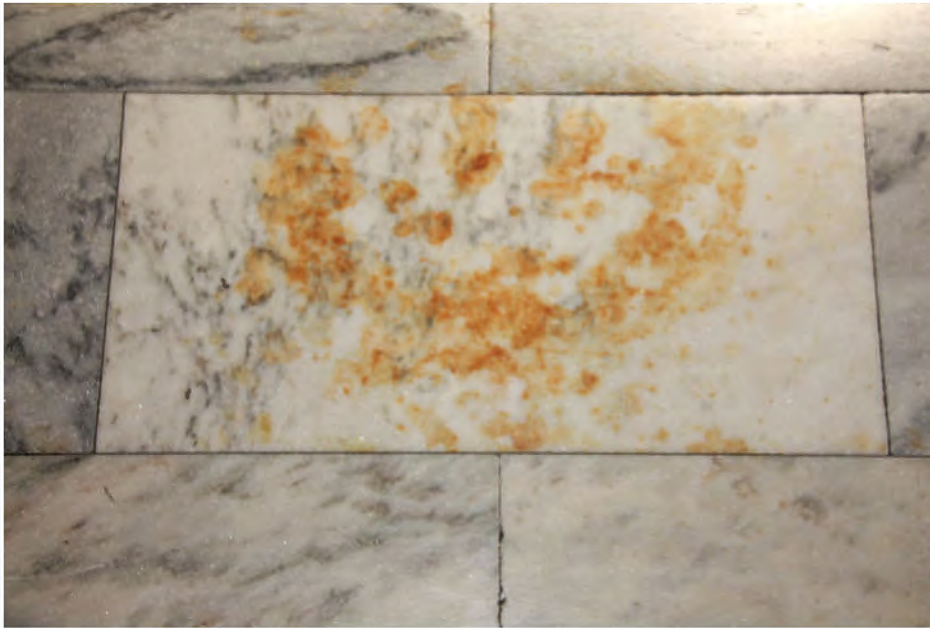
✿ **Staining:** Rust stain from old file cabinet can be observed along the corridors

FIGURE 75: Rust Stains on the Corridor's Marble Floor, 2012. Photo Courtesy OLBN Inc..

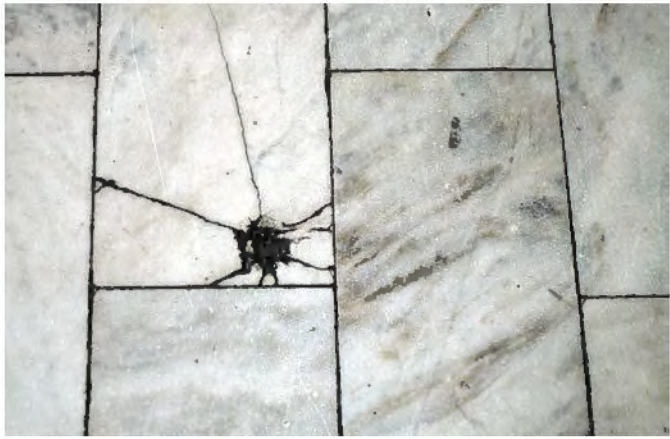
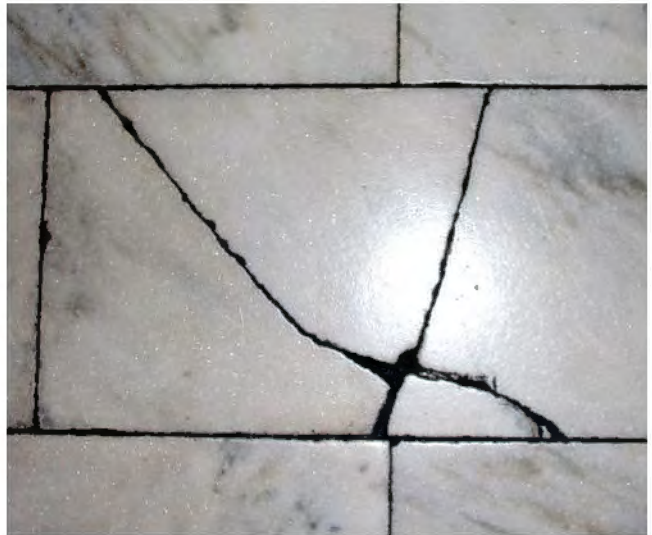
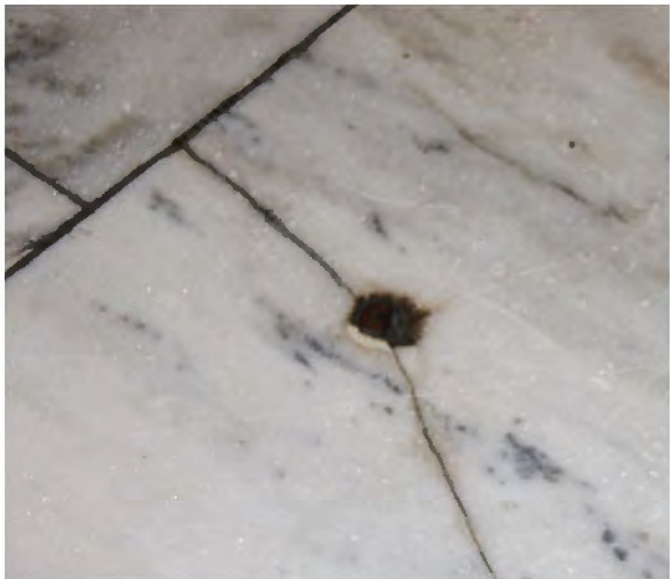
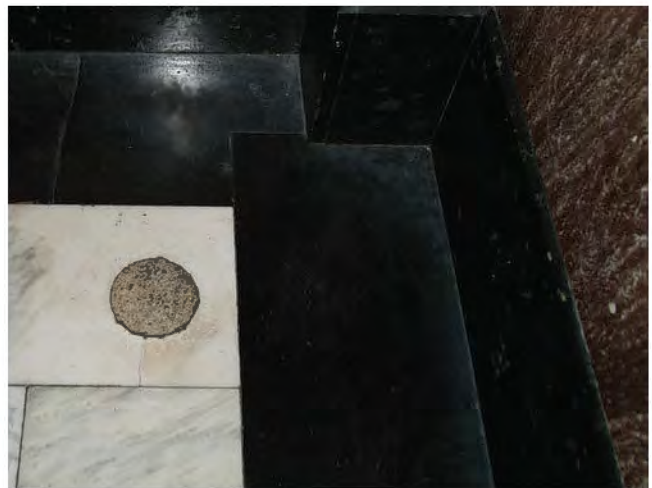
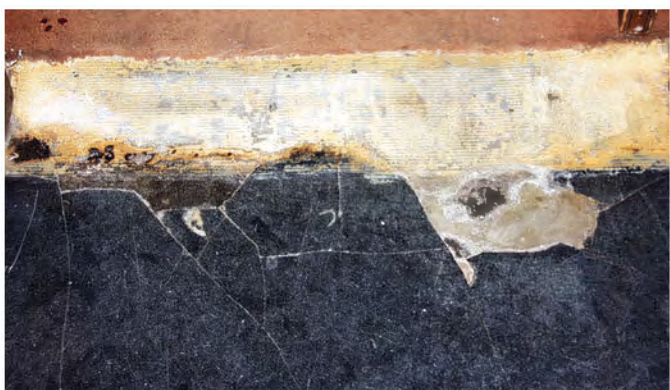
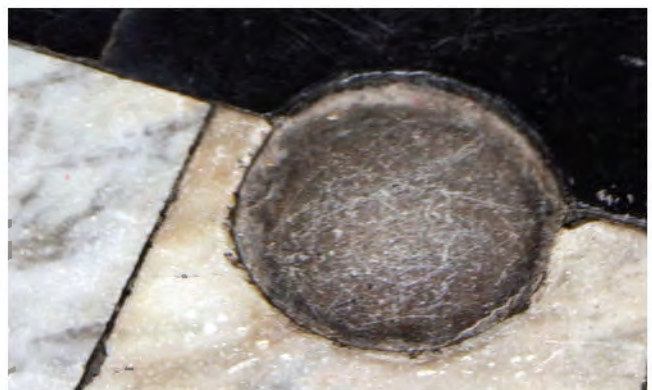
✿ **Mechanical Damage:** Cracked, broken, chipped and worn pieces in all corridors and lobbies associated with impact damage, aging and use.

In some locations there is evidence that previous pipes or heavy equipment was removed. In those cases the remaining holes have been patched with a grout, which does not match the adjacent marble. In other locations the holes have not been filled.

FIGURES 76, 77, 78 & 79: Different Types of Mechanical Damage Inflicted on the Marble Floor, 2012. Photos Courtesy OLBN Inc..

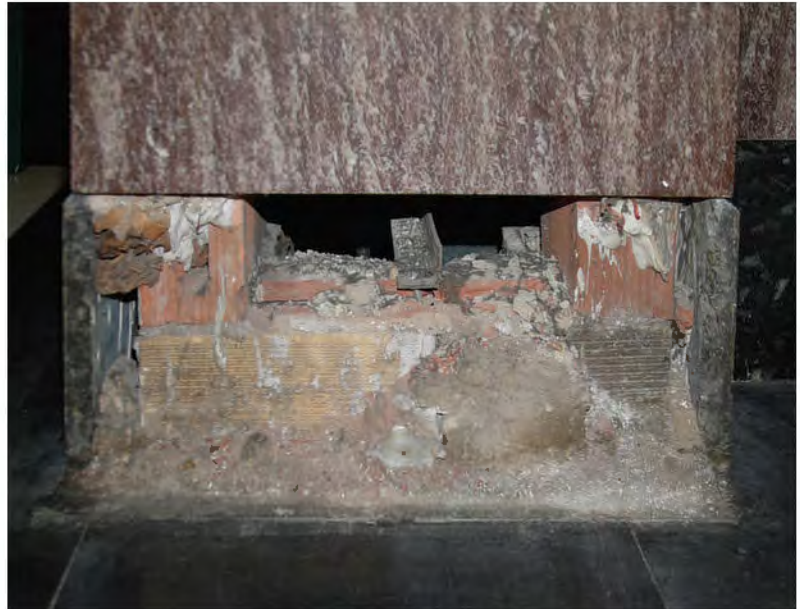
FIGURE 85: Missing Baseboard Slab, 2012. Photos Courtesy OLBN Inc.

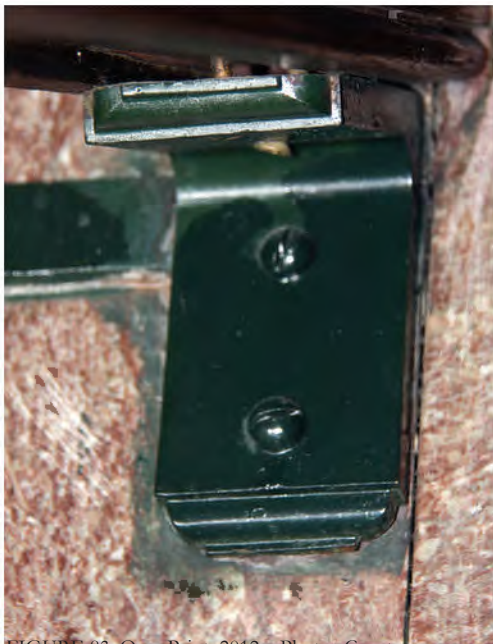
FIGURE 83: Over Paint, 2012. Photos Courtesy OLBN Inc.

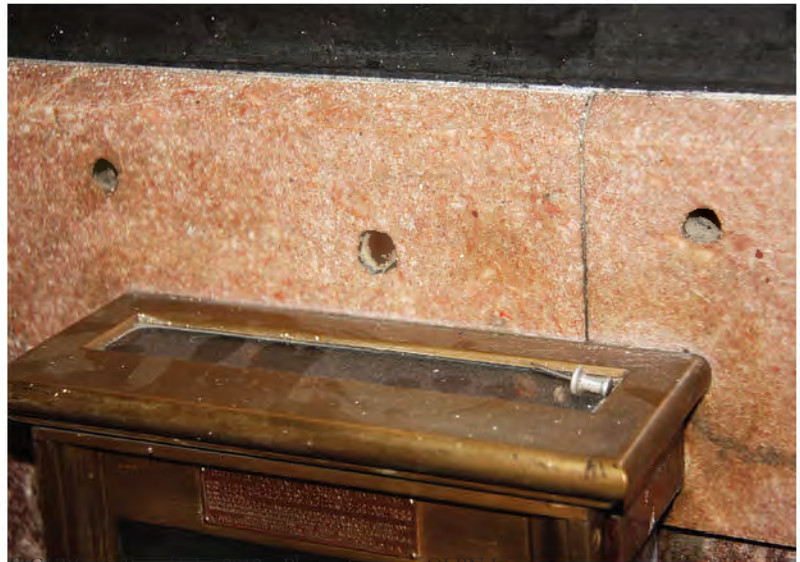
✦ **Bore Holes**

FIGURE 85: Bore Holes 2012. Photos Courtesy OLBN Inc.

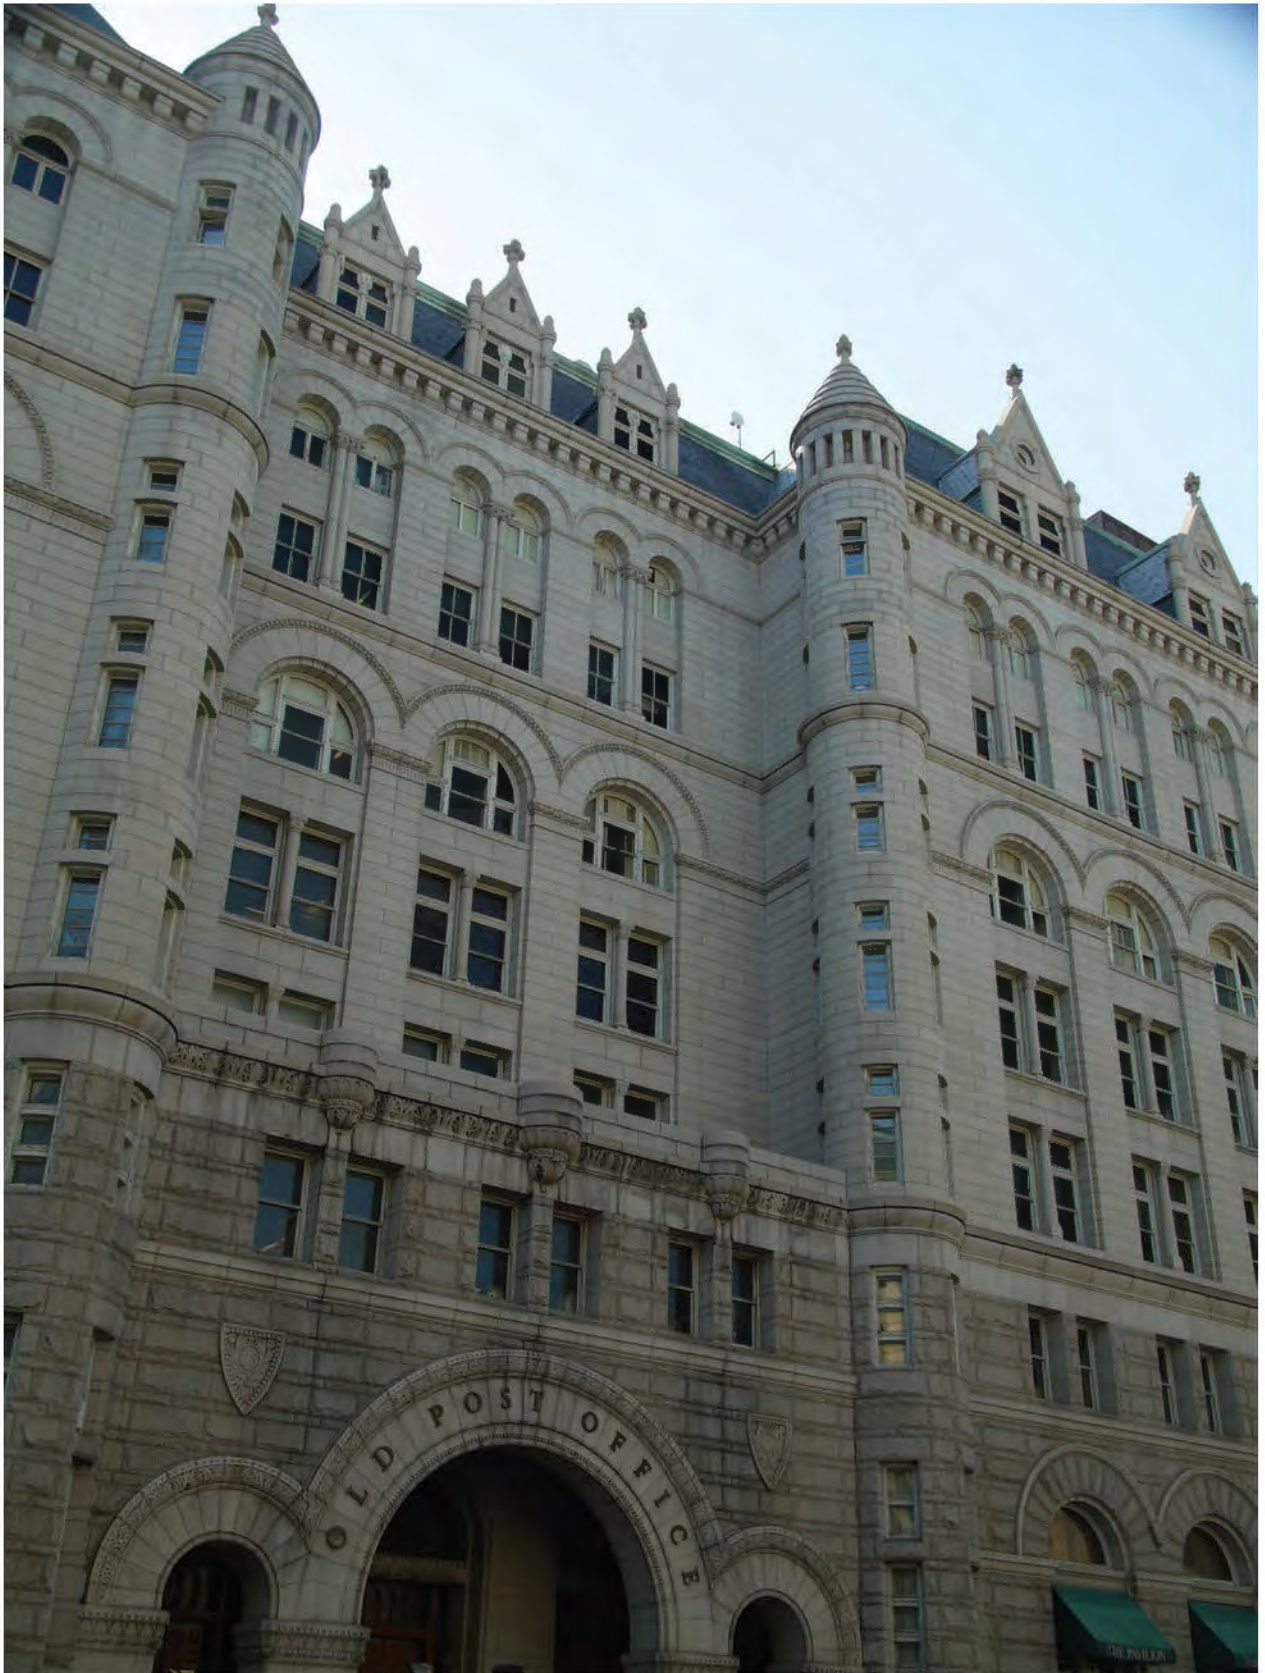
FIGURE 17: Partial View of the 12th Street Elevation of the Old Post Office Looking South, 2012. Photos Courtesy OLBN Inc.

Currently, the exterior granite cladding of the Old Post Office is in good condition, without structural problems but with some stone deterioration and a few cracks and holes in stone units, as well as a few deteriorated joints that allow water to enter the masonry.
